# McCarthy Middle School

## ARCHITECTURAL ASSESSMENT

The building survey for this report was conducted on February 16, 2016.

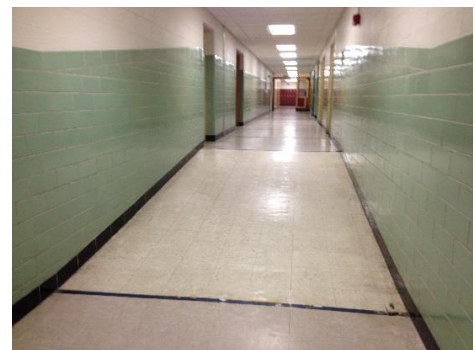
Image 10

- Regrade ramp in corridor to meet required maximum slope, install handrails on each side and new textured flooring or regrade to meet requirements of sloped walkway (Image 10)

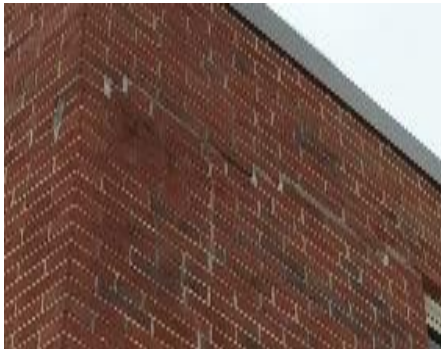
Image 19

- Exterior walls are mostly brick veneer w/CMU backup in fair condition. There are indications of moisture infiltration in some areas (Image 19 & 20).
- Some brick are protruding/cracking from the wall at southeast corner along North Rd. (Image 19).
- Wall cavity moisture/efflorescence is seen in multiple brick/opening locations (Image 20).
- Some weeps have been blocked by debris or insects.
- Control joints are in fair condition throughout the school.
- Pod classrooms are wood cladding and are in fair to poor condition. Many gutters and downspouts

- Discover the source of moisture infiltration and develop program for repair
- Remove bricks that are in need of realignment, install new bricks to allow proper ventilation and drainage from wall cavity.
- Remove debris from weeps to allow proper ventilation and drainage from wall cavity.
- Replace pods
- Install gutters and downspouts that are missing or damaged

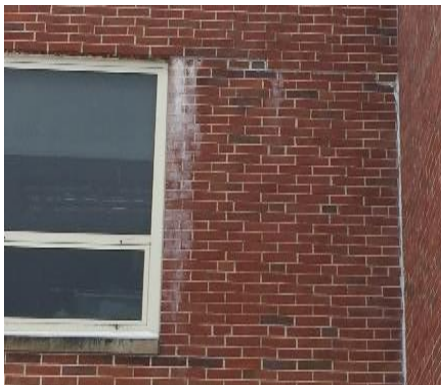
Image 20

are damaged or missing causing water runoff and staining. (Image 20).

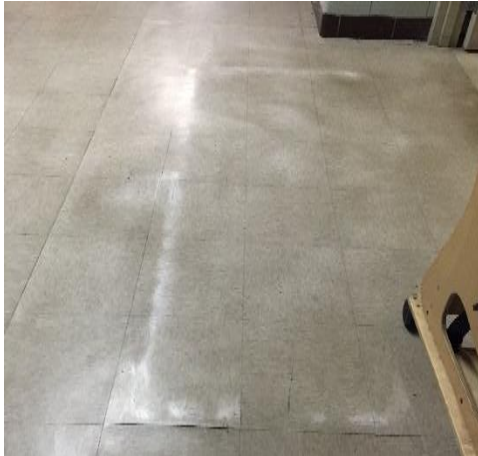
Image 26

- Sports flooring system in aux gymnasium and large gymnasium with a faux wood finish is in fair condition.
- Corridors in original building have VCT floors in fair condition. Patching is noted in a few locations where door entries have been renovated. Cracking and heaving is also visible in several locations (Image 26).

- Install non-slip material at the ramp to meet current codes.
- Proper slab measures to correct VCT cracking and heaving.

- Replace aux gym floor
- Review conditions of heaving and cracking in the VCT tile, replace and repair tiles
- Clean quarry tile in the kitchen area, replace tiles as needed.

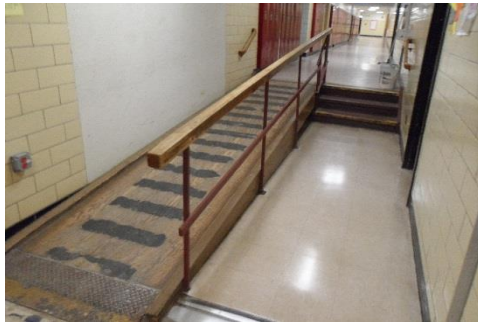
Image 27

- Corridor stairs have metal treads in fair condition. Corridor ramp slip resistant membrane is worn and only has plywood membrane surface (Image 27).
- Classrooms, offices, and cafeteria have VCT generally in fair condition. VCT in the Art/Band classrooms appear to be newer, however there are seams and tiles that are popping or separating (Image 28).

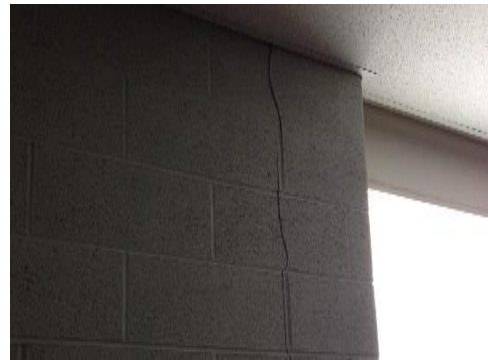
Image 30

- Corridor walls are largely painted CMU and glazed CMU tile. Most walls are in good shape, however there are some areas have cracking at the glazed CMU walls (Image 29).
- In some classrooms the CMU walls have severe cracking in the corners of the room (Image 30).
- Gypsum wallboard partitions are in generally good condition.

- Repair the cracked glazed tile wall located near the water fountain
- In classrooms where the CMU block wall is cracking investigation to determine the cause of the cracking remove CMU and replace.

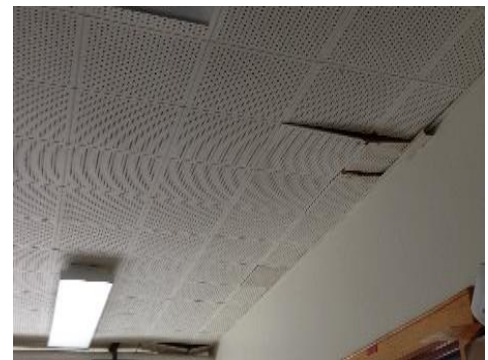
Image 31

- Acoustic ceiling tile (2x4) and grid that are in classrooms are in good condition, they were recently replaced with renovations.
- Acoustic ceiling tile and grid in the rest of the building is in fair condition, with select areas of staining due to water leaking above the ceiling.
- Older ceilings are cupping and many are damaged at the edges (Image 31).

- Further investigation is warranted to determine the cause of water leaking. Replace stained tiles.
- Replace damaged tiles

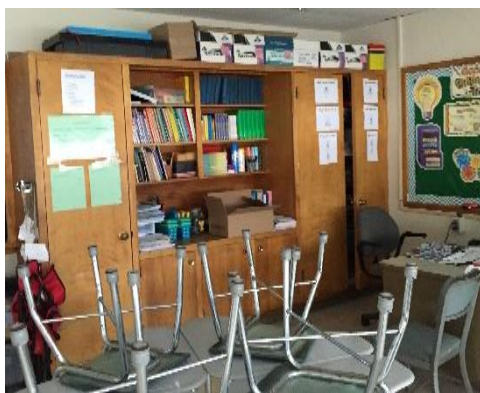
Image 34

- Teacher wardrobes are in fair condition (Image 34).
- Casework with counters and sinks in classrooms are in fair condition. Cabinets are delaminating and laminate countertops are lifting. These counter areas do not meet current accessibility code (Image 35).
- Toilet rooms in the locker room areas did not meet current code accessibility requirements for minimum heights. Accessories are mounted too high to meet current accessibility code requirements. Compliant under-sink protectors are not installed (Image 36).
- Locker room benches didn't allow proper width for accessibility requirements in current code. No accessible bench with fixed back was noted. Showers did not have accessible controls per current code requirements (Image 37).
- Designated accessible lockers are required in both locker rooms and in the general corridors.

- Install new teacher wardrobes
- Install new casework and sinks to meet the current code requirements.
- Reinstall toilet fixtures and accessories to the correct height and install pipe guard under accessible sink.

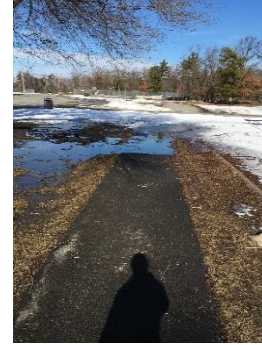
Image 9

Walkways onsite are asphalt and are generally in fair condition with some areas of cracking/degradation. There are some areas of ponding (Image 9).

- Mill and overlay sections of pavement where cracking/degradation has occurred.
- Regrade paved areas to prevent ponding which can lead to ice patches in the cold weather.
- Replace areas of asphalt curb that have been damaged.
- Reset vertical granite curb as needed
- Confirm walkways and courtyard areas are ADA accessible.

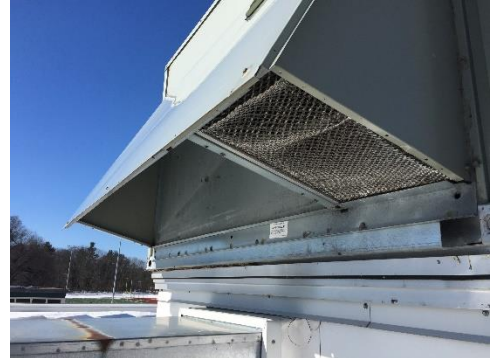
*Image 9 – Missing Moisture Elimination Screen on Library RTU*

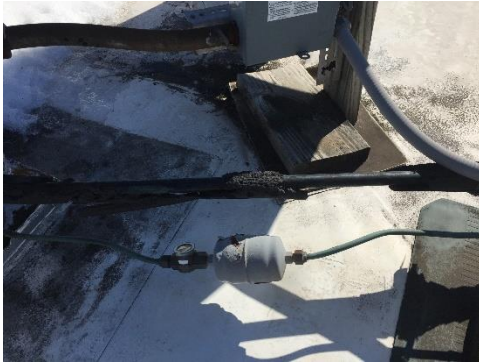
- The refrigerant piping insulation has deteriorated at the condensing units on the roof. (Image 13)

*Image 13 – Deteriorated Refrigerant Piping Insulation*

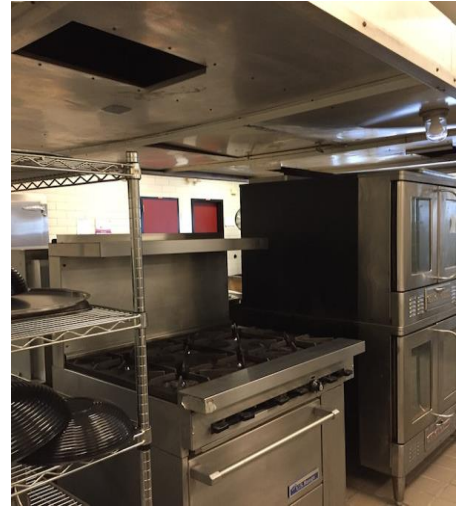
Image 1

- The hood is rather old and non-compliant with current standards. It is type II hood, meaning it is not designed to filter out grease-laden vapors. However, the range below the hood is capable of producing grease-laden vapors. Also note that there is no fire suppression system for surface protection for the range top. Also non-compliant.
- The hood hanging structure is visible. Modern hoods have the structure hidden above the ceiling and the construction of the hood is made so that it is easy to clean and provides adequate lighting at the cooking surfaces. This hood lacks those features and the low lighting levels are a code related deficiency.

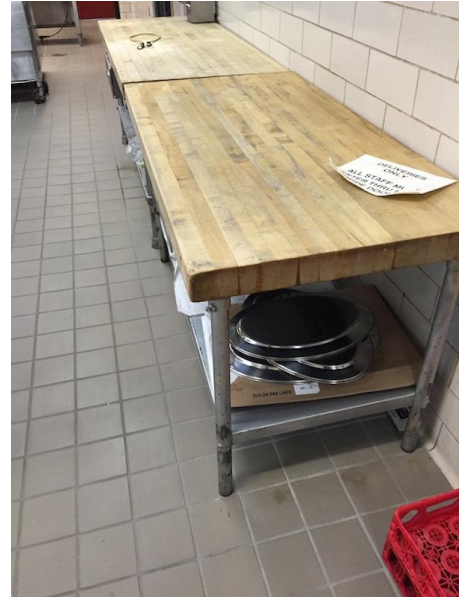
Image 4

- Wood topped table can be seen in this image. Wood topped work surfaces are not allowed in a kitchen unless it is being used for scratch baking purposes. There is no scratch baking taking place in this kitchen.
- Image 5 is a close up of the table shown in Image 4. Mold can be seen growing between where the wood slats are glued together. This kitchen seems to mainly be a warming kitchen so the risk is low but all wood topped tables should be eliminated.

1. Eliminate all wood surfaces and replace with appropriate stainless steel tables.
2. Add appropriate mobile worktables to provide for additional flexible work surfaces.
3. Add hand sink to provide for hand washing stations.
4. Replace the antiquated cooking equipment and exhaust hood to better prepare and allow more cooking at this facility.
5. Supply a new hood and fire suppression system for code compliance and for tie in to the building fire alarm system.
6. A targeted refit of foodservice equipment for this kitchen is estimated to cost approximately \$210,000.
