ARCHITECTURAL ASSESSMENT

101 Mill Row, also known as the Adams / Russell House was constructed in 1816 (Image 1 and 2) and is part of the Chelmsford Historic Commission (Image 3). The Adams / Russell House had been converted into office building space; at one time the Chelmsford Department of Health utilized the space. However, at the time of our study the facility was not being used. There was an addition added to the original 1816 building; the date of such construction is unknown.

The building survey for this report was conducted on February 17, 2016.

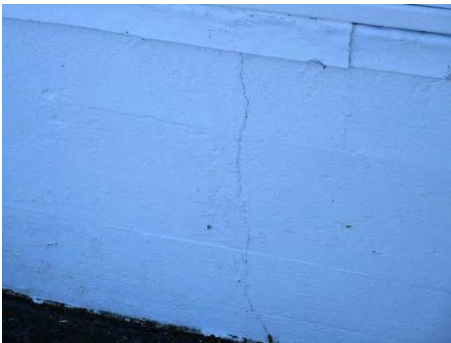
Image 13

- There are some cracks in the foundation wall (Image 13).
- A sump pump is located in the basement to address water infiltration (Image 14).

- Further investigation is warranted to determine cause of cracking at the foundation wall. It is likely that the building, over the years, has settled which has caused the cracks. Repair should be considered to prevent water infiltration.
- Further investigation is warranted to determine the cause of water infiltration into the basement. It is likely that water is finding its way through some of the cracks in the foundation wall and up through the basement floor. An approach to maintain a dry basement should be developed to prevent the buildup of moisture or mold.

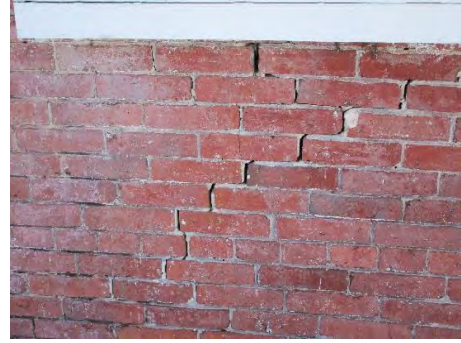
Image 15

- There is severe cracking occurring in the exterior brick veneer walls (Image 15, & 16).
- The vinyl siding in a few areas has cracks and holes exposing the substrate behind the siding (Image 17, & 18).

- Further investigation is warranted to determine the cause of cracking brick and a permanent fix. It is likely that water is finding its way behind the brick, freezing and causing brick movement and further damage. Remove areas where brick is in poor condition and replace with new brick. Repoint all exterior brick walls and maintain.
- Remove sections of vinyl siding that have damage and replace with new vinyl siding to match existing. Investigate wall behind the vinyl to assure that moisture damage has not occurred.

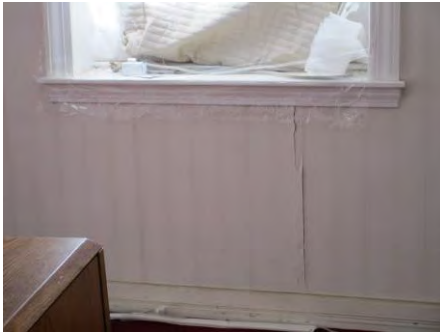
Image 20

- On some of the window sills and window casings the paint is flaking and the wood looks punky or soft (Image 19).
- Some of the windows have been covered in plastic on the inside (Image 20). This is assumed to mean there is air and water infiltration around the windows. It is not known when the plastic cover was installed but this condition prevents the window from being operable.

- Remove plastic from the windows. If there is air leaking in around the windows remove the interior trim and pack insulation between the window frame and the R.O. framing, reinstall window trim around the window. If water infiltration is occurring, remove window and rebuild around the window and replace with new window. Inspect surrounding walls and cavity to assure that water damage and mold buildup has not occurred.

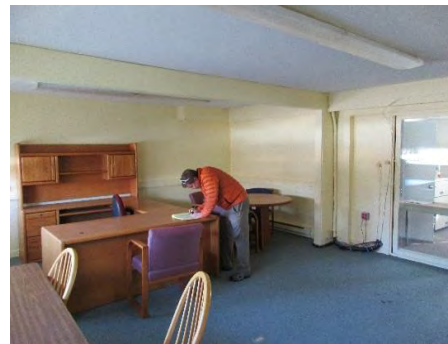
Image 24

- Some of the carpet has minor staining and wear throughout the building. (Image 24)
- The sheet vinyl in the kitchen is severely stained near the radiator, possibly from a leak at the radiator. Damage to the subfloor, if any, was unknown at the time of the survey (Image 25).
- In some of the rooms the carpet has a lot of wrinkles and humps in it. These are considered tripping hazards.
- In some of the bathrooms the floors have some staining.

- All carpets throughout the building needs to be shampooed.
- In the kitchen remove the existing sheet vinyl flooring. Inspect the subfloor by the radiator where the leak occurred. If the subfloor is damaged remove the damaged portion and patch to match adjacent subfloor, then install new sheet vinyl floor.
- In the rooms where the carpet is wrinkled stretch out the carpet towards the exterior walls. Trim any excess carpet at the exterior walls and re-tack the carpet around the perimeter of the room.
- In the bathrooms that have stained floors, a thorough cleaning and scrubbing are needed.
- At the circulation stairs remove the carpet runner and install an adhered track aid, such as grip tape, across the entire stair tread.

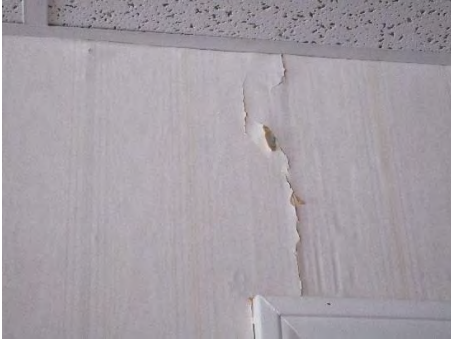
Image 26

- There are several areas in the building where wallpaper is torn, damaged, and falling from the wall surface (Image 26).
- The second floor dormer is severely damaged from previous roof leaks (Image 27).
- There are a few areas on the second floor where the wall finish has become damaged from previous roof leaks.
- There are a couple of areas where the walls have cracks in them (Image 30).

- In the areas of the building where the wallpaper is torn or damaged, completely remove the wallpaper, then prime and paint the walls.

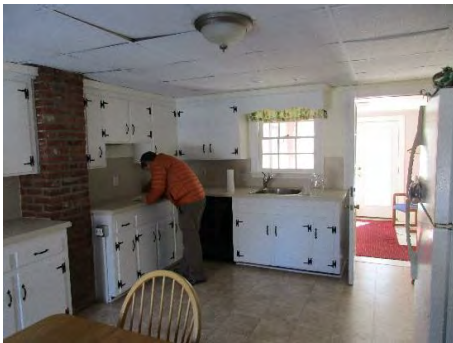
Image 31

- In the kitchen many of the acoustical ceiling tiles are bowed or lifted (Image 31).
- Some of the acoustical ceiling tiles have water stains on them (Image 32, & 33).
- In one of the closets on the third floor where the ceiling and wall meet, there is a crack that has formed that carries in the ceiling (Image 34).

- In the kitchen remove the bowed ceiling tiles and replace to match existing. Where the tiles are lifted replace them back into the ceiling grid.
- At the areas that have water stained tile remove the tile and replace to match existing.
- In the third floor closet that has the crack, further investigation is warranted to determine the cause of the crack and resolve with a permanent fix.

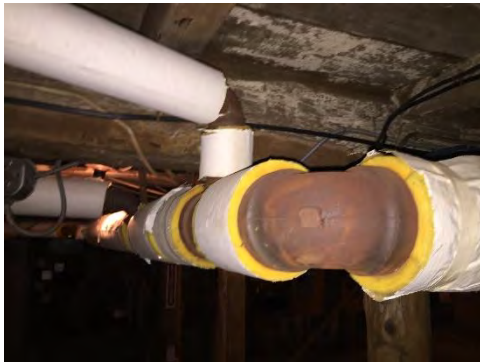
Image 6

of the straight sections of pipe (Image 6). There is a pressure reducing valve and bypass on the steam header. Steam traps consist of a mixture of newer orifice traps and older F&T traps. The boiler is vented with single wall galvanized sheet metal, which connects to the original masonry chimney (Image 7).

- Missing piping insulation on elbows and some straight sections.
- Humidity levels in the basement.
- Combustion air requirements for the boiler

- Replace older steam traps under preventive maintenance schedule.
- Replace all sections of piping insulation that is missing
- Evaluate the steam condensate piping system and replace the sections that have deteriorated due to corrosion.
- Provide additional humidifiers or provide a commercial type of dehumidification system within the basement.

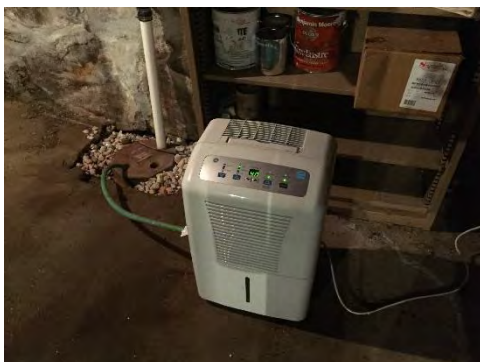
Image 8

The basement is provided with a floor mounted residential style dehumidifier to help maintain humidity levels. This appears to be an issue as many of the fittings and flanges on the steam piping are corroded and beginning to rust (Image 8).
