Byam Elementary School

ARCHITECTURAL ASSESSMENT

The facility assessment for this report was conducted on February 17, 2016.

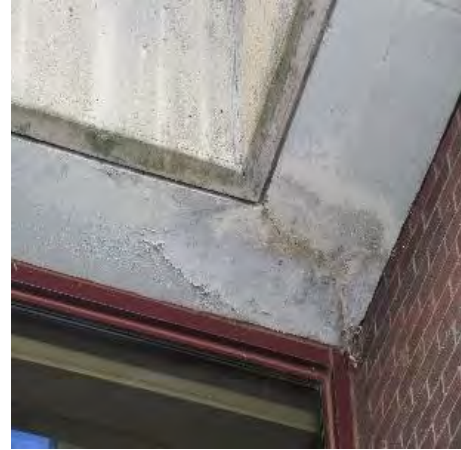
Image 18

- Several areas of severe cracking on the brick and mortar veneer (Image 16).
- Several areas where the precast concrete cantilevers are spalling and in some cases exposing the rebar (Image 17).
- Few locations where concrete window sills have cracked.
- Few locations where the steel lintel supporting the precast concrete band above the 2nd floor windows is rusting.
- There are several areas where the paint on the soffits are flaking and falling off, this may be due to moisture (Image 18).
- Maintenance of downspouts, roof overflow drains

- Repair exterior brickwork to prevent further damage.
- Patch and repair spalling concrete cantilevers.
- Patch and repair concrete window sills
- Determine cause of water / moisture damage in soffits; repair.
- In the internal courtyard, where the ivy and vegetation is growing against the building, cut the vines at the base of the wall and remove from side of building.
- At the supporting angles for precast band above second story windows sand blast or remove rust, paint steel angles with rust inhibitive paint.
- Scrape old paint from underside of soffits and repaint with exterior grade enamel paint.
- At the exterior lighting remove bird nests and all debris. Fabricate and install bird cages around exterior lighting.

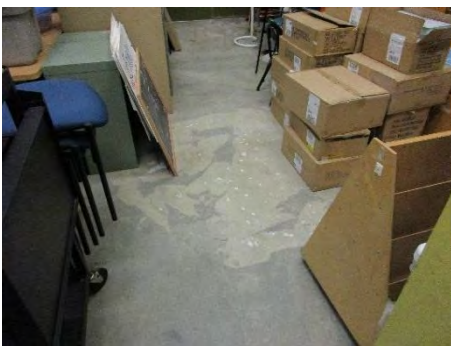
Image 31

- In most areas of epoxy painted concrete floor the paint is showing severe wear and is exposing the raw concrete (Image 31).
- The wood stage flooring is showing its age there are several areas of deep gouges, exposed raw wood and “spongy” or soft when walked on (Image 27).
- Carpeted areas such as the library appear to be in good condition.
- The Gym floor is in good condition.
- The quarry tile kitchen floor is in good condition but in need of proper cleaning.

- At the recessed walk off mat remove the VCT tile around the area of lifted concrete, then grind adhesive, remove any loose concrete, level flooring around the walk off mat and install new VCT tile.
- In areas where VCT is cracked remove damaged VCT tiles and replace with new.
- At the stair treads remove existing topping and install raised rubber tile on the stairs or refinish existing concrete.
- Review floor cleaning methods throughout the facility. Clean floors and wall bases that have been stained or damaged from existing cleaning methods.
- At the bathrooms where the marble thresholds are cracked or damaged, remove the existing threshold and install new marble thresholds.
- In the rooms where the existing epoxy paint is peeling or damaged strip the remaining paint and repaint with epoxy floor paint.
- Replace stage flooring.

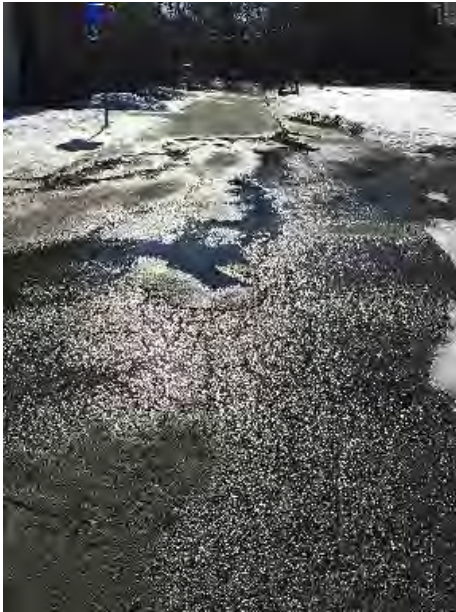
Image 13

The asphalt pavement within the site is in generally fair condition with some areas of cracking. There are areas of ponding, mainly in the driveway around the school (Image 12 and 13).

- Mill and overlay sections of pavement where cracking/degradation have occurred.
- Regrade paved areas to prevent ponding which can lead to ice patches in the cold weather.
- Clean out the sediment accumulation in the culvert.
- Replace vitrified clay pipes.
- Reset vertical granite curb as needed.

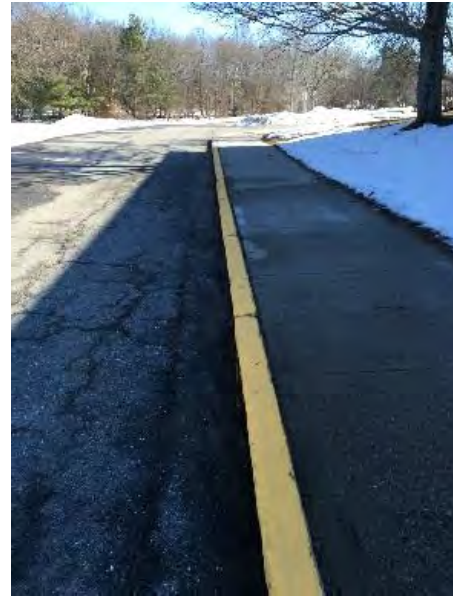
Image 15

Walkways onsite are asphalt and concrete and are generally in good condition (Image 14). Some of the accessible ramps on site have ponding (Image 15). There is a walkway from Maple Road to the school site that was not accessible at the time of the site visit because it was covered in ice.

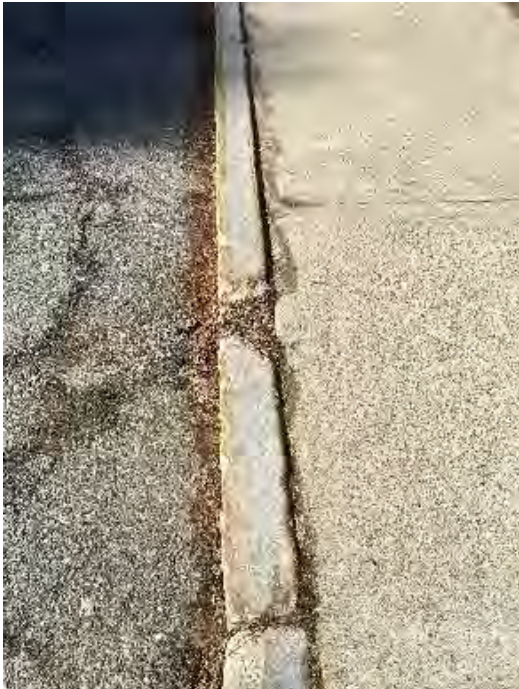
Image 17

There is concrete curb and vertical granite curb between the sidewalk on the southeast face of the building and the parking lot/driveway (Image 14 and 16). This concrete curb is in generally good condition and the vertical granite curb is in generally fair condition. The curb along the driveway entrance was covered in snow at the time of the site visit and no curb was observed. Sloped granite curb was observed along the driveway and parking areas. Limited areas of curb were exposed through the snow but the curb that was observed was in fair to poor condition (Image 17).

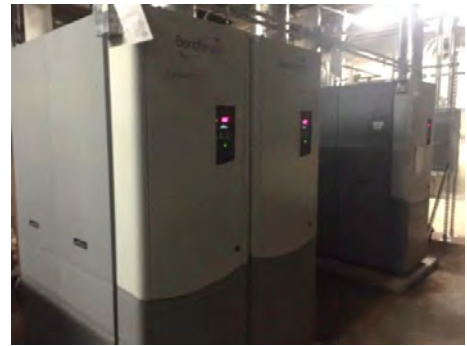
Image 1 – Hot Water Boilers

The Byam Elementary school is heated by a hot water boiler plant consisting of three (3) gas fired hot water boilers, hot water pumps, accessories, breeching, combustion air ductwork, and controls. The boilers were manufactured by Aerco, with an estimated heating capacity of 1,706 MBH output, and maximum input of 2,000 MBH each. The boilers were installed in 2002 and appear to be in very good condition. The boiler flue gases are vented through the use of a stainless steel breeching through the roof. Combustion air for the boilers is provided through the use of insulated sheet metal vent ducts (Image 1, 2, & 3).

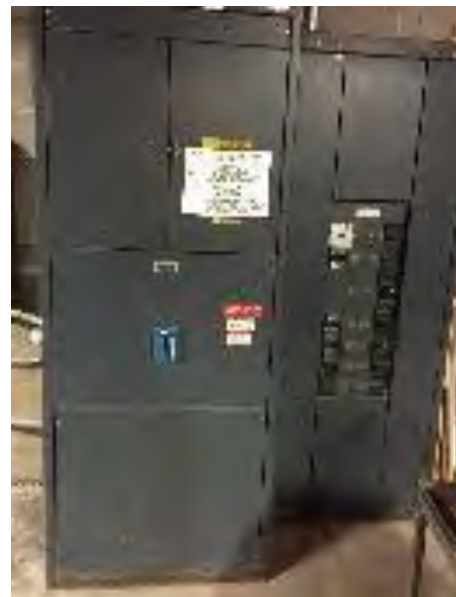
Image 3 – Switch Gear

A 1,200 ampere, 120/280 volt, 3 phase, 4 wire service serves the building. The main service equipment is located within the building's boiler room. The switchboard consists of a main/C.T. cabinet and a main distribution section, distribution style construction. The equipment is of original vintage and manufactured by General Electric. No ground was observed at the building's main water service, which is a code requirement (Image 3).

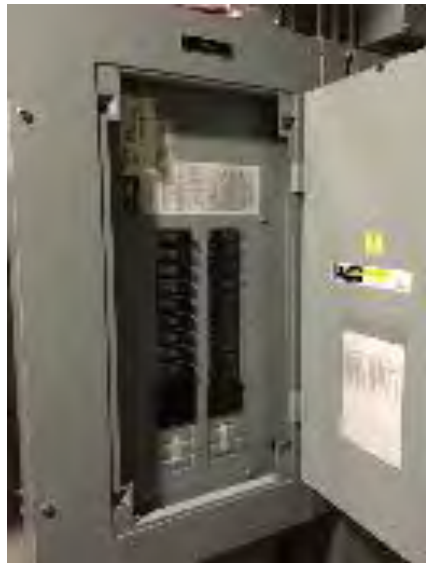
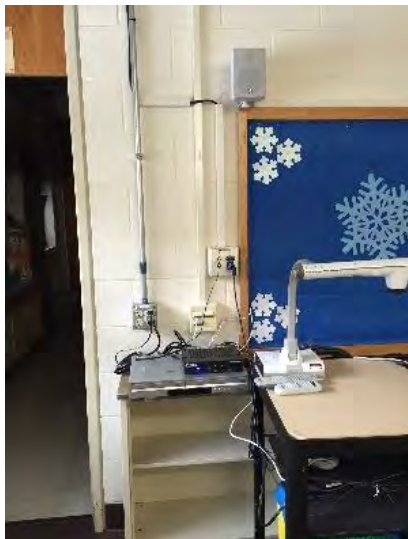
Branch circuit panelboards vary from original General Electric panelboards that are in poor condition to recently installed General Electrical panelboards that are in good condition. There has been some additional branch circuitry added throughout the school. New power branch circuits

(blue) are installed in color coded conduits (Image 4, 5, & 6).

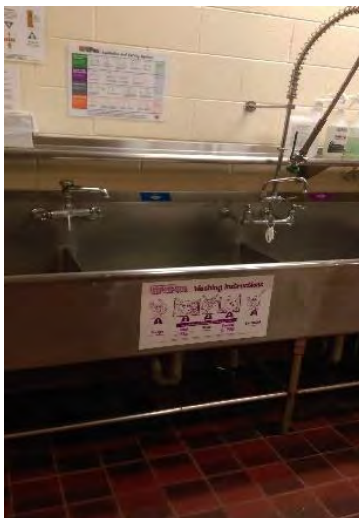
Image 6 – Pot Wash Sink

Kitchen area fixtures are in fair condition. The pot washing sink is not piped to a grease interceptor (Image 6).

- Provide reduced pressure backflow preventers at Janitor's closet soap dispenser.
- Local sewer may require Kitchen waste be directed to exterior grease trap.
- Install a high efficiency water heater including master mixing valve, recirculated hot water and expansion tank on cold water make-up line.
- Sanitary, waste, vent and storm drainage piping should be video-taped to determine condition.

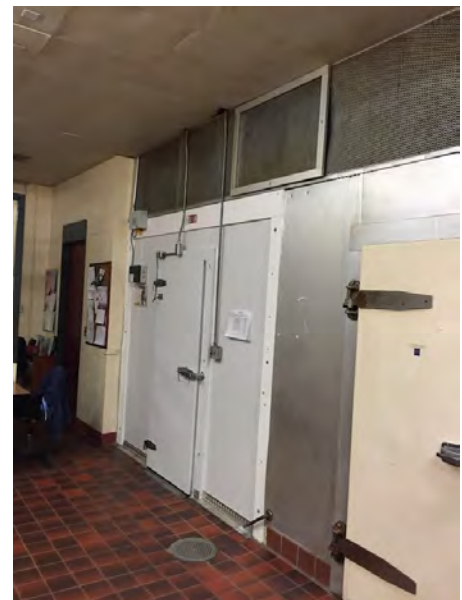
Image 2

Walk-in Cooler & Freezer Image 2:

- The walk-in panels and doors are outdated and inefficient. The condensing units for the walk-in cooler and freezer are located indoors, resulting in noise and

heat being rejected into the indoor space. There is visible corrosion on the surface of the walk-in panels.

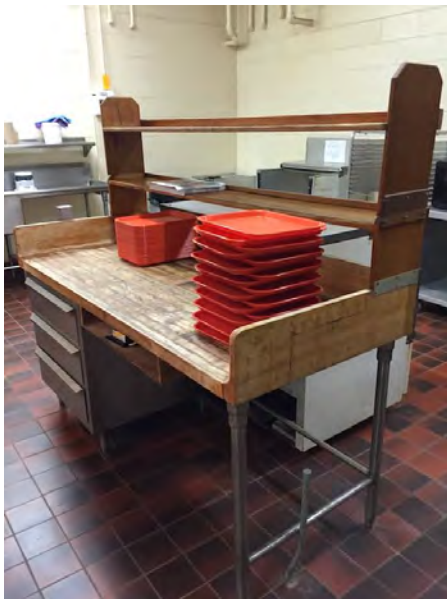
Image 4

Work surfaces (Image 4):

- This image is of a baking table that was appropriate at a time when many schools utilized a scratch-baking program. Wood is a restricted material. In this case given the age of the wood, the material has split and open gaps are present in the work surface. Food debris accumulates in the gaps and effective cleaning and sanitizing of this type of wood surface is not possible.
