Center Elementary School

ARCHITECTURAL ASSESSMENT

The building survey for this report was conducted on February 17-18, 2016.

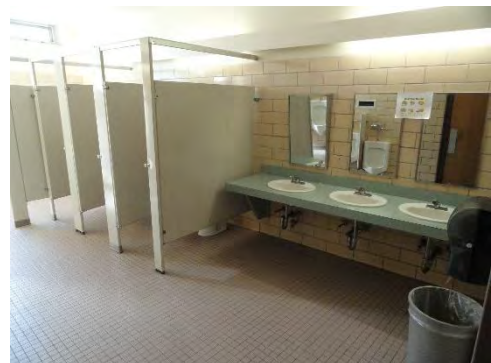
Image 10

- Provide new handrails with extensions or continuous wrap at ramps and stairs where extensions do not currently exist.
- Provide insulation or pipe protection at accessible sinks.
- Relocate stored items to allow access to the lift.
- Review heights of sinks and toilet accessories to verify that they meet ADA and MAAB requirements.
- Provide handrails per requirements (example: missing handrail Image 9).

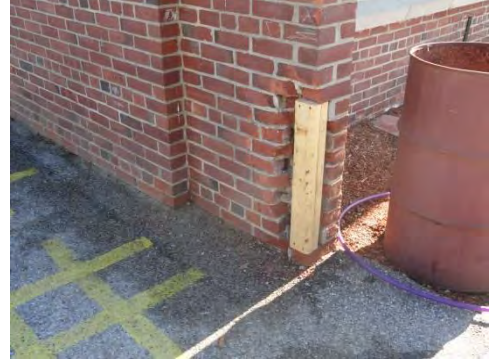
Image 16

- Recent accident where a vehicle hit the wing wall at the northern-most classrooms which is in need of immediate repair to avoid further damage to the brick (Image 16).
- Common bond brick is in fair condition in many areas and should be replaced
- Repointing and patching is needed in many areas.
- Prefinished metal wall panels are in good condition.
- Brick veneer is at grade around much of the building and in poor condition in many locations
- Occasional mortar is loose or missing at window lintels.
- Some weeps at the newer brick walls have been filled by insects and/or dirt.

- Install bollards at locations where vehicles drives are adjacent to the walls.
- Keep brick weeps clear in order for moisture to drain properly
- Repair or replace brick at grade, consider replacement with a non-porous stone material.
- Repoint brick work where needed

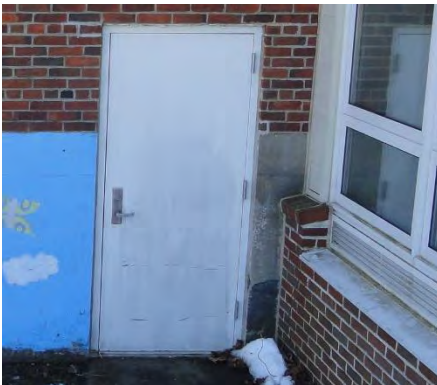
Image 21

- Main entrance doors and secondary entrances are aluminum storefront systems in good condition.
- Egress doors and maintenance entries are hollow metal doors and frames in fair condition with some dents and rusting (Image 21 & 22).
- The main entrance doors do not have a vestibule, which is not energy efficient.

- Repair / repaint doors and frames that are rusting
- Install a vestibule at the main entrance doors to increase energy efficiency (Image 20).

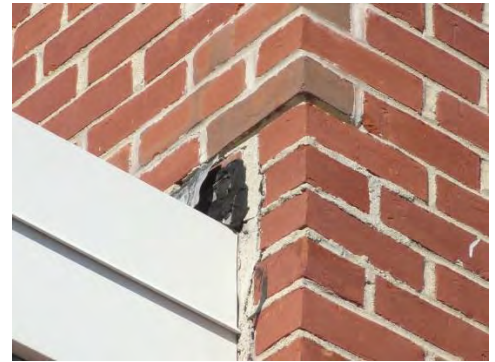
Image 24

- Termination flashing is in poor condition at the connector above the office and storage rooms on the south side of the gym as seen from the ground (Image 24).
- Several locations inside the building are showing cracks in gypsum wallboard. Onsite personnel believe these may have been a result of the heavy snow loads during the 2015 snowfall. This possibility has not been confirmed.
- Prefinished metal soffits and fascia in good condition.
- Prefinished metal gutters and downspouts in good condition, with the exception of the one downspout that has become disconnected from the cast iron pipe that runs below grade.
- Redirection of rain water to avoid puddling and icy sidewalks.
- Several interior ceiling tiles have water stains.

- Repair the termination joint above the office and storage room on the south side of the gym.
- Removal of snow in extreme situations is required.
- Review interior ceiling conditions to verify that water stains are not from roof leaks

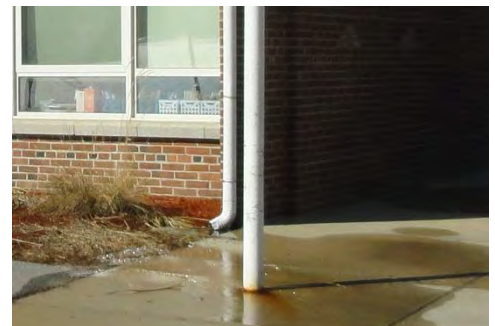
Image 26

The columns at the front canopy are rusting at the base of the column due to the pooling of water around the base.

- Surface of the concrete is chipping and parged.
- The corner of the concrete has cracked.
- Bumpers are worn.
- Concrete around railing post at stairs has cracked and chipped.
- Rusting columns at the canopy.

- Repair loading dock.
- Replace bumpers.
- Repair area around railing post.
- Replace rusting hand rails.
- Develop base detail for column that will resist rusting (Image 26).

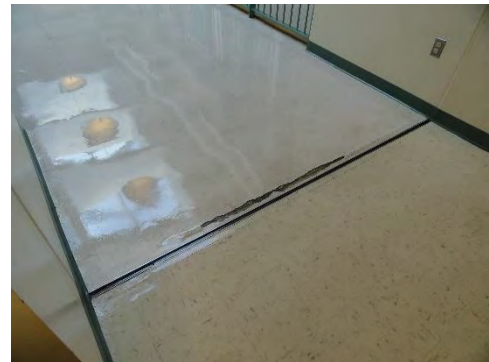
Image 33

- 2x2 porcelain tile in bathroom is in good condition but in need of thorough cleaning of tile and grout
- VCT staining may be due to uneven surface of the subfloor telegraphing through the VCT in hallways and creating expanses of dark spots where floor wax pools and can't be fully stripped, or improper waxing and cleaning of the VCT. The VCT is generally in good condition with a few concentrated areas of cracking at building joints. (Image 33)

- Repair or replace VCT where cracking has occurred.
- Review cause of VCT staining.
- Replace worn carpets, consider replacement with carpet tile to provide flexible changing of carpet areas in the future.
- Repair color strips on stairs and ramps.
- Repair gym flooring.
- Repair or replace stage flooring.

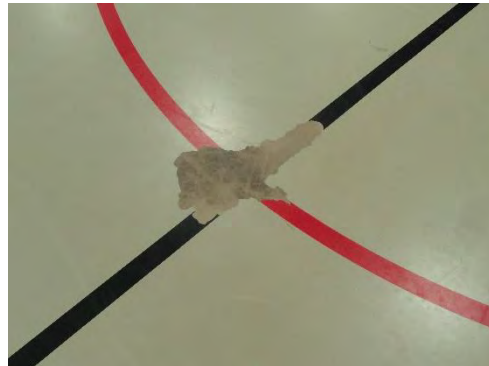
Image 34

- VCT has cracked in some areas of flooring transition and along building joints
- The gym has a sports floor system in fair condition. Some areas are showing excessive wear or delamination of the surface (Image 34).

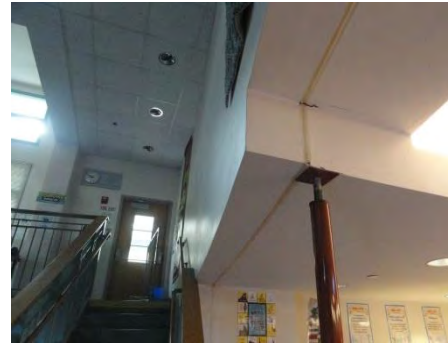
Image 39

- A gypsum wallboard soffit in the library is being held up with a lally column. Building staff suspected that the roof deflected after the Jan / Feb 2015 snow storms (Image 39).
- Multiple stains are evident on ceiling tiles throughout the school. These could be an indication of leaks from above ceiling equipment or from the roof.
- Ceiling tiles appear to be cupping throughout the school.
- Wood framing is supporting electrical and mechanical equipment above the ceilings. In the area noted, insulation has been installed above the ceiling tiles in some bays but appears to be missing in others (Image 40).

The structure of the 1999 addition appeared to be performing well for the most part. We observed a crack in the library soffit and signs of past repairs consisting of a temporary screw-jacket shoring post. This item was discussed with the architect in a separate correspondence.

- Resolve source of staining above the ceiling and replace damaged tiles.
- Repair soffit structure and wall board in the library.
- Investigate above ceilings for dampness and humidity or other causes for cupping of ceiling tiles. Location of insulation may be a factor in this condition.
- Repair any cracking in soffits around joints.

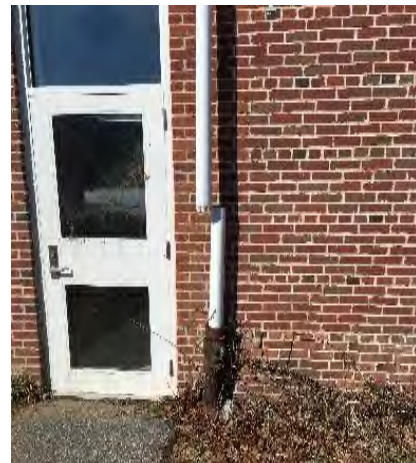
Image 2

wetlands. A broken downspout was observed onsite (Image 2).

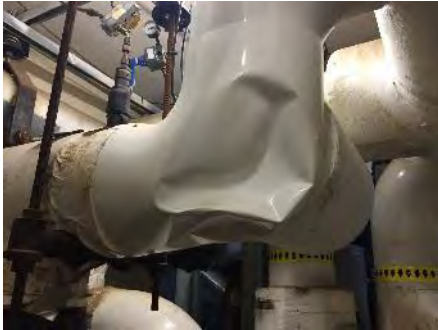
Image 5 – Existing Damaged Piping Insulation

- Some insulation is soiled at the air separator and pumps. There is slight damage at some elbows and valves.
- The majority of the hot water distribution piping and insulation is original to the building and in fair to poor condition.
- Replace pneumatic control valves with DDC control valves.
- Propeller type unit heaters are original and appear to be nearing the end of their useful service life.

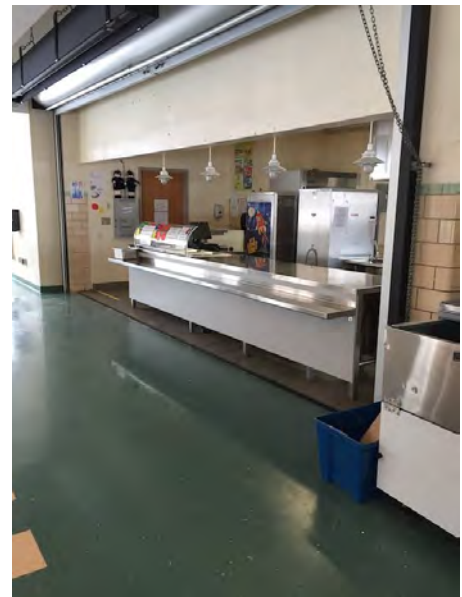
Image 2

- The sneeze shield used to protect the hot food on the serving line is out of date with current health code standards. Current standards now require an end panel in addition to the front glass panel.
- The milk cooler is located outside the footprint of the kitchen. Ideally, the milk cooler should be located within the kitchen so that it can be secured more easily.
