# Chelmsford High School

## ARCHITECTURAL ASSESSMENT

The building survey for this report was conducted on February 16 - 17, 2016.

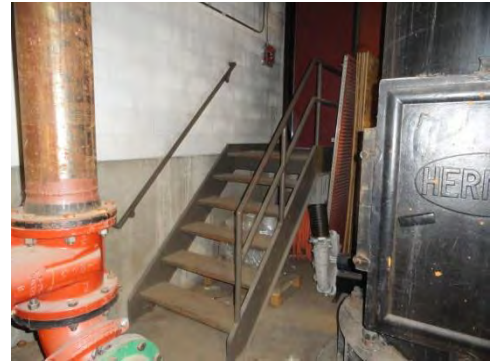
Image 17

- Formed in place interior foundation walls below grade are in good to fair condition (Image 17)
- Areas of the school have retaining concrete foundation walls that are in fair to poor condition.
- The northeast classroom wing appears to have some cracking in the foundation walls. (Image 18)

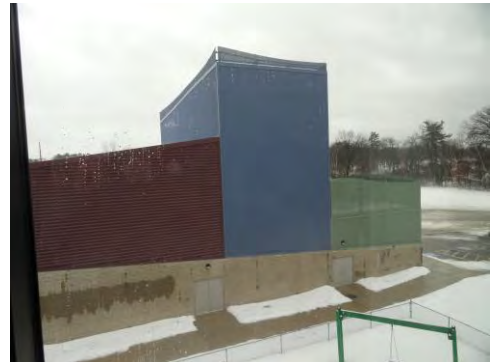
Image 19

- Most of the exterior walls are split-face block and in good condition.
- Accent metal panels are located at the front entrance (Image 1), and at the theater addition (Image 19). These panels are in good condition.
- Standing seam metal panel soffits at the gymnasium are losing their paint (Image 20).
- Some weeps in the CMU and split-face block walls have been blocked by debris or insects.
- Control joints are in fair condition throughout the school.

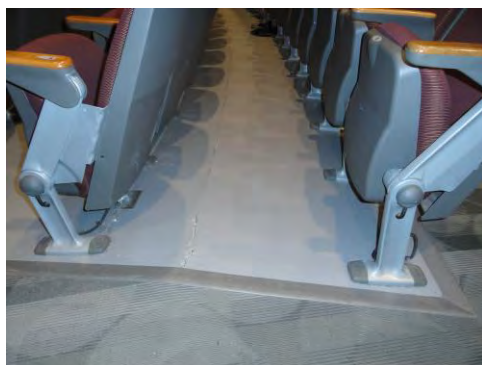
Image 32

- Flooring in the Ice Room has been removed, but adhesive and the seams of old floor tiles are visible.
- In general the flooring in the Arts Wing is in good to very good condition. There are some areas where the concrete topping surface has cracked and should be repaired (Image 32)

- Carpet in the Art Wing and Library is in good condition (Image 32 & 33)
- Carpet in the administration offices and other area appears worn and in good – fair condition

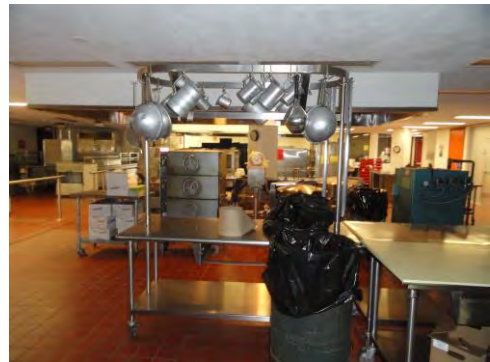
Image 35

- The quarry tile in the kitchen and servery is in fair condition. Portions of tile have been replaced with mismatched quarry tiles. Older portions of the tile have grout that has stained and appears dirty (Image 35).

- Review VCT in all classrooms and corridors, replace tiles that are popping or cracked
- Replace bathrooms, locker rooms, and shower area ceramic tile floors with epoxy flooring
- Install non-slip material at the ramp, preferably at the same time as correcting the slope to meet current codes.
- Install non-slip flooring in the ice room.
- Patch and repair concrete flooring in the workshop areas
- Replace quarry tile flooring in the kitchen and servery space

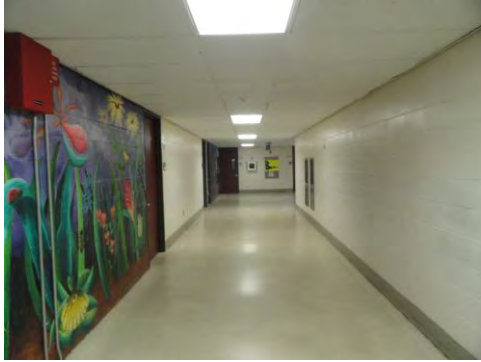
Image 37

- Folding partitions are in poor condition. These partition walls do not appear to be operable (Image 36).
- Corridor walls are largely painted CMU in good condition. (Image 37). There are many murals by students throughout the building, some require re-painting.
- Some CMU walls have step cracks or cracks at the joints that should be repaired
- Gypsum wallboard partitions are in generally good condition. (Image 38)
- Accent walls with split face block or ribbed block are in good condition. (Image 39)
- Vinyl wall base on many of the walls is very dirty and is peeling off the wall
- CMU walls have painted base that is water stained and dirty from floor cleaning

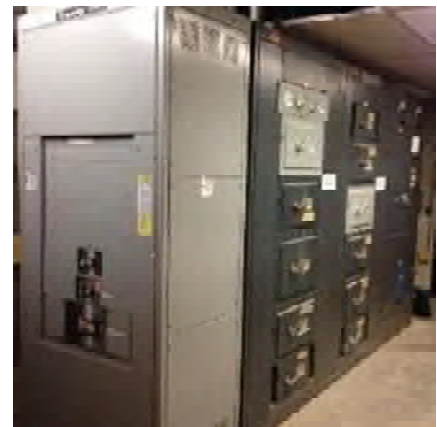
Figure 2 – Main Switchboard

The switchboard manufactured by GE, is original to the building and is in poor condition. Most local and remote GE panelboards are also original and are generally full and in poor condition. Panels are of the breaker type and generally located within electric closets. Stepdown transformers have been replaced with newer Powersmiths ultra efficient units.

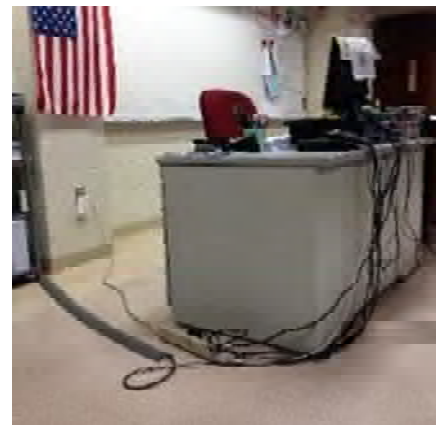
Figure 20 – Science Room Desk Wiring

Teachers desks in Science labs are located away from the wall requiring cables across floor, causing a trip hazard.

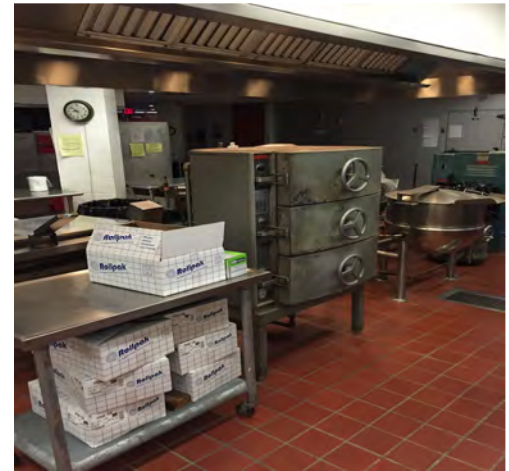
Figure 4

- The pressure steamer shown here is a style that is no longer commonly used. It is a pressure steamer meaning the doors are sealed allowing high-pressure to build in the steam cavity. This provides for fast cooking times however these types of steamers destroy the integrity of the food. Vegetables cooked in this type of steamer tend to be soggy and less likely to appear crisp and fresh looking.
- Additionally, the high-pressure steam condition caused a safety hazard. Steam burns with this type of steamer are more likely.
- Modern steamers are much more efficient with the use of water and take up much less floor area.

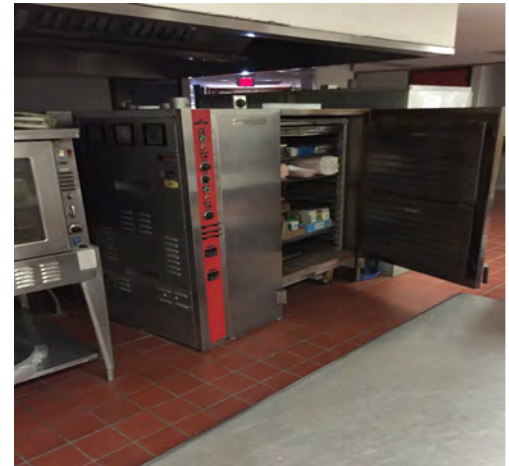
Figure 5

- There are two roll in ovens that are part of the cooking equipment. The model of oven shown in this image is no longer in common use. This roll in concept is still used but modern ovens have a much more compact footprint. The specific model shown in the image is no longer manufactured.
- The oven shown here is not used. It appears the unit has failed. The unit is now used for storage. Associated with the oven is a complimentary warming cabinet located at the end of the cooking line. See Figure 6.

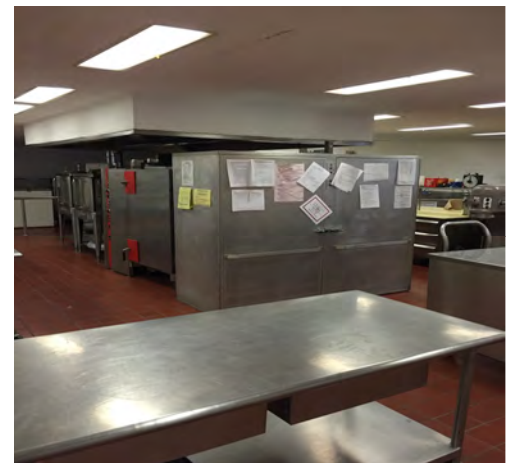
- The location of the warming cabinet shown in Figure 6 is not located in a convenient location. It is rather detached from the serving lines. Additionally, the unit is large. Modern units are much more compact, fully insulated, and Energy Star rated, and much more mobile.

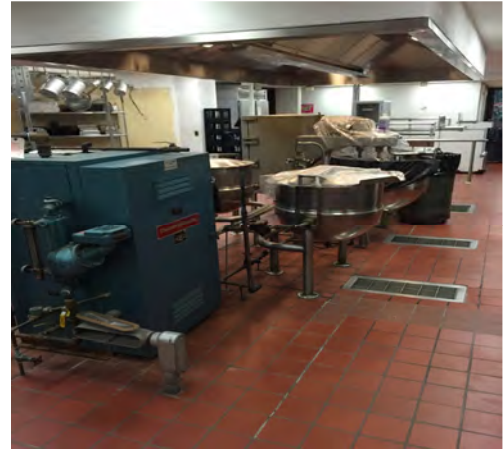
- The blue steam generator shown in this image is used to generate steam for the steamer shown in Figure 4 and for the kettles shown in Figure 7.
- Not all the kettles in Figure 7 appear to be used. Two kettles have plastic coverings over them indicating they have been mothballed. Additionally, one of the kettles has a mixer associated with it. The mixer does not appear to be used which is not surprising since the style of cooking is no longer needed for the modern school lunch program.

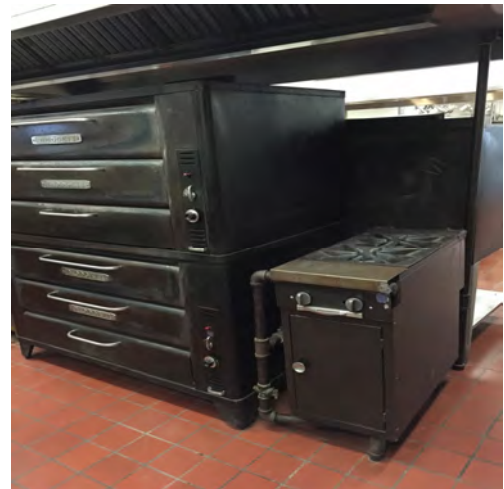
Figure 8

The range does not have a surface protection that is provided by a fire suppression system. A fire protection system is prescribed by current NFPA 96 code. In a modern kitchen the range top would be protected by a wet chemical fire suppression system that is also tied into the building fire alarm system.

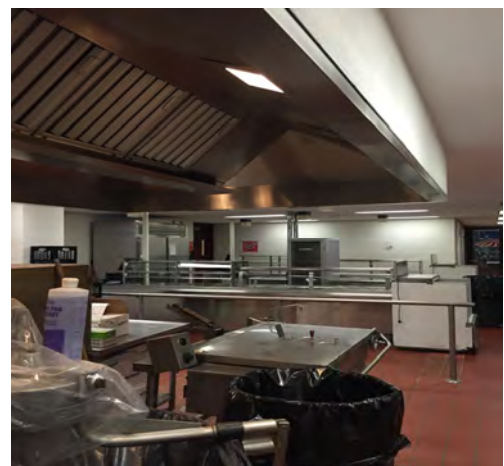
Figure 9

The cover assist mechanism on the braising pan is broken.
