# Harrington Elementary School

## ARCHITECTURAL ASSESSMENT

HARRINGTON ELEMENTARY SCHOOL  
ARCHITECTURAL ASSESSMENT

CHELMSFORD FACILITIES ASSESSMENT

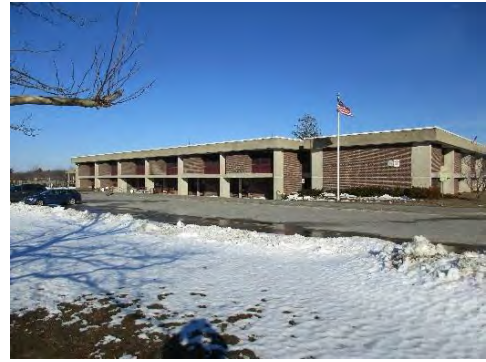
Image 1

The school is located at 120 Richardson Road and was designed by The Architects Collaborative in 1967. (Image 1). The building shares the campus with the Chelmsford High School. Recent upgrades include the mechanical systems and new boilers, window replacement in 2004 and complete reroofing in 2011.

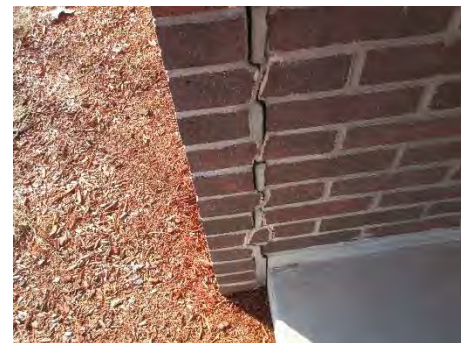
Image 16

- There are several areas of severe cracking on the brick and mortar veneer. (Image 16, 17, 20, & 21). This condition should be investigated further to determine if moisture is getting behind the brick or if other stresses are causing the brick to fail in these areas.

- Repair damaged brick and mortar, replace cracked bricks and clean weeps.
- Where the precast cantilevers are spalling or damaged, patch and repair to prevent further damage.
- Repair cracking in concrete frames

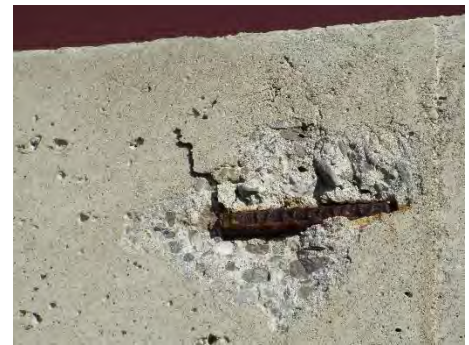
Image 23

- There are several areas where the precast concrete cantilevers are spalling and in some cases exposing the rebar. (Image 23). Deterioration of the concrete will increase as the steel continues to rust and expand.

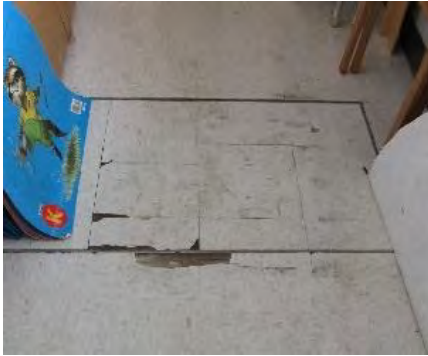
Image 34

- There are areas of cracking and chipping of the VCT flooring around the school. (Image 34).
- The topping on the stair treads is completely worn off exposing raw concrete. (Image 35)

- Remove and replace broken and damaged VCT tiles.
- Remove what is left of the existing topping on the stair treads and install raised rubber tile on the stairs
- Clean all ceramic tile floors and grout joints in bathrooms and kitchen
- Repair chipped and broken floor tiles.
- Replace drain covers as needed.
- Remove non-slip flooring strips in the kitchen and replace with non-slip mats or replace 6x6 tile with quarry tile with a greater slip resistant surface
- Review the cause for the lifting of the VCT tile in the cafetorium. Repair and replace tile.
- Replace stair treads on stairs that lead to the stage area.
- Replace existing stage flooring with a resilient wood flooring system.
- Where walls have been removed grind surface and install flooring to match existing. (image 38)
- Repair epoxy floor surfaces or painted concrete surfaces to protect concrete floors

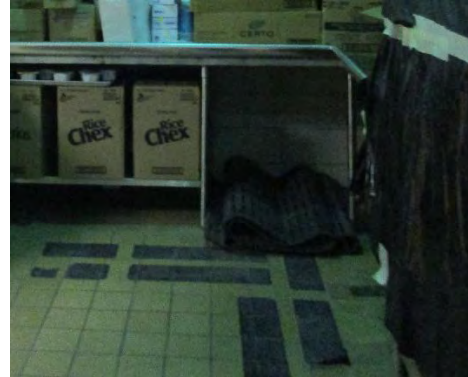
Image 39

- Where walls were removed in restrooms to provide accessibility the flooring is uneven and the flooring material inconsistent. (image 36)
- The non-slip strips that have been added to the kitchen floor near the sink and other wet areas has peeled and is lifting off the floor. These loose strips could cause tripping and the worn strips will no longer function as anti-slip material. (image 39)

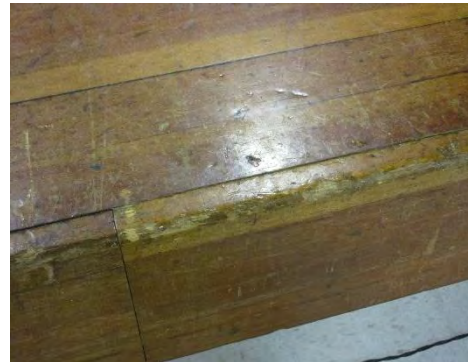
Image 40

- The wood stage flooring is showing its age as there are several areas of deep gouges and several areas where the finish is rubbing off exposing raw wood. The flooring in some places feels "spongy" or soft. (Image 40)

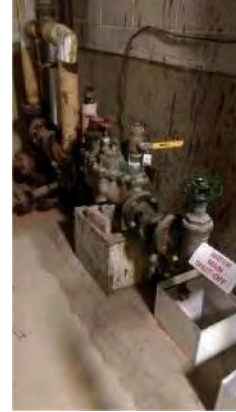
Image 7 — Water Meter

The domestic water service is located in the Mechanical Room. The service appears to be 4" in size and includes a meter and two (2) reduced pressure backflow preventers in parallel. (Image 7)

- Provide reduced pressure backflow preventers at Janitor's closet soap dispenser.
- Local sewer may require Kitchen waste be directed to exterior grease trap.
- Install a high efficiency water heater including master mixing valve, recirculated hot water and expansion tank on cold water make-up line.
- Sanitary waste, vent and storm drainage piping should be video-taped to determine condition.
- Original domestic water piping should be replaced. Domestic water piping shall be insulated, labeled and isolated with tagged brass ball valves. The valve tags should be charted for ease of maintenance.

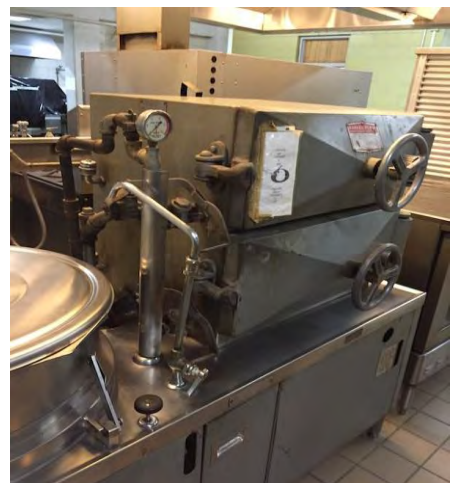
Image 3

Antiquated Equipment (Image 3):

- The cooking equipment is composed of a convection oven and a combination kettle and steamer. The pressure steamer shown in this image is a pressure steamer. This type of steamer is no longer in common use.
