McCarthy Middle School

ARCHITECTURAL ASSESSMENT

The building survey for this report was conducted on February 16, 2016.

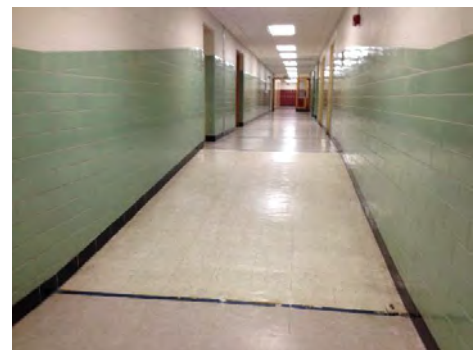
Image 10

- Regrade ramp in corridor to meet required maximum slope, install handrails on each side and new textured flooring or regrade to meet requirements of sloped walkway (Image 10)

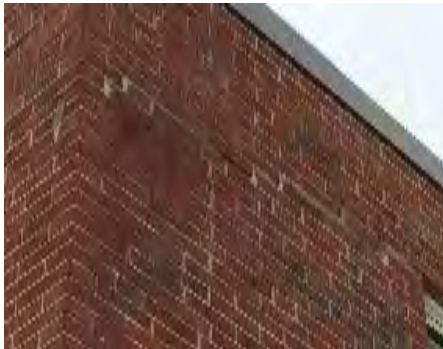
Image 19

- Exterior walls are mostly brick veneer w/CMU backup in fair condition. There are indications of moisture infiltration in some areas (Image 19 & 20).
- Some brick are protruding/cracking from the wall at southeast corner along North Rd. (Image 19).
- Wall cavity moisture/efflorescence is seen in multiple brick/opening locations (Image 20).
- Some weeps have been blocked by debris or insects.
- Control joints are in fair condition throughout the school.
- Pod classrooms are wood cladding and are in fair to poor condition. Many gutters and downspouts

- Discover the source of moisture infiltration and develop program for repair
- Remove bricks that are in need of realignment, install new bricks to allow proper ventilation and drainage from wall cavity.
- Remove debris from weeps to allow proper ventilation and drainage from wall cavity.
- Replace pods
- Install gutters and downspouts that are missing or damaged

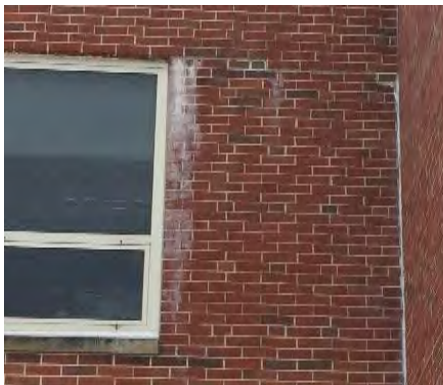
Image 20

are damaged or missing causing water runoff and staining. (Image 20).

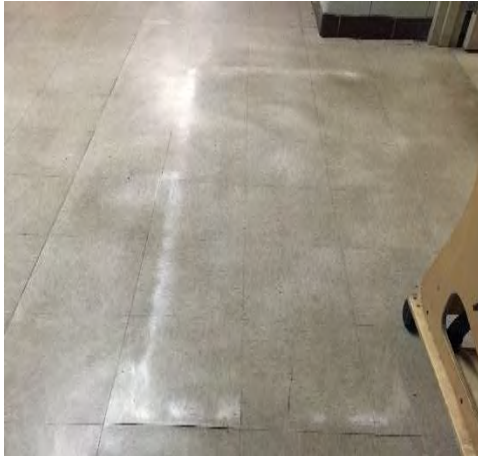
Image 26

- Sports flooring system in aux gymnasium and large gymnasium with a faux wood finish is in fair condition.
- Corridors in original building have VCT floors in fair condition. Patching is noted in a few locations where door entries have been renovated. Cracking and heaving is also visible in several locations (Image 26).

- Replace aux gym floor
- Review conditions of heaving and cracking in the VCT tile, replace and repair tiles
- Clean quarry tile in the kitchen area, replace tiles as needed.

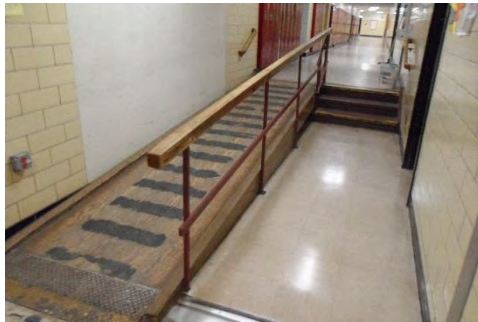
Image 27

- Corridor stairs have metal treads in fair condition. Corridor ramp slip resistant membrane is worn and only has plywood membrane surface (Image 27).
- Classrooms, offices, and cafeteria have VCT generally in fair condition. VCT in the Art/Band classrooms appear to be newer, however there are seams and tiles that are popping or separating (Image 28).

- Install non-slip material at the ramp to meet current codes.
- Proper slab measures to correct VCT cracking and heaving.

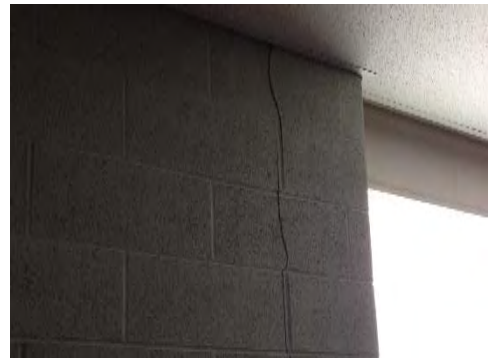
Image 30

- Corridor walls are largely painted CMU and glazed CMU tile. Most walls are in good shape, however there are some areas have cracking at the glazed CMU walls (Image 29).
- In some classrooms the CMU walls have severe cracking in the corners of the room (Image 30).
- Gypsum wallboard partitions are in generally good condition.

- Repair the cracked glazed tile wall located near the water fountain
- In classrooms where the CMU block wall is cracking investigation to determine the cause of the cracking remove CMU and replace.

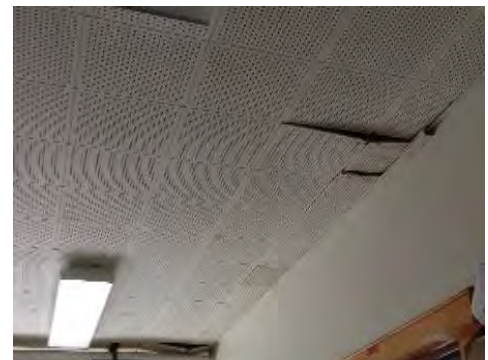
Image 31

- Acoustic ceiling tile (2x4) and grid that are in classrooms are in good condition, they were recently replaced with renovations.
- Acoustic ceiling tile and grid in the rest of the building is in fair condition, with select areas of staining due to water leaking above the ceiling.
- Older ceilings are cupping and many are damaged at the edges (Image 31).

- Further investigation is warranted to determine the cause of water leaking. Replace stained tiles.
- Replace damaged tiles

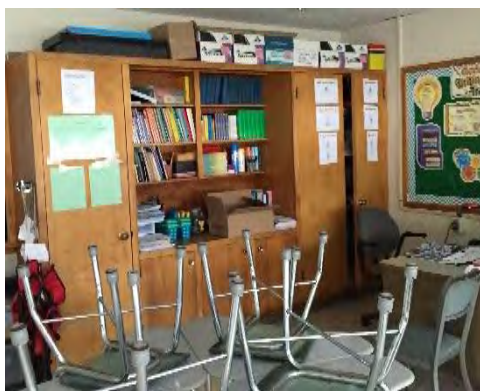
Image 34

- Teacher wardrobes are in fair condition (Image 34).
- Casework with counters and sinks in classrooms are in fair condition. Cabinets are delaminating and laminate countertops are lifting. These counter areas do not meet current accessibility code (Image 35).
- Toilet rooms in the locker room areas did not meet current code accessibility requirements for minimum heights. Accessories are mounted too high to meet current accessibility code requirements. Compliant under-sink protectors are not installed (Image 36).
- Locker room benches didn't allow proper width for accessibility requirements in current code. No accessible bench with fixed back was noted. Showers did not have accessible controls per current code requirements (Image 37).
- Designated accessible lockers are required in both locker rooms and in the general corridors.

- Install new teacher wardrobes
- Install new casework and sinks to meet the current code requirements.
- Reinstall toilet fixtures and accessories to the correct height and install pipe guard under accessible sink.

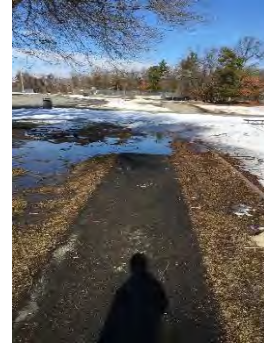
Image 9

Walkways onsite are asphalt and are generally in fair condition with some areas of cracking/degradation. There are some areas of ponding (Image 9).

- Mill and overlay sections of pavement where cracking/degradation has occurred.
- Regrade paved areas to prevent ponding which can lead to ice patches in the cold weather.
- Replace areas of asphalt curb that have been damaged.
- Reset vertical granite curb as needed
- Confirm walkways and courtyard areas are ADA accessible.

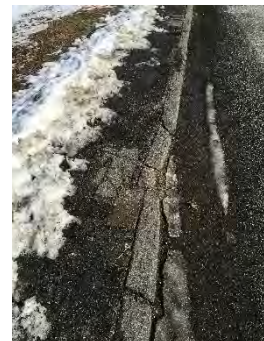
Image 12

Curbing on site is either vertical granite curb, concrete curb, or asphalt curb. The vertical granite curb on site is in generally good condition. The asphalt curb and concrete curb on site is in fair to poor condition with some areas where the curb is no longer there (Image 10, 11, and 12).

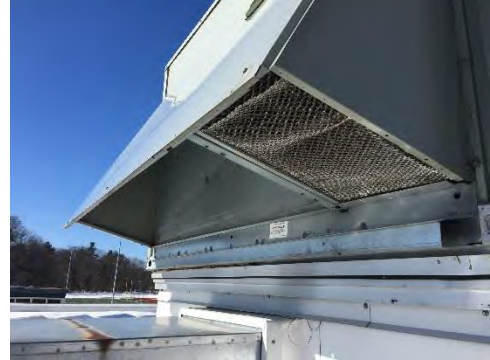
Image 9 – Missing Moisture Elimination Screen on Library RTU

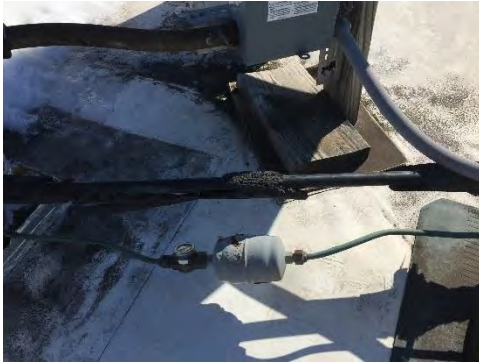
- The refrigerant piping insulation has deteriorated at the condensing units on the roof. (Image 13)

Image 13 – Deteriorated Refrigerant Piping Insulation

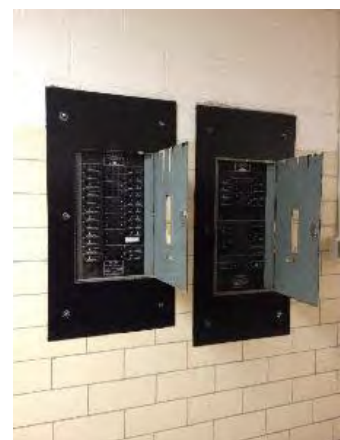
Image 3 – Flush FPE Panels in Corridor

The switchboard manufactured by Federal Pacific, FPE, is original to the building, is obsolete, and is in poor condition. Most local and remote panelboards are also FPE original and are generally full and in poor condition. Panels are of the breaker type, and generally not located within electric closets.

1. Provide new pad mounted transformer to replace existing vault transformer.
2. The original FPE switchgear is in poor condition, generally full and should be replaced. The existing feeders and branch circuits would be refed from the new switchgear.

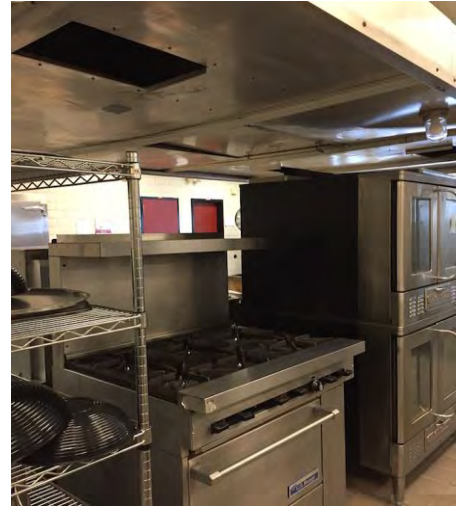
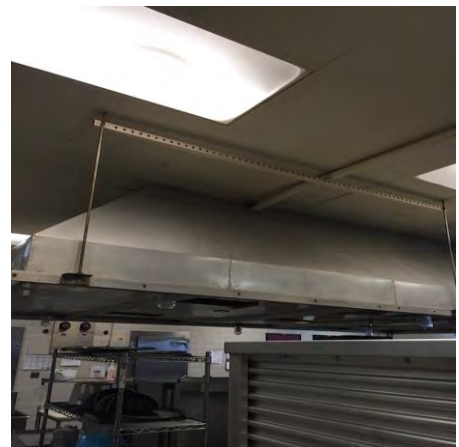
- The hood is rather old and non-compliant with current standards. It is type II hood, meaning it is not designed to filter out grease-laden vapors. However, the range below the hood is capable of producing grease-laden vapors. Also note that there is no fire suppression system for surface protection for the range top. Also non-compliant.
- The hood hanging structure is visible. Modern hoods have the structure hidden above the ceiling and the construction of the hood is made so that it is easy to clean and provides adequate lighting at the cooking surfaces. This hood lacks those features and the low lighting levels are a code related deficiency.

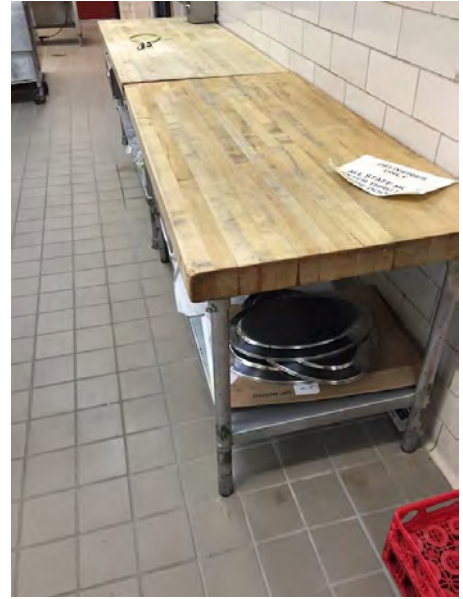
Image 4

- Wood topped table can be seen in this image. Wood topped work surfaces are not allowed in a kitchen unless it is being used for scratch baking purposes. There is no scratch baking taking place in this kitchen.
- Image 5 is a close up of the table shown in Image 4. Mold can be seen growing between where the wood slats are glued together. This kitchen seems to mainly be a warming kitchen so the risk is low but all wood topped tables should be eliminated.

1. Eliminate all wood surfaces and replace with appropriate stainless steel tables.
2. Add appropriate mobile worktables to provide for additional flexible work surfaces.
3. Add hand sink to provide for hand washing stations.
4. Replace the antiquated cooking equipment and exhaust hood to better prepare and allow more cooking at this facility.
5. Supply a new hood and fire suppression system for code compliance and for tie in to the building fire alarm system.
6. A targeted refit of foodservice equipment for this kitchen is estimated to cost approximately \$210,000.
