Parker Middle School

ARCHITECTURAL ASSESSMENT

The building survey for this report was conducted on February 17, 2016.

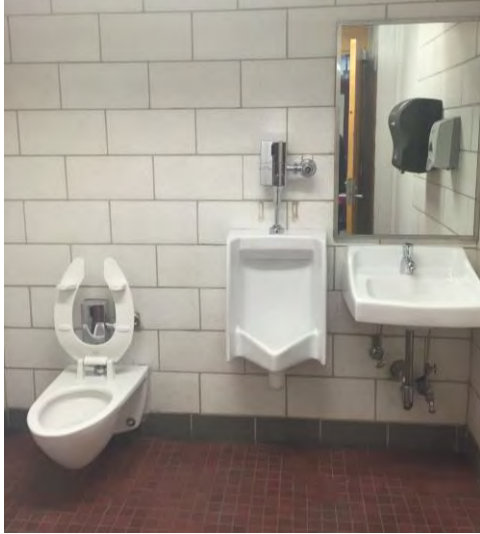
fixtures and / or accessories are not installed to meet accessibility requirements. An example of these conditions can be seen in Image 10 and these include: proper separation between fixtures (the urinal and sink are not the correct distance apart), proper height of controls, (the controls on the urinal are located too high), proper height of accessories (the paper towel and soap dispenser are located too high), lack of handrails and lack of insulation or shroud around the hot water piping under the sink. In other areas, such as the gang toilet rooms, all of the urinals and sinks have been installed at the same height. Accessibility requirements note that if more than one fixture is located in a restroom at least one must meet accessibility requirements.

- Install proper handrails at all exterior stairs and ramps
- Install an elevator in each wing to connect the lower level to the main floor level
- Install proper handrails at all interior stairs and ramps
- Install proper cane detection and guard rail near stair landings
- Review restroom fixture installations and adjust to meet proper height and location requirements
- Install new drinking fountains to meet accessibility requirements

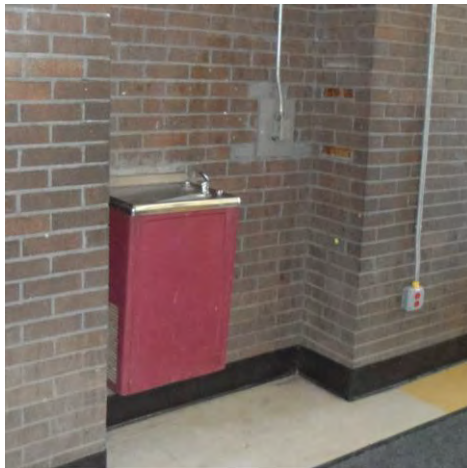
Image 11

There are several drinking fountains throughout the building that are not accessible (Images 11 & 12).

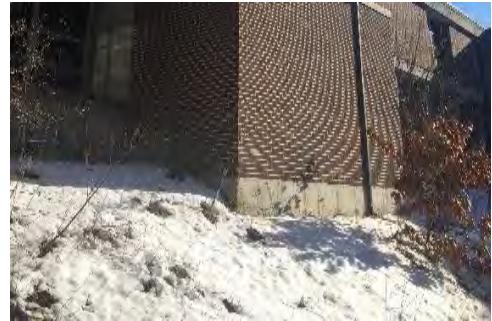
Image 13

- Foundation walls below grade are formed in place concrete that is in fair condition. Exposed areas are in good condition (Image 13).

- No recommendations needed.

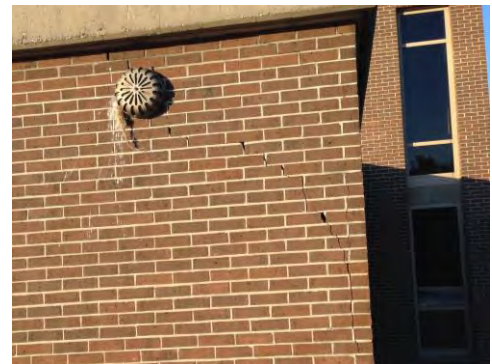
Image 14

- Exterior walls are mostly brick veneer w/CMU backup in fair condition. Some brick are showing moisture and sever cracking in contained areas (Image 14 & 15).
- Control joints are in fair condition throughout the school. Boy's Locker Room uneven brick settle with ruptured joint (Image 16).
- Some precast concrete cantilevers are spalling and exposing rebar (Image 17).
- Pod classrooms are wood/vinyl cladding and are in fair condition. Some cladding is falling off the structure (Image 18).

- Remove debris from weeps to allow proper ventilation and drainage from wall cavity.
- Further investigation is warranted to determine the cause of brick cracking.
- Repair/install a new control joint.
- Where precast cantilevers are spalling remove all the loose concrete and then patch to match profile of the cantilever.
- Re-install cladding at pod classrooms.

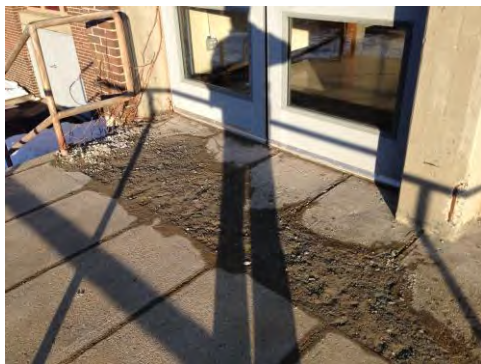
Image 20

- Some doors have thresholds and approaches that do not meet current codes due to height of threshold (in excess of $\frac{1}{2}$ ") or due to the condition of the landing surface outside the door. (Image 20)

- Repair and replace thresholds at doors that exceed $\frac{1}{2}$ " in height at egress exits.
- Install an approach pad that meets all current MAAB / ADA code requirements.

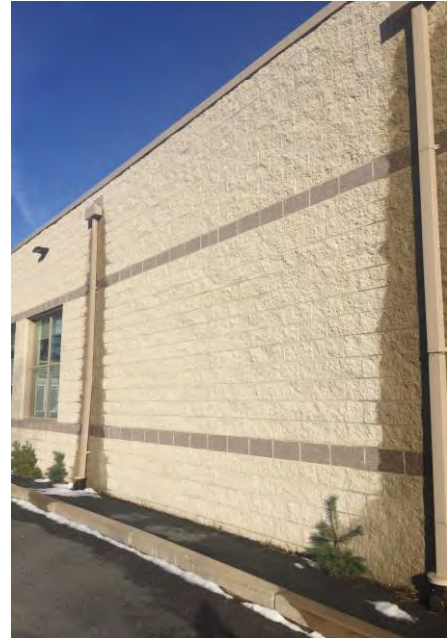
Image 21

- Recent replacement of roof with an adhered membrane system.
- Recent installation of photo-voltaic cells on roofs.
- Some ceiling tiles were found with stains, indicative of a possible roof leak, yet the age of the stains is unknown.
- Overflow scuppers appear clogged, or the connection between the wall and downspout is not correctly attached to the walls (Image 21).

- Investigate areas where ceiling tiles are stained to verify source.
- Review scuppers and repair down spouts

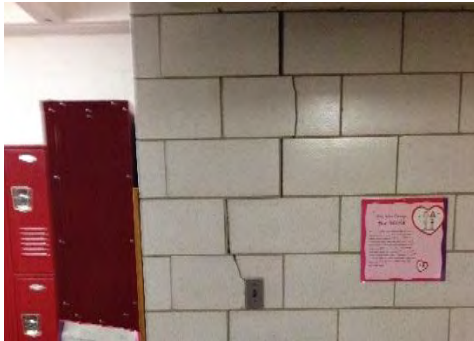
Image 25

- Corridor walls are largely painted CMU/tile in good condition.
- Locker Rooms have cracking at the soap tile walls (Image 25).
- In some classrooms and corridor walls the CMU walls have severe cracking in the corners (Image 26 & 27).
- Gypsum wallboard partitions are in generally good condition.
- Wood paneling in gym is in poor condition (Image 28).
- Folding partition walls are in poor condition (Image 29).

- In areas where the cmu/tile is cracking or separating further investigation is warranted to determine the cause. Repair is required.
- Replace wood paneling in gym, add padding to walls for safety
- Remove folding partition walls and replace with gypsum wall board partitions that provide proper acoustical separation between spaces
- In spaces where partitions have been installed that do not extend to the underside of the slab and do not provide proper acoustical separation between classrooms extend walls to the underside of the deck or provide dropped ceilings on both sides of the wall.

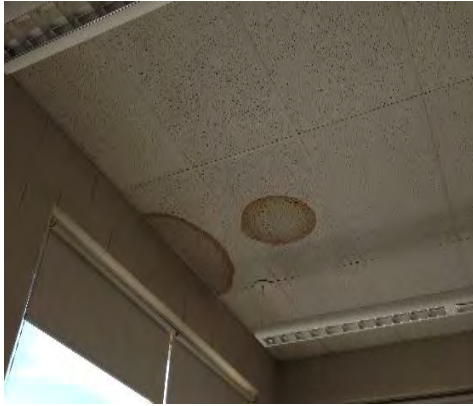
Image 30

- Acoustic ceiling tile (1x1), adhered to underside of waffle slab, in classrooms/corridors are in fair condition.
- Acoustic ceiling tile and grid in the Library is in fair condition.
- Several ceiling tiles throughout the building have water stains due to roof or equipment leaks above the ceiling (Image 30 & 31).
- Gypsum soffit boards are generally in good condition.

- Further investigation is warranted to determine the cause of water leaking, repair source and replace ceiling tiles.
- Several ceiling tiles are cracked and damaged and should be replaced.

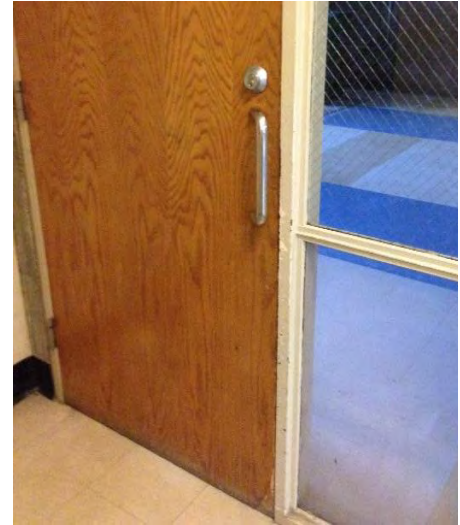
Image 33

- The base of some doors and frames have water damage or rust as a result of floor cleaning
- Some of the corridor wood doors with sidelight have wired glass (Image 33).

- Add kick plates to the bottom of doors to prevent further damage
- Repair rusting at the base of door frames
- Remove all wired glass panels from the interior doors, sidelights and interior glazing. Replace with tempered glass.

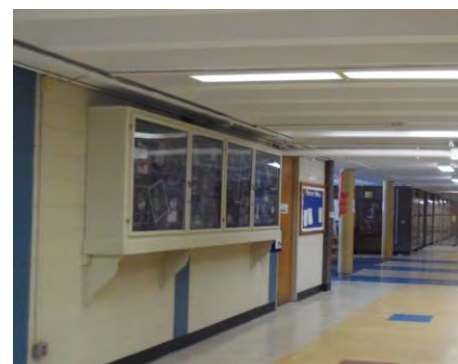
Image 35

- Shelving units near cafeteria appear worn
- Display cases are in fair condition and protrude into the hallway beyond the allowable distance per accessibility codes (Image 35)
- Showers in the locker rooms did not meet current code accessibility requirements. These rooms do not appear to be used on a regular basis (Image 36).

- Replace display cabinets in hallway and provide cane detection to meet accessibility requirements.
- Install new casework in classrooms.
- Install accessible lockers in both the corridors and in the locker rooms.

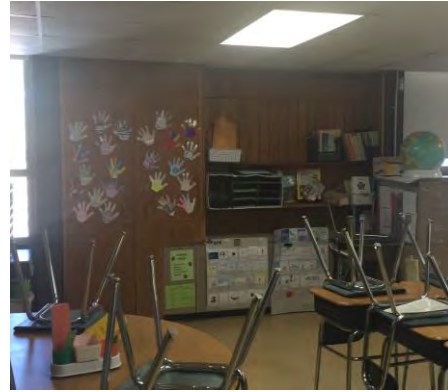
Image 39

- Casework, shelving, counters and sinks in classrooms are original to the building and are in poor condition (Image 37 & 38).
- Teacher wardrobes are original to the building and in poor condition (Image 39).
- Lockers in both the corridors and locker rooms do not provide accessible lockers.

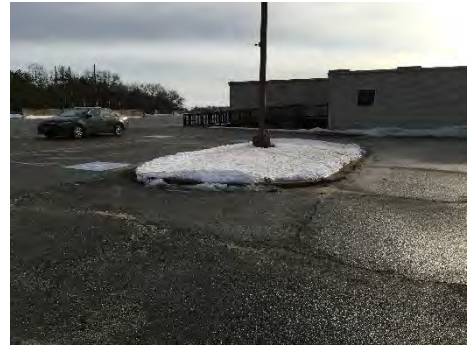
Image 9

The asphalt pavement within the site is in generally fair condition with some areas of cracking and degradation (Image 9). There is some accumulation of sediment in paved areas onsite and some areas of ponding/icing (Image 10 & 11).

- Mill and overlay sections of pavement where cracking/degradation has occurred.
- Regrade paved areas to prevent ponding which can lead to ice patches in the cold weather.

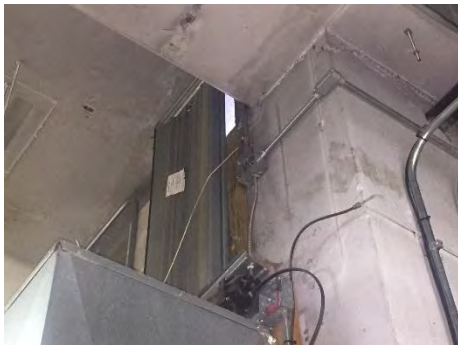
Image 4 – Combustion Air Damper w/ Gap

Combustion air is brought into the boiler room through two wall mounted louvers, with a high opening and a low opening that terminates 2 ft above the floor. The openings are dampened using electric actuators. There is a gap in the upper damper that allows outside air to infiltrate into the boiler room (Image 4).

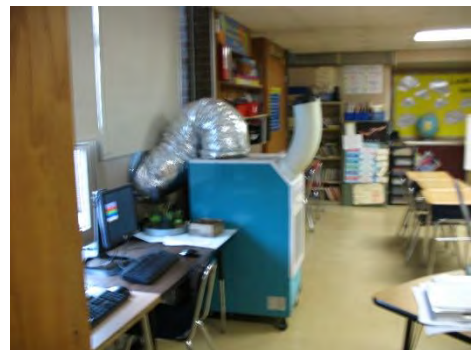
Image 15 – Portable Air conditioner

ventilation settings with actual room occupancy. Some of the classrooms are cooled by portable air conditioners that duct hot condenser air to a window (Image 15).

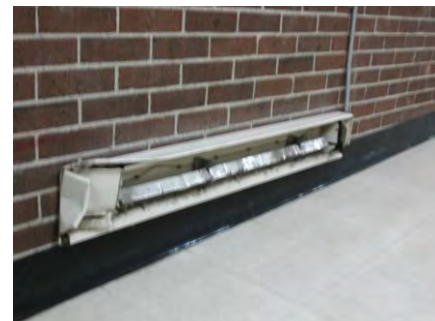
Image 22 – Portable Classroom Corridor Damaged Electrical Baseboard

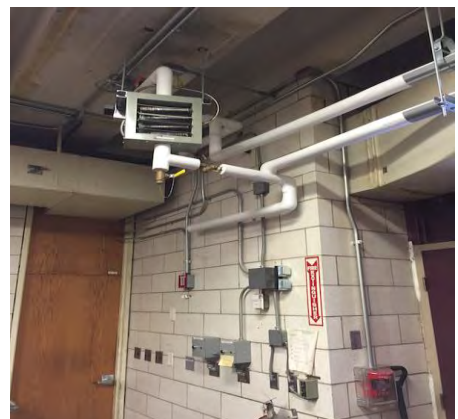
Image 3

The health code mandates all surfaces be smooth and easy to clean because deep cleaning of all the conduits and exposed heating system vents, lighting fixtures, and horizontal surfaces are not easy to clean (Image 3).
