# Westlands School

## ARCHITECTURAL ASSESSMENT

### GENERAL DESCRIPTION

The building survey for this report was conducted on February 16, 2016.

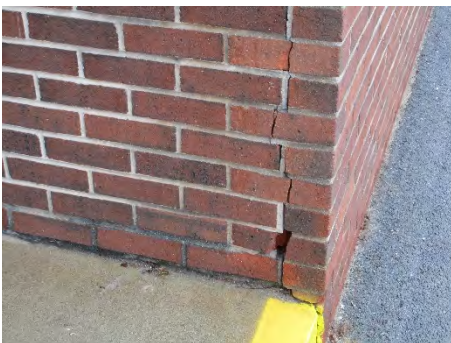
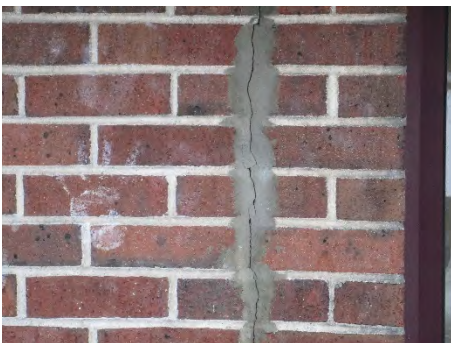
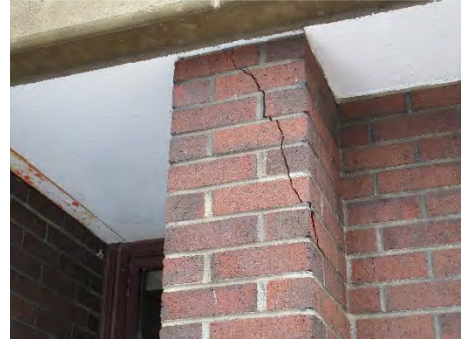
- There several areas of severe cracking on the brick and mortar veneer (Image 14, Image 15, Image 16).
- There are several areas where the precast concrete cantilevers are spalling and in some cases exposing the rebar (Image 17, Image 18).
- At a few areas on the exterior wall the brick control joint caulking is severely deteriorating. (Image 19)

- Further investigation is warranted to determine cause of cracking brick and a permanent fix is required. It is likely that water is finding its way behind the brick. The freezing and thawing is causing brick movement and additional cracking.

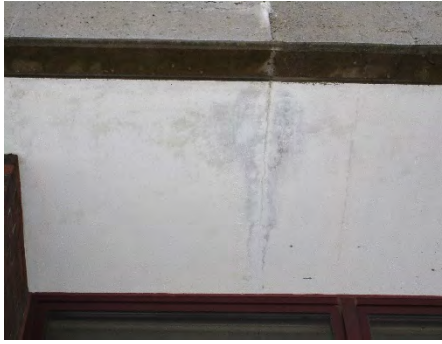
Image 20

- There are several areas where the paint on the soffits are deteriorating. (Image 20)
- There are several soffits that have moisture along the entire underside. (Image 21)
- In several locations the steel angle holding up the soffit at the building expansion joint is rusting. (Image 22)

- At the soffits scrape the soffits to remove any loose paint then prime and repaint the soffits.
- At the areas of the soffit that have excessive moisture ponding on the underside further investigation is warranted to determine the cause and permanent fix.

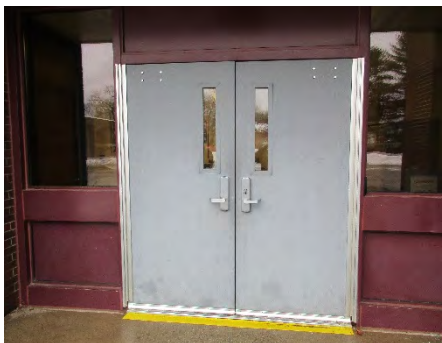
Image 23

- On some of the exterior doors the paint is peeling (Image 23, 24, & 25).
- At one of the doors at the back side of the building the door seal strips are damaged and bent (Image 24).
- At the elevator machine room the door is showing signs of surface rust (Image 25).

- At the doors where the paint is flaking off, or there is rusting, scrape off all loose paint. Prime and repaint the door with rust inhibitive primer and repaint.
- At the doors that have been damaged and have bent door seal strips remove the damaged strips and replace with new door seal strips.

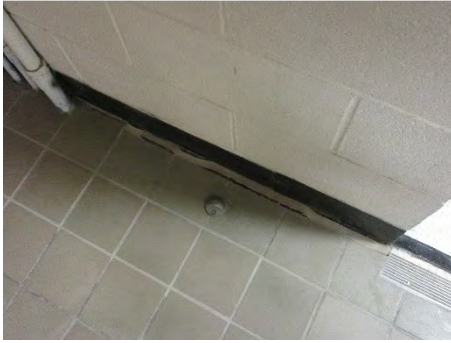
Image 27

- In the lobby there is an area where five quarry tiles were cut too short and the rest of the space to the wall was filled with sealant (Image 27).
- The topping on the stair treads is completely worn off exposing raw concrete (Image 28).
- The 6"x6" quarry tile in all the bathrooms is very dirty and the grout joints have become stained (Image 29).
- In one of the bathrooms the 6"x6" quarry tiles have become damaged (Image 30).
- In most of the areas of epoxy painted concrete floor the paint is showing severe wear and is exposing the raw concrete (Image 31).
- The wood stage flooring is showing its age; there are several areas of deep gouges, and several areas where the finish is rubbing off exposing raw wood. Additionally, the flooring in some places is loud when walked on and spongy (Image 32).
- In office 137 there is quite a large and severe stain on the VCT floor tile (Image 33).

- In the lobby remove the five short quarry tiles and replace with new quarry tiles to match existing color and adjacent tiles' length.
- At the stair treads remove what is left of the existing topping on the stair treads and install raised rubber tile on the stairs.

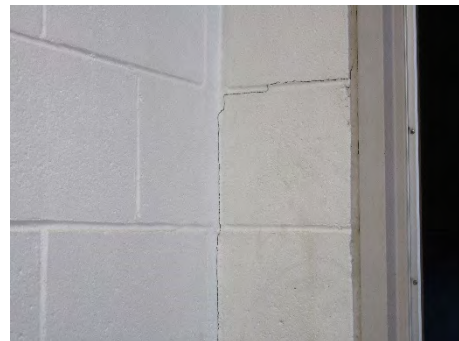
Image 34

- In some of the rooms the CMU walls have severe cracking in the corners of the room (Image 34).
- In some of the rooms throughout the school there are cracks in the face of the CMU walls (Image 35, Image 36).
- The building expansion joint is drying out and shrinking (Image 37, Image 39).
- There are several areas in the building that have old plastic wall anchor sleeves that have never been removed (Image 39).
- There are several areas in the building where the wall paint is scuffed.

- In the rooms where the CMU is cracking in the corners, further investigation is warranted to determine both the cause of the cracking CMU and a permanent fix.
- If CMU cracks around the building, are through the mortar remove the mortar and install new mortar joint. If the block is cracked replace the CMU block.
- At the building expansion joint, remove the old caulking and backer material. Install new backer material, install new sealant, and install metal expansion joint cover.
- At the areas that have the plastic wall anchor sleeves remove the old plastic anchors. Patch holes in the CMU block wall with mortar and touch up paint over the wall patches to match adjacent wall paint.
- At scuffed and damaged wall paint around the building, scrape area to remove any loose paint and then touch up area to match existing paint.

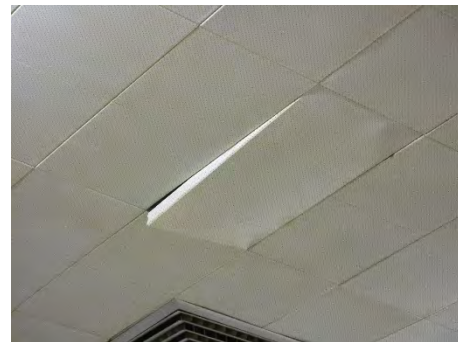
Image 41

- In the kitchen and kitchen support areas the 9"x9" ceiling tile is in poor condition, the tiles are full of stains and some tiles are missing, or falling (Image 41).

- In the kitchen and kitchen support areas remove 9"x9" ceiling tile system and replace with new lay in acoustical ceiling tile system.

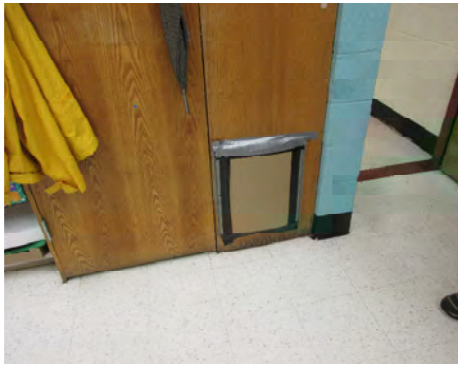
Image 43

- Much of the fixed furniture appears to be in fair condition but appears tired and dated. This was specifically noted with the classroom casework and the teacher's work room casework (Image 43-46).
- The toilet room fixtures and toilet partition walls are in very poor condition. Most of the fixtures are not accessible and the partitions are rusted, dented and / or broken (Image 47, Image 48).

- Replace all classroom casework, sinks, teachers' wardrobes, storage shelving, and teachers' work spaces casework. New casework and sinks are to meet MAAB / ADA code requirements.
- All bathroom fixtures and toilet partitions should be removed and replaced with new fixtures and toilet partitions. Fixtures to be located to MAAB / ADA code requirements.

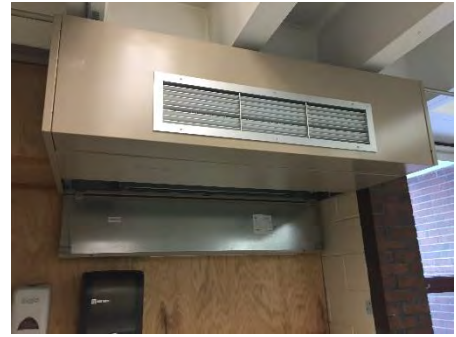
Ceiling suspended horizontal classroom unit ventilators are utilized for the heating and ventilation requirements of the majority the classroom spaces. The unit ventilators are manufactured by MagicAire and appear to have been installed in 2014. There are approximately ten (10) unit ventilators located on the first floor and eleven (11) unit ventilators located on the second floor, for a combined total of (21) unit ventilators. Ventilation air is introduced to each of these units through a wall-mounted louver. Some of the louvers appear to be in need of cleaning, repair, and/or replacement. Each unit is equipped with a hot water heating coil, supply fan and filter. The units are in very good condition. The classroom spaces are provided with exhaust systems to remove any outdoor air that is introduced through the unit ventilators which helps maintain a neutral pressure within the space. Most of the classrooms are served by central roof mounted exhaust fan systems. The majority of classrooms with exterior walls also have perimeter hot water fin tube radiation. The fin tube radiation appears to be originally installed equipment and is generally past its expected useful service life. Some of the fin tube radiation enclosure grilles are damaged and dirty (Image 9, and 10).

Image 9 – Classroom Unit Ventilator

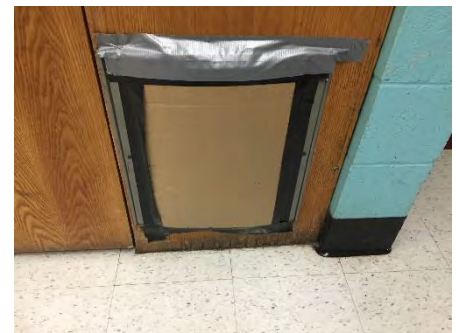
- The majority of the exhaust fans do not have dampers installed and as a result, many classrooms have covered up the associated exhaust grilles due to draft concerns.
- Some of the fin tube radiation enclosure grilles are damaged and dirty. The fin tube radiation appears to be originally installed equipment and is generally past its expected useful service life.

Image 10 – Classroom Covered Exhaust Grille

- Install dampers for all exhaust fans.
- Existing ductwork and air distribution devices should be cleaned.

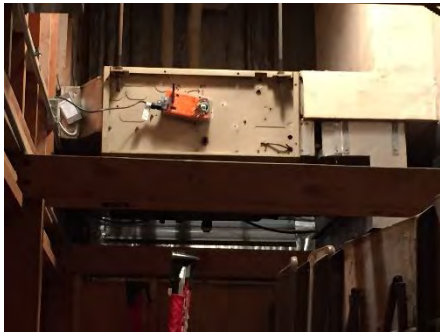
Image 14 – Gym Indoor H&amp;V

The Gym is served by two (2) indoor heating and ventilation units that are located in the adjacent Gym storage room. The H&V units are ceiling suspended units. The units each have a hot water coil, supply fan and filter section; and the manufacture is unknown. Galvanized sheet metal ductwork is distributed from the air-handling units to the Gym. Supply air diffusers are located on the sidewall and low floor return air registers are installed in the gym. The indoor air-handling units and associated ductwork appear to be originally installed equipment that are in poor condition and past their expected useful service life (Image 14).

- The indoor air-handling units and associated ductwork appear to be originally installed equipment that are in poor condition and past their expected useful service life.

- Existing indoor air-handling units should be replaced; new hot water branch piping and valves with insulation, ductwork connections and insulation, and controls should be provided.
- Existing ductwork and air distribution devices should be cleaned.

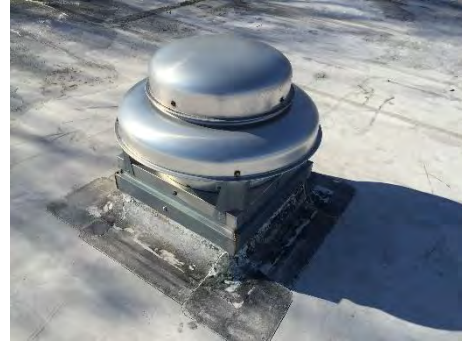
The majority of classroom spaces are exhausted through roof mounted exhaust fans. There are also dedicated exhaust fans which are roof mounted for areas such as the gang toilets, Kitchen hood, storage rooms and the large group spaces such as the Gym and Cafeteria. These areas utilize a galvanized sheet metal duct distribution system from the space to the roof mounted exhaust fans. There are approximately 27 roof mounted exhaust fans. The majority of the exhaust fans appear to be in very good condition, with most appearing to have been recently replaced. The majority of exhaust fans were manufactured by Loren Cook or CentriMaster. The majority of the exhaust fans do not have dampers installed, and as a result many classrooms have covered up the associated exhaust grilles due to draft concerns. The majority of the existing exhaust air ductwork appears to be originally installed and past its useful expected service life (Image 15)

Image 15 – Roof Mounted Exhaust Fan

- The majority of the exhaust fans do not have dampers installed.

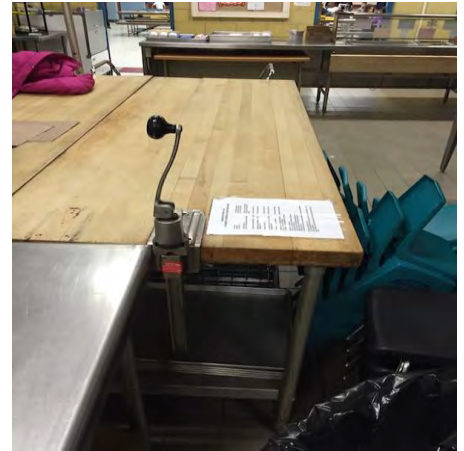
Image 3

- Wood topped work tables (Image 3) and wood surfaces are not allowed in a kitchen unless it is being used for intense scratch baking purposes. Wood surfaces are difficult to maintain. Surfaces must be oiled after each use to prevent the wood from shrinking causing splits that result in a health code violation. The gaps can fill with food debris and become impossible to clean and sanitize.

1. Eliminate all wood surfaces and non-health code compliant work surfaces.
2. Create a separation between the commercial foodservice related needs of the program and the community based teaching kitchen needs.
3. Remove equipment from the dish room to provide for additional storage.
4. Refit equipment, as needed, to suite the actual uses of this kitchen.
5. Assuming it is used in the traditional sense of providing meals to a school population, a refit of this kitchen as a stand-alone full service kitchen will cost approximately \$270,000.
