# Parker Middle School

## **ARCHITECTURAL ASSESSMENT**

The building survey for this report was conducted on February 17, 2016.

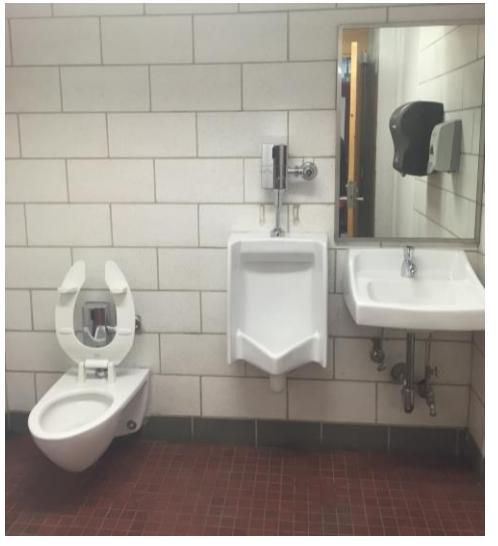
fixtures and / or accessories are not installed to meet accessibility requirements. An example of these conditions can be seen in Image 10 and these include: proper separation between fixtures (the urinal and sink are not the correct distance apart), proper height of controls, (the controls on the urinal are located too high), proper height of accessories (the paper towel and soap dispenser are located too high), lack of handrails and lack of insulation or shroud around the hot water piping under the sink. In other areas, such as the gang toilet rooms, all of the urinals and sinks have been installed at the same height. Accessibility requirements note that if more than one fixture is located in a restroom at least one must meet accessibility requirements.

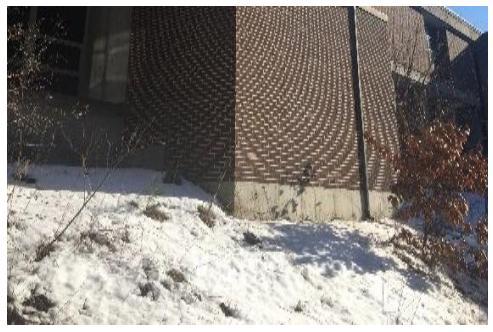
Image 13

Foundation walls below grade are formed in place concrete that is in fair condition. Exposed areas are in good condition (Image 13).

No recommendations needed.

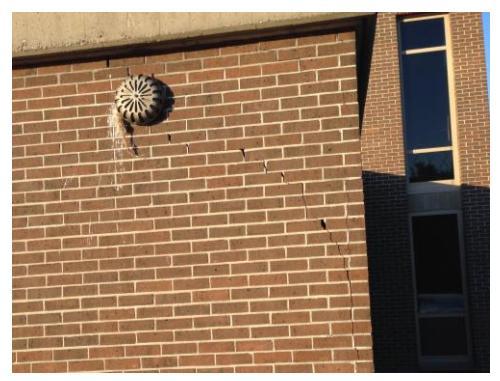
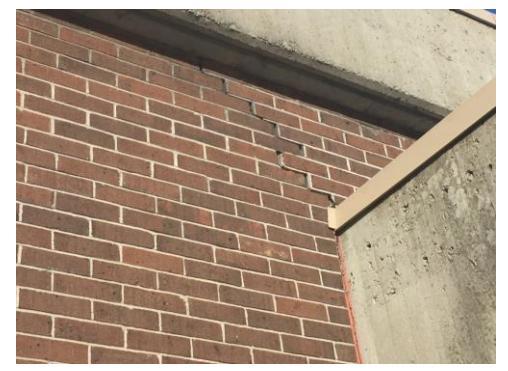
- Exterior walls are mostly brick veneer w/CMU backup in fair condition. Some brick are showing moisture and sever cracking in contained areas (Image 14 & 15).
- Control joints are in fair condition throughout the • school. Boy's Locker Room uneven brick settle with ruptured joint (Image 16).
- Some precast concrete cantilevers are spalling and exposing rebar (Image 17).
- Pod classrooms are wood/vinyl cladding and are in fair condition. Some cladding is falling off the structure (Image 18).

- Remove debris from weeps to allow proper • ventilation and drainage from wall cavity.
- Further investigation is warranted to determine the cause of brick cracking.
- Repair/install a new control joint.
- Where precast cantilevers are spalling remove all the loose concrete and then patch to match profile of the cantilever.
- Re-install cladding at pod classrooms.

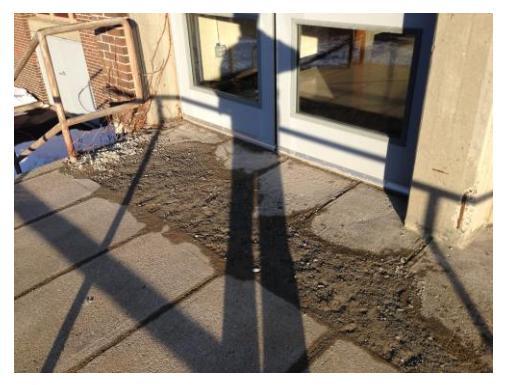
Image 20

Some doors have thresholds and approaches that do not meet current codes due to height of threshold (in excess of ½") or due to the condition of the landing surface outside the door. (Image 20)

- Repair and replace thresholds at doors that exceed 1/2" in height at egress exits.
- Install an approach pad that meets all current MAAB / ADA code requirements.

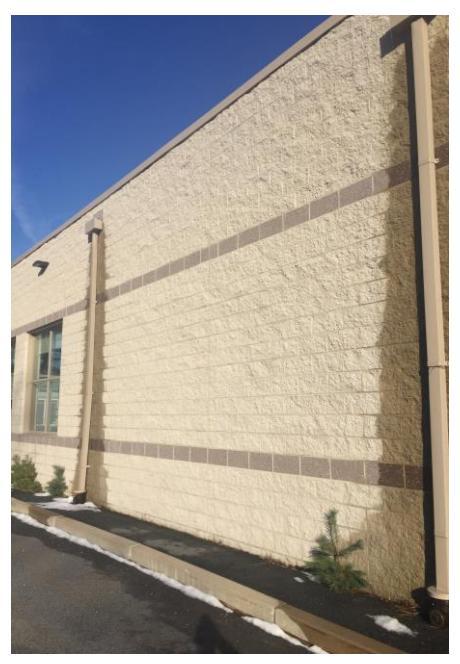
Image 21

- Recent replacement of roof with an adhered membrane system.
- Recent installation of photo-voltaic cells on roofs.
- Some ceiling tiles were found with stains, indicative of a possible roof leak, yet the age of the stains is unknown.
- Overflow scuppers appear clogged, or the connection between the wall and downspout is not correctly attached to the walls (Image 21).

- Investigate areas where ceiling tiles are stained to verify source.
- Review scuppers and repair down spouts

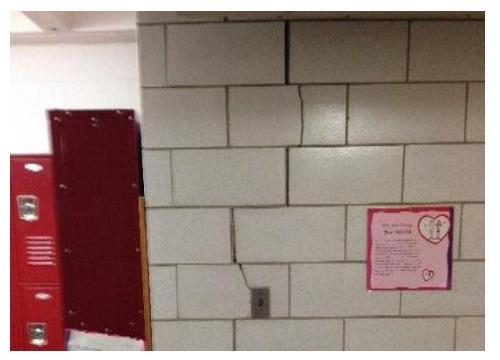
Image 25

- Corridor walls are largely painted CMU/tile in good condition.
- Locker Rooms have cracking at the soap tile walls (Image 25).
- In some classrooms and corridor walls the CMU walls have severe cracking in the corners (Image 26 & 27).
- Gypsum wallboard partitions are in generally good condition.
- Wood paneling in gym is in poor condition (Image 28).
- Folding partition walls are in poor condition (Image 29).

- In areas where the cmu/tile is cracking or separating further investigation is warranted to determine the cause. Repair is required.
- Replace wood paneling in gym, add padding to walls for safety
- Remove folding partition walls and replace with gypsum wall board partitions that provide proper acoustical separation between spaces
- In spaces where partitions have been installed that do not extend to the underside of the slab and do not provide proper acoustical separation between classrooms extend walls to the underside of the deck or provide dropped ceilings on both sides of the wall.

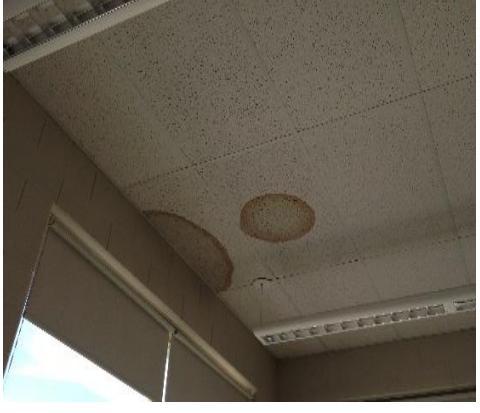
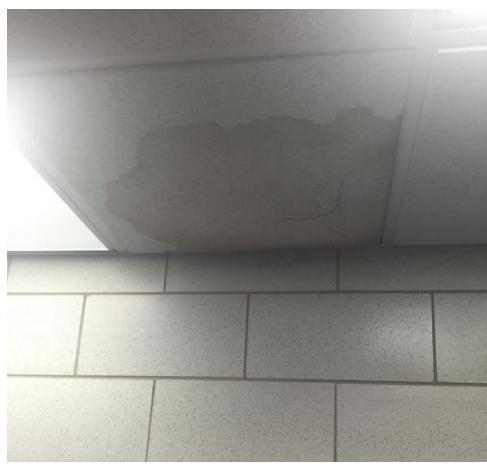
- Acoustic ceiling tile (1x1), adhered to underside of waffle slab, in classrooms/corridors are in fair condition.
- Acoustic ceiling tile and grid in the Library is in fair condition.
- Several ceiling tiles throughout the building have water stains due to roof or equipment leaks above the ceiling (Image 30 & 31).
- Gypsum soffit boards are generally in good condition.

- Further investigation is warranted to determine the cause of water leaking, repair source and replace ceiling tiles.
- Several ceiling tiles are cracked and damaged and should be replaced.

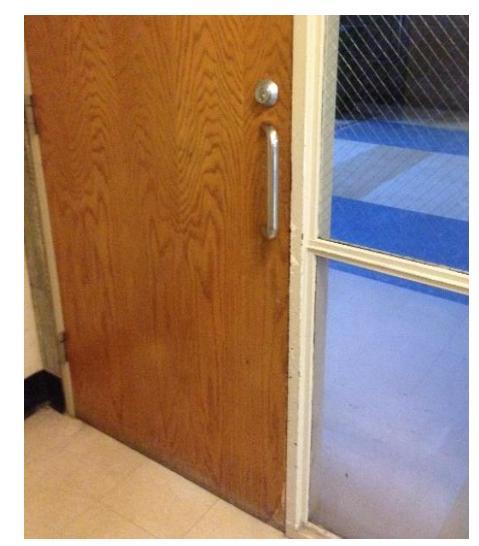
Image 33

- The base of some doors and frames have water damage or rust as a result of floor cleaning
- Some of the corridor wood doors with sidelight have wired glass (Image 33).

- Add kick plates to the bottom of doors to prevent further damage
- Repair rusting at the base of door frames
- Remove all wired glass panels from the interior doors, sidelights and interior glazing. Replace with tempered glass.

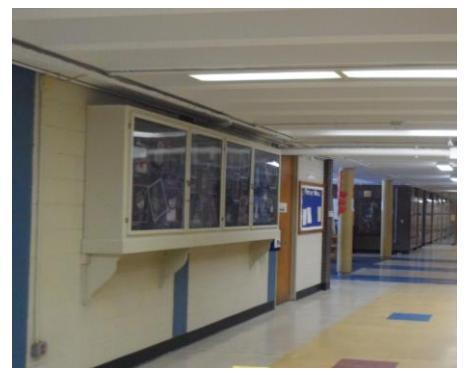
Image 35

- Shelving units near cafeteria appear worn
- Display cases are in fair condition and protrude into the hallway beyond the allowable distance per accessibility codes (Image 35)
- Showers in the locker rooms did not meet current code accessibility requirements. These rooms do not appear to be used on a regular basis (Image 36).

- Replace display cabinets in hallway and provide cane detection to meet accessibility requirements.
- Install new casework in classrooms.
- Install accessible lockers in both the corridors and in the locker rooms.

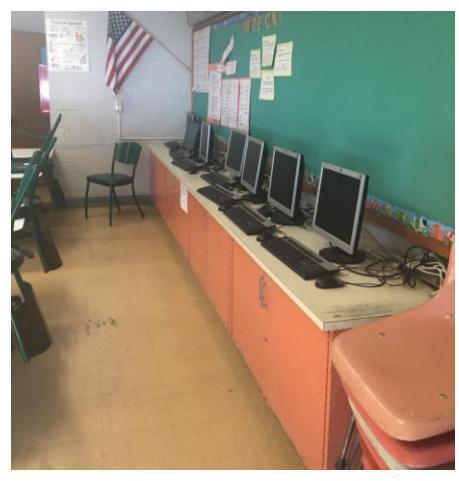
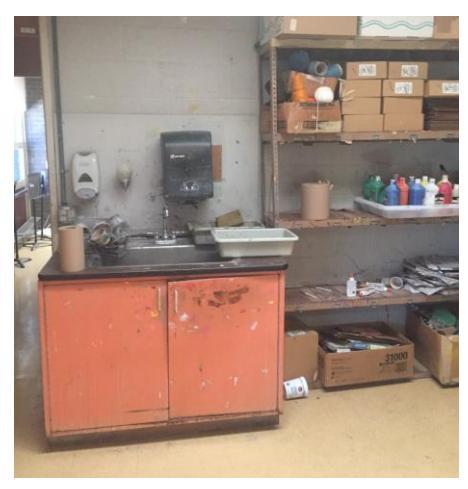
- Casework, shelving, counters and sinks in classrooms are original to the building and are in poor condition (Image 37 & 38).
- Teacher wardrobes are original to the building and in poor condition (Image 39).
- Lockers in both the corridors and locker rooms do not provide accessible lockers.

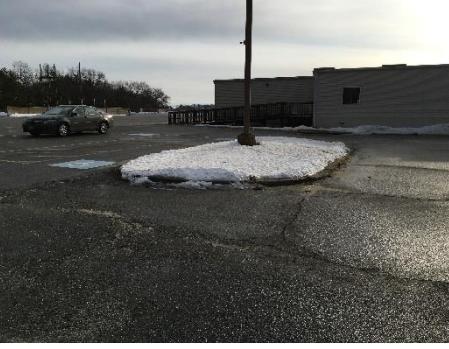
Image 9

The asphalt pavement within the site is in generally fair condition with some areas of cracking and degradation (Image 9). There is some accumulation of sediment in paved areas onsite and some areas of ponding/icing (Image 10 & 11).

- Mill and overlay sections of pavement where cracking/degradation has occurred.
- Regrade paved areas to prevent ponding which can lead to ice patches in the cold weather.

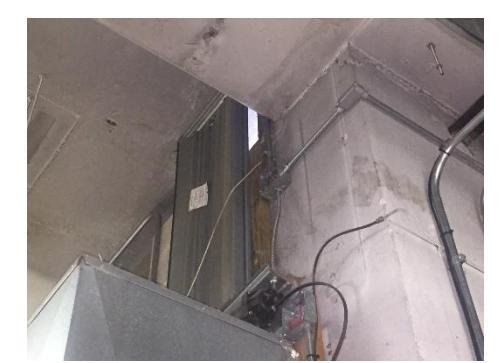
Image 4 – Combustion Air Damper w/ Gap

Combustion air is brought into the boiler room through two wall mounted louvers, with a high opening and a low opening that terminates 2 ft above the floor. The openings are dampened using electric actuators. There is a gap in the upper damper that allows outside air to infiltrate into the boiler room (Image 4).

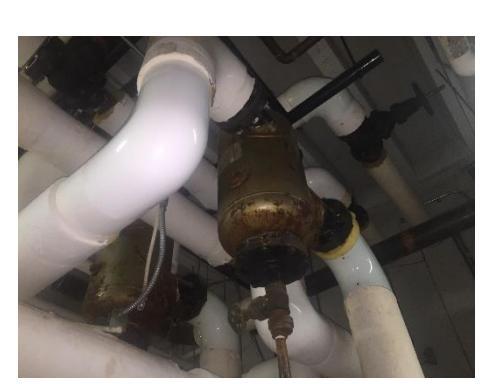
Image 7 – Uninsulated Air Separators

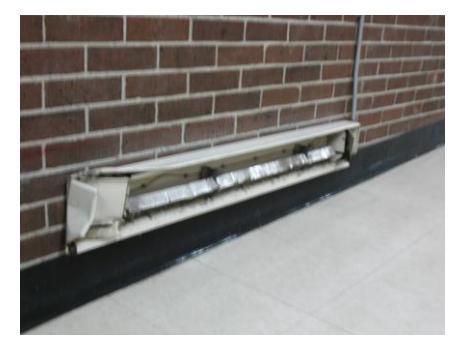
Image 22 – Portable Classroom Corridor Damaged Electrical Baseboard

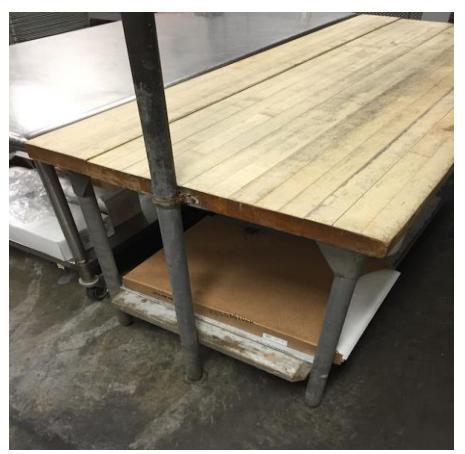
Image 5

Lighting and Surfaces (Image 5):

- The lighting levels in the kitchen are too low for food service equipment. The current levels are below the code minimum for food production areas.
- This wood framed door beyond is the access point to what was once a dishwashing room. The room has since been converted to a storage room.

- 1. Eliminate all wood surfaces and add hand-washing sinks.
- 2. Add appropriate mobile worktables to provide for additional work surfaces.
- 3. Redeploy the dish room or eliminate the equipment from the dish room to provide for additional storage. Build a wall that is constructed of easy to clean materials
- 4. Consider installing a lay in washable ceiling and improve the lighting levels in the kitchen
- 5. Add a fire suppression system for the hood system and two-burner range.
- As complete refit of this kitchen will cost approximately \$425,000. There is very little here that can be saved.
