Dore & Whittier Architects Inc.

South Row Elementary School

SOUTH ROW ELEMENTARY SCHOOL ARCHITECTURAL ASSESSMENT

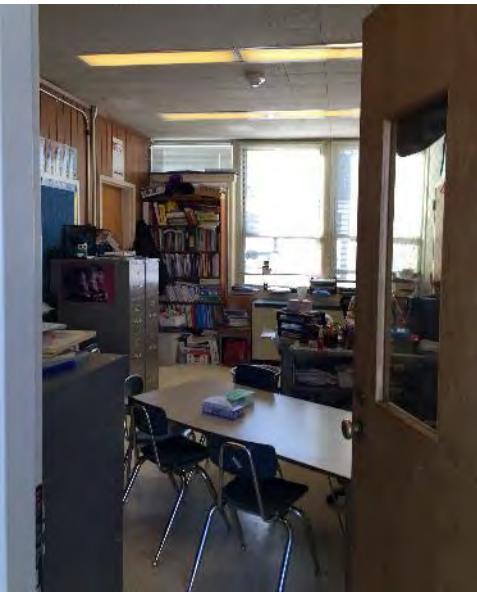
Image 13

Many doors throughout the facility still have knob hardware and in many locations the push / pull clearance at the door location does not meet accessibility guidelines. (image 13 & 14). This condition limits access to restrooms, offices, and classrooms throughout the facility. A clear path of access to the accessible restroom has not been provided. This is in part due to the lack of dedicated teaching spaces. In this condition the corridor is being used as a tutoring space and blocks the access to the accessible restroom.

- Renovate main office counter to meet accessibility requirements
- Replace existing handrails at the stage to meet ADA / MAAB
- Install a lift or ramp to access stage
- Install segment of upper handrail on ramp in corridor
- Install new handrails at stair locations to meet ADA
 / MAAB requirements for dimension of handrail and extension beyond the top and bottom riser.
- Provide clear access to the accessible restroom
- Renovate restrooms, offices and classrooms to provide push / pull clearances at doorway
- Install protection around sink pipes

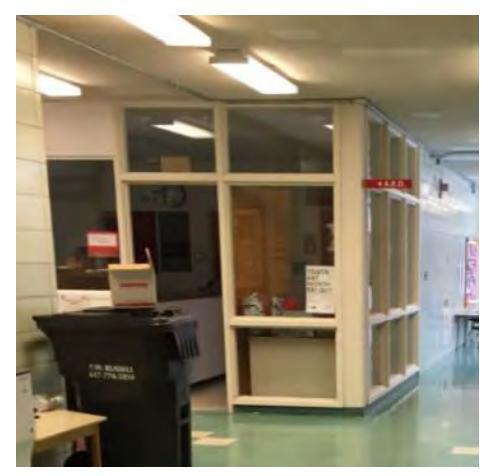
Image 44

- Most doors and frames are original and are in fair condition.
- Doors and interior glazing contain wired glass that no longer meets code.
- The Admin office hollow metal frame storefront / borrowed lite system has wired glass. (Image 44)

- Renovate all classroom doors to have upgraded hardware including levers and locking devices
- Repair / refinish classroom doors
- Remove wire glazing from doors, sidelights and other interior glazed locations
- Remove all wired glass panels from the interior doors and replace with tempered glass during a larger renovation or if the door is otherwise in need of replacement.

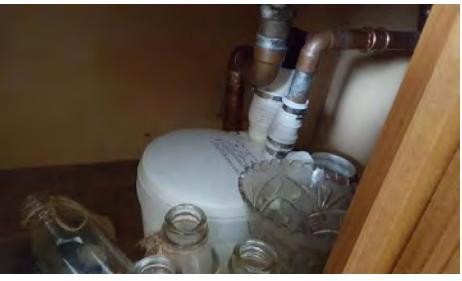
Figure 11 – Waste Ejector Pump

- Plumbing fixtures meet current code for water conservation. However, new high-efficiency low flow fixtures (faucets & flush valves) could be installed to reduce water consumption. It should be confirmed that the existing water closets & urinal are compatible with current low flow flush valves.
- We recommend video inspection of existing drains to confirm integrity and correct pipe invert. If pitch is determined to be shallow, we would not recommend low flow plumbing fixtures.
- Provide new high-efficiency gas-fired domestic water heater once the existing water heater has expired.
- Install expansion tank and mixing valve at water heater.
- Remove air admittance valve at waste ejector pump and vent per Massachusetts Plumbing Code.
