# McCarthy Middle School

## ARCHITECTURAL ASSESSMENT

The building survey for this report was conducted on February 16, 2016.

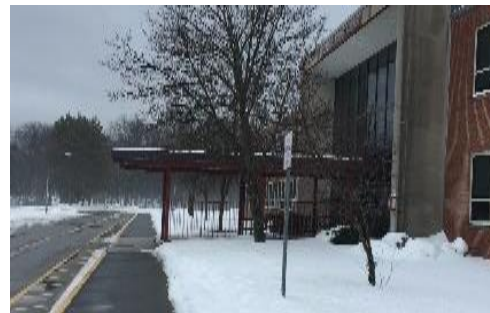
Image 2

The main entrance is handicap accessible (Image 2 and 3). However, due to the bus drop off area accessible parking is not located within the minimum distance of the front door. Accessible parking is provided along the side of the building in several locations with access to different points of the building such as near the cafeteria and gym (Image 4 & 5). Most exterior doors appear to be accessible for exiting. Ramps are located at doors where a transition to grade is required.

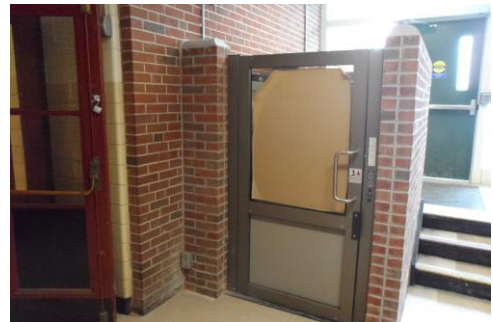
Image 8

The building includes barriers to accessibility, as it does not include an accessible route throughout the building. Several efforts have been made to improve access throughout the building, including a lift at the side entrance near the cafeteria/gym (image 8) and the installation of raised walkway in the hallway (Image 9). Access to other spaces remains non-conforming.

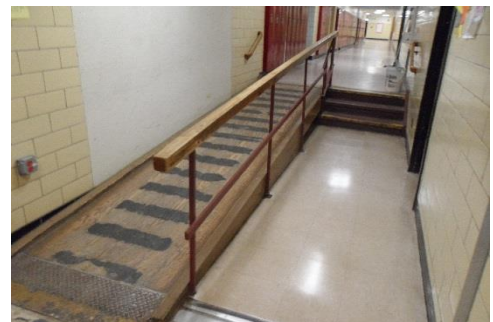
Image 9

- Multiple entries (classrooms, offices, etc.) do not have at least 12" clear at the door, especially 18" minimum clear for pulling the door open if it has a closer. (Image 9).

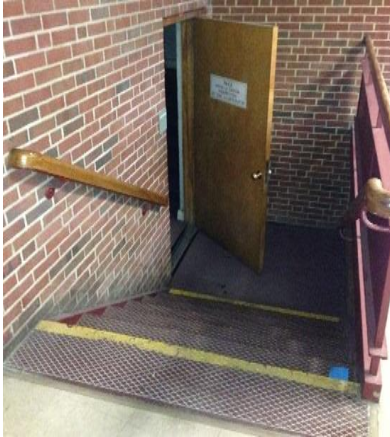
Image 11

The Performing Arts wing is accessible from the exterior however, from within the building a steep non-compliant ramp (Image 10) and stairway (Image 11) are the only means to access this area.

- At stairway to theater remove existing handrail and install new handrails that are compliant for diameter and extensions beyond the top and lowest risers (Image 11).

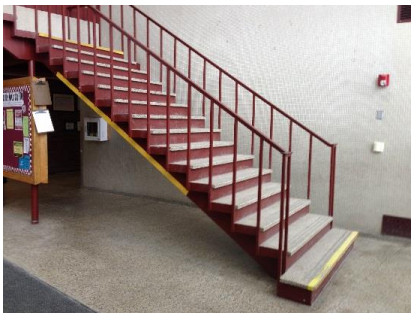
Image 12

- Stairways do not provide handrails and guard rails that meet code. Remove existing handrails and guard rails and install railings with extensions at both the top and bottom of the risers and guardrails that provide less than 4" opening (Image 12).

- Some areas do not provide cane protection. (Image 12) Install barriers to prevent someone from walking into or under the stairway.
- Several drinking fountains do not provide the required space clearance below and are not at the proper height. These fountains should be replaced with drinking fountains that meet accessibility requirements (Image 13).

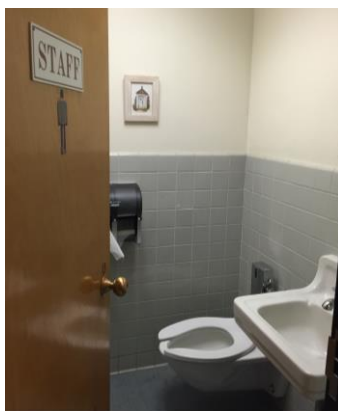
Image 14

- Many areas do not have push / pull clearances that meet accessibility requirements.
- Doors throughout the facility have knob hardware which should be replaced with lever hardware (Image 14)

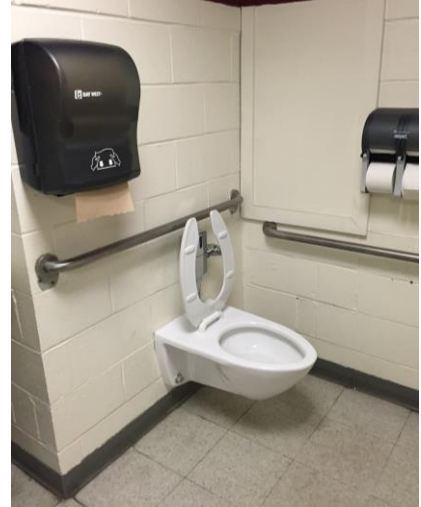
Image 15

- Several restrooms are not fully accessible or do not have accessories located properly (ie. Fixtures are located too high or not located correctly) (Image 15)

- Install new teacher wardrobes
- Install new casework and sinks to meet the current code requirements.
- Reinstall toilet fixtures and accessories to the correct height and install pipe guard under accessible sink.

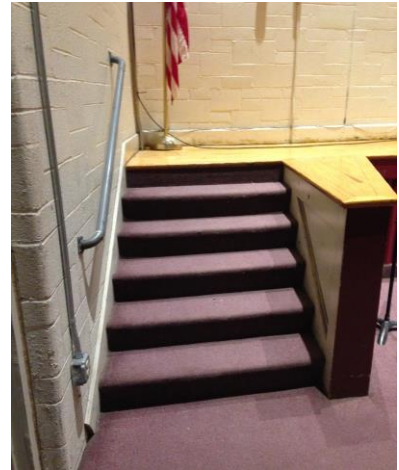
Image 16

- The auditorium stage is not accessible from the auditorium (Image 16). A lift should be installed from the main floor to the stage
- The auditorium control platform is non-accessible to someone in a wheelchair (Image 17).

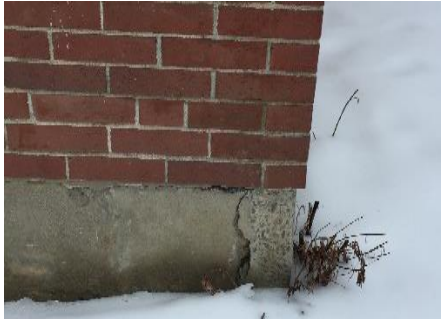
Image 18

- Foundation walls below grade are formed in place concrete that is in good to fair condition.
- Multiple top of foundation exposed corners are in fair to poor condition. One example seen at the Aux Gymnasium northwest corner foundation. (Image 18).
- Some areas around the foundation were parking

- Further investigation is warranted to determine the cause of cracking.
- Review areas of parking

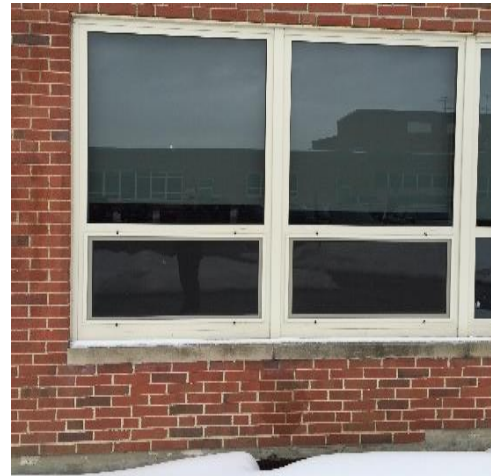
Image 22

- Aluminum-framed awning/fixed windows throughout the school and Library addition are in good condition.
- The sealing at the windows appears to be in fair condition.
- Multiple window precast sills have gaps or cracked mortar. Water runoff from the windows is stained below them (Image 22).
- The Gymnasium clerestory films are damaged or deteriorating (Image 23).

- Repair precast window sills and retool new mortar.
- Remove existing film at the clearstory and install new Gymnasium clerestory film

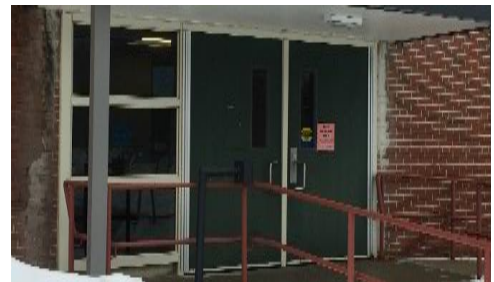
Image 24

- Hollow metal doors throughout the school and Library addition are in good condition (Image 24).

- Aluminum-framed louvers throughout the school are in fair condition. Areas with brick sill have gaps or cracked mortar. Water runoff from the louver is stained below them (Image 24).

- Repair brick sills and retool new mortar.

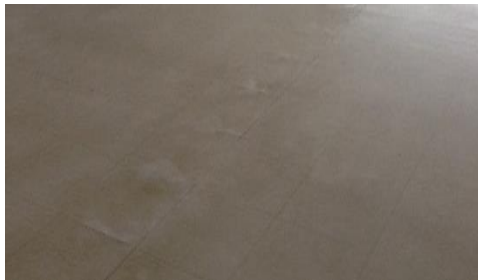
Image 28

- Corridor stairs have metal treads in fair condition. Corridor ramp slip resistant membrane is worn and only has plywood membrane surface (Image 27).
- Classrooms, offices, and cafeteria have VCT generally in fair condition. VCT in the Art/Band classrooms appear to be newer, however there are seams and tiles that are popping or separating (Image 28).

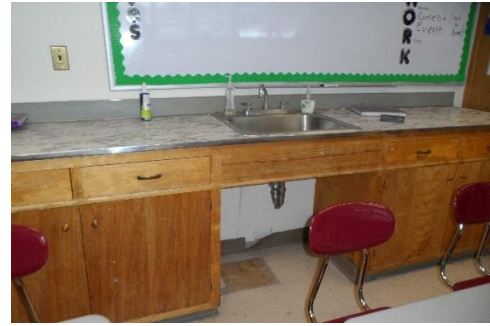
Image 35

- Teacher wardrobes are in fair condition (Image 34).
- Casework with counters and sinks in classrooms are in fair condition. Cabinets are delaminating and laminate countertops are lifting. These counter areas do not meet current accessibility code (Image 35).
- Toilet rooms in the locker room areas did not meet current code accessibility requirements for minimum heights. Accessories are mounted too high to meet current accessibility code requirements. Compliant under-sink protectors are not installed (Image 36).
- Locker room benches didn't allow proper width for accessibility requirements in current code. No accessible bench with fixed back was noted. Showers did not have accessible controls per current code requirements (Image 37).
- Designated accessible lockers are required in both locker rooms and in the general corridors.

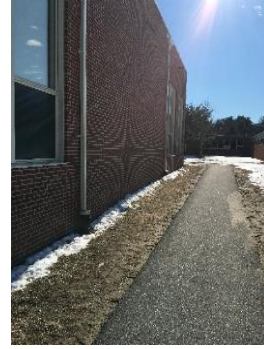
Image 1

Stormwater runoff from the roof of the building appears to be collected in downspouts on the building that discharge to a below grade closed drainage system (Image 1). Stormwater runoff from the paved parking lots to the north and south of the building is collected in catch basins (Image 2). The catch basin appear to discharge through a headwall into the stream adjacent to the site, however, it is also possible they drain to the drain main in North Road.

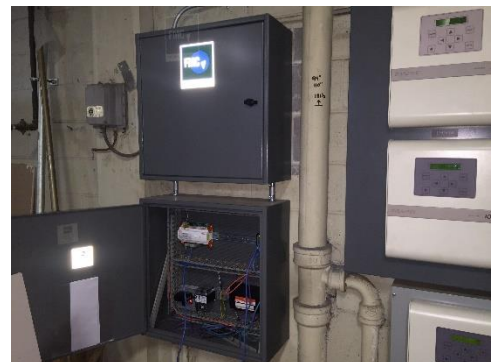
*Image 4 - DDC Control Panel*

The building is served by Novar/Trend Tridium based direct digital controls. (Image 4) The school is nearing the end of a controls upgrade that started in 2014. Trend combination temperature sensors/CO2 sensors are being retrofitted to each classroom to provide demand control ventilation at each unit ventilator. In the boiler room, the Trend system monitors HWS temp, HWR temp, OA temp, HW differential pressure and boiler alarms. The Trend system controls pump start/stop and speed, differential pressure bypass valve position and split air conditioner start/stop. The air handlers in the big gym, small gym and auditorium are variable speed operating from 80-100% based on either ventilation or temperature demand. The Trend system monitors CO2, opens the outside air damper and increases fan speed as necessary. When temperature setpoint is not being maintained, fan speed is increased. The boilers are sequenced and operate via the stand alone boiler management controller. Boiler faults are picked up by the Trend system. The portable classrooms are controlled by stand-alone programmable thermostats. Utility type spaces and bathrooms are controlled by local controls with no night setback capability. The boiler plant is equipped with an automatic outdoor air reset control function which provides energy savings when the building load does not require high temperature water due to warmer outdoor conditions.

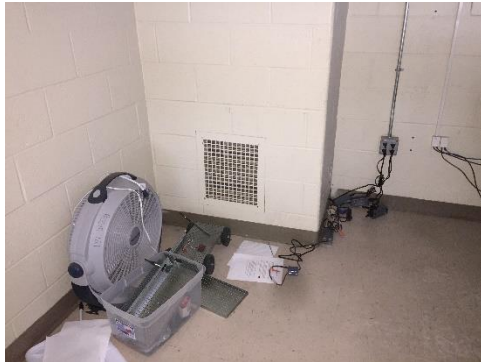
Image 5 – Typical Low Wall Exhaust Grille

Each classroom is provided with a low wall mounted exhaust register which communicates to a central roof mounted exhaust fan through a galvanized sheet metal duct collection system (Image 5).

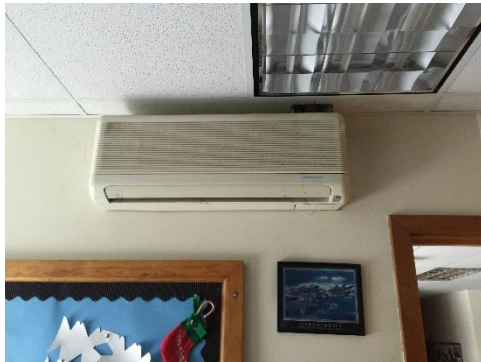
Image 6 – Admin Area Ductless Heat Pump

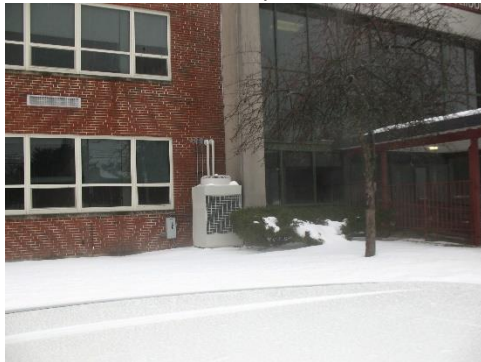
Image 7 – Admin Area Condensing Unit

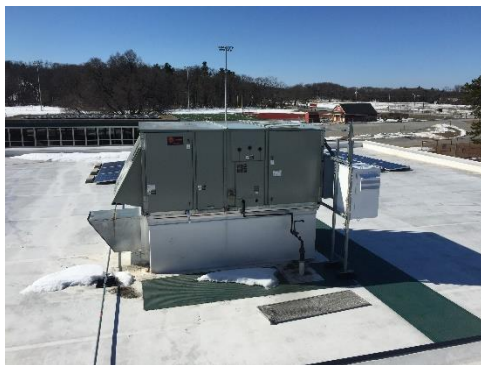
Image 8 – Library RTU

The library is served by a 17.5 ton constant volume roof top unit, which consists of a supply and exhaust fan, filter section, gas furnace and direct expansion cooling coil (Image 8). This roof top unit is associated with a galvanized sheet metal duct distribution system which delivers and returns the conditioned air to and from the spaces via ceiling diffusers and grilles. The unit delivers a mixture of outside air and return air, which is then conditioned through the unit's gas furnace or DX cooling coil. The library is broken into 3 temperature zones – north exposure, south exposure and center/clerestory. Duct mounted hot water coils further heat/reheat the tempered air being supplied by the rooftop unit. Hot water slopetop baseboard radiation is run along the perimeter of the library as supplemental heat. The fresh air damper at the rooftop unit is controlled by CO2 sensors in the space to match fresh air damper ventilation settings with actual room occupancy

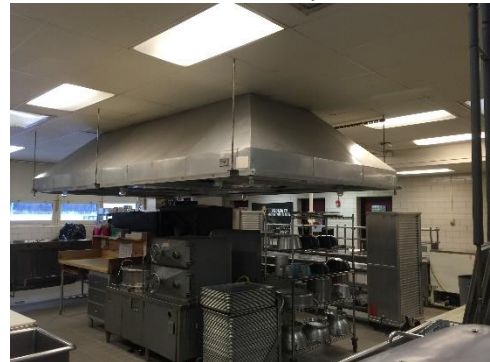
*Image 10– Canopy Kitchen Hood*

The kitchen functions as a warming kitchen. The hood has no Ansul fire suppression system. The hood has an interior panel with adjustable slide gates to adjust airflow through the slide gate openings. (Image 10 & 11) Partial make-up air is supplied via a wall mounted vertical unit ventilator which draws in fresh air through a high louver. (Image 12) The remainder of the hood make-up air is transferred from the cafeteria via open doors/transfer grilles. The kitchen offices are heated by slopetop baseboard radiation. The offices are ventilated by a ceiling exhaust register.

- Install a variable speed demand control kitchen hood control system. This system monitors the heat and smoke given off by cooking processes and adjusts hood airflow to compensate. When little cooking is taking place, the hood runs at reduced airflow, saving energy.

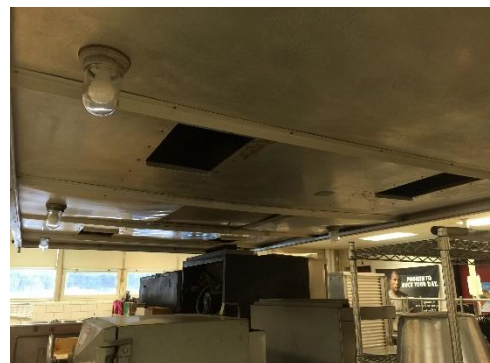
*Image 11– Slide Gates Inside Kitchen Hood*

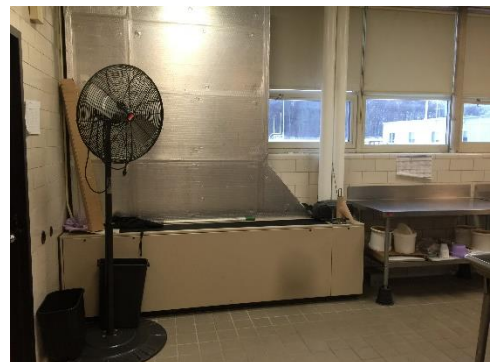
*Image 12– Kitchen Unit Ventilator*

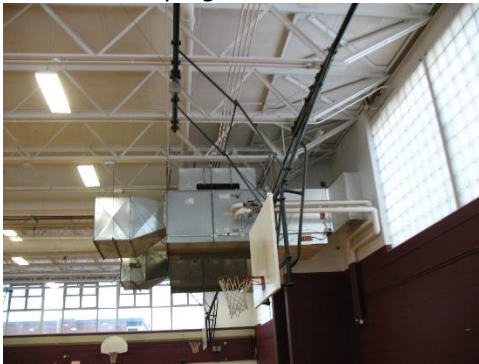
*Image 14– Gym Air Handlers*

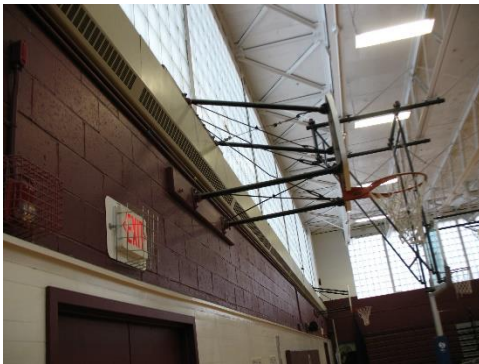
*Image 15– Slopetop Radiation at Gym Clerestory*

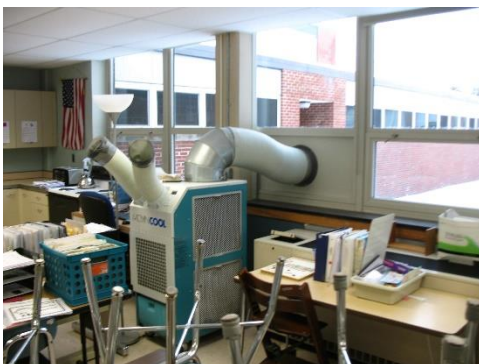
*Image 16– Portable Air Conditioner*

The home economics room is cooled by a portable air conditioner with hot condenser air ducted to a window opening (Image 16).

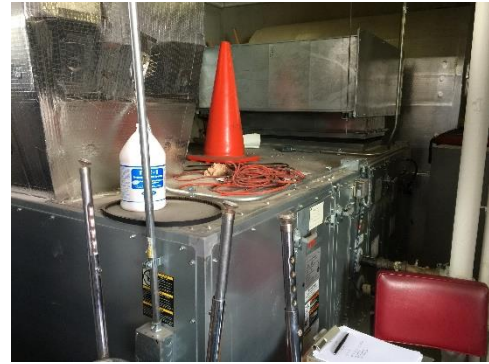
Image 17 – Auditorium Air Handler

The auditorium is served by a 6800 CFM Trane indoor air handler and remote return air fan. (Image 17 & 19) The air handler consists of a supply fan, filter section and hot water coil. The unit is associated with a galvanized sheet metal duct distribution system which delivers supply air to large ceiling diffusers. The unit delivers a mixture of outside air and return air, which is then heated through the hot water coil. The return fan draws air back from the auditorium and returns most to the air handler with the remainder being exhausted out a wall louver. The auditorium has no air conditioning. It is provided with economizer cooling, which uses cool outdoor air to provide cooling during moderate weather. The fresh air damper at the air handler is controlled by CO2 sensors in the space to match fresh air damper ventilation settings with actual room occupancy.

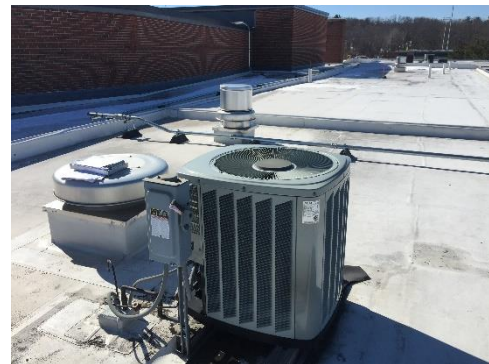
Image 18– Roof Mounted Condensing Unit &amp; Fans

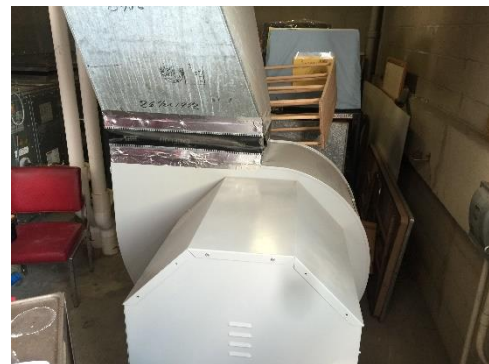
Image 19– Auditorium Return Fan

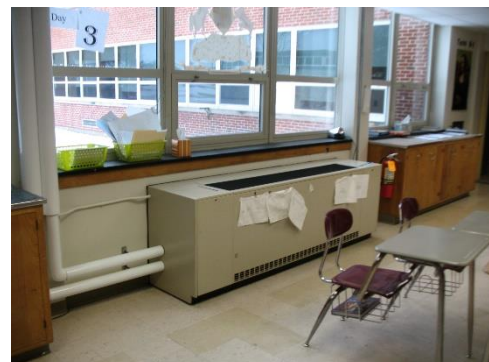
Image 20– Typical Classroom Unit

Single wall mounted vertical unit ventilators are provided in each classroom. (Image 20) These units provide outside air through the use of a through wall louver system which is ducted to the back of the unit ventilator. Within the unit is a supply fan, hot water coil, face and bypass dampers, a filter rack and outside/return air dampers. The unit ventilators are provided with electric actuators. Each unit ventilator is controlled via the standalone wall mounted sensor tied into the Trend DDC control system. This combination temperature/CO2 sensor provides demand control ventilation to more closely match fresh air damper ventilation settings with actual room occupancy. The unit ventilators are manufactured by Trane.

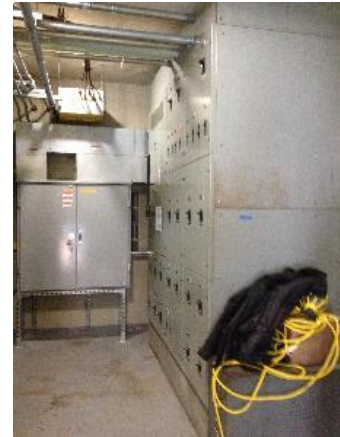
*Image 1 – Main Switchboard*

The switchboard manufactured by Federal Pacific, FPE, is original to the building, is obsolete, and is in poor condition. Most local and remote panelboards are also FPE original and are generally full and in poor condition. Panels are of the breaker type, and generally not located within electric closets.

1. Provide new pad mounted transformer to replace existing vault transformer.
2. The original FPE switchgear is in poor condition, generally full and should be replaced. The existing feeders and branch circuits would be refeed from the new switchgear.

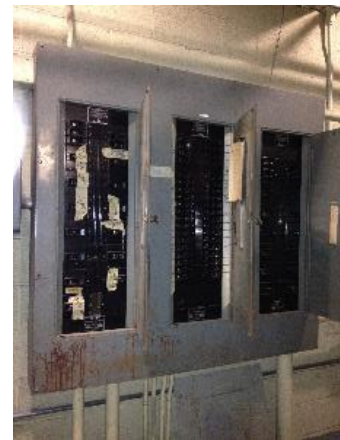
*Image 2 – Typical Original FPE Panels*

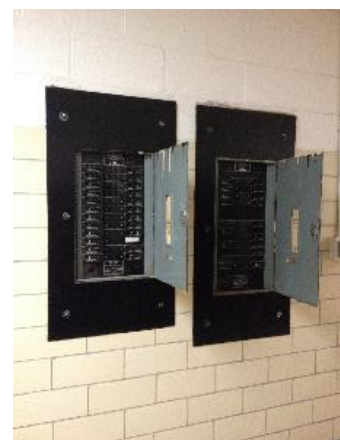
*Image 3 – Flush FPE Panels in Corridor*

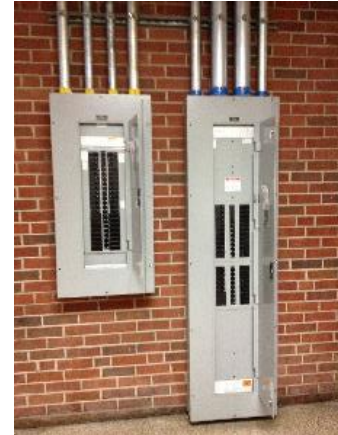
*Image 4 – Typical 2005 Panels in Corridor*

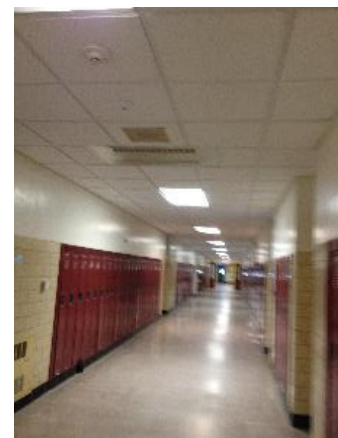
*Image 5 – Corridor Lights*

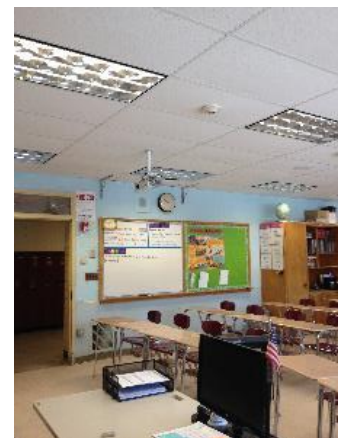
*Image 6 – Classroom Lights*

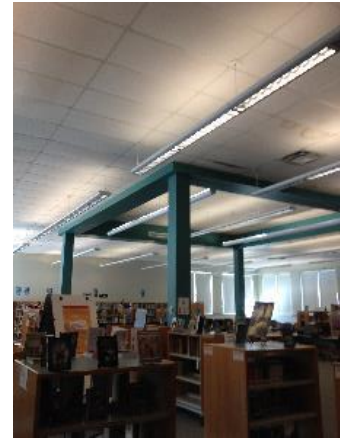
*Image 7 – Library Lights*

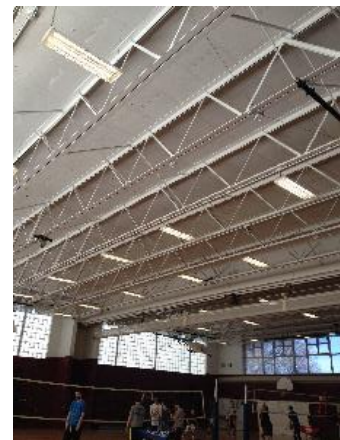
*Image 8 – Gym Lights*

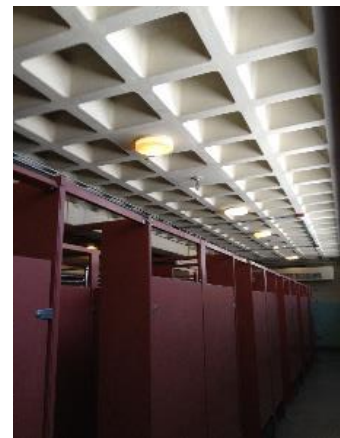
*Image 9 – Locker Room Lights*

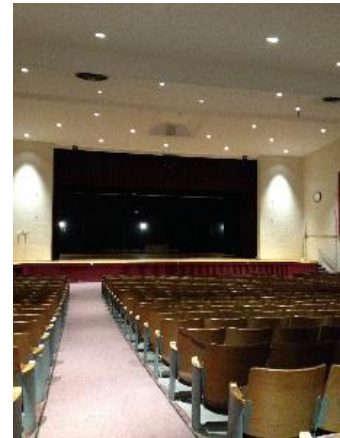
Image 10 – Auditorium Lights

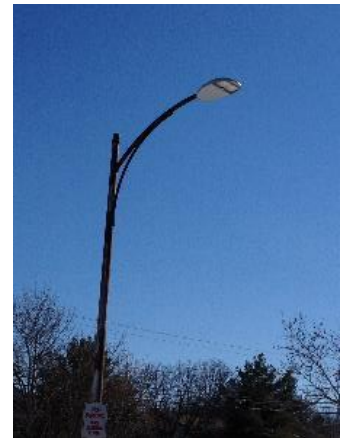
Image 11 – Pole Lights

1. Replace building mounted HID and compact fluorescent sconces with LED fixtures of the cut-off type.
2. Provide uniformed pole mounted LED fixtures of the cut-off type for parking areas.

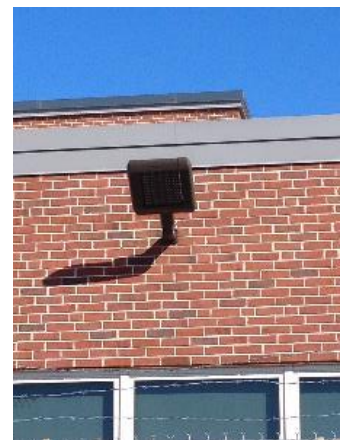
Image 12 – Exterior Wall Fixtures

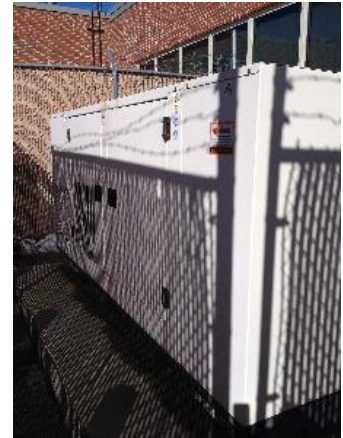
Image 13 – Exterior Generator

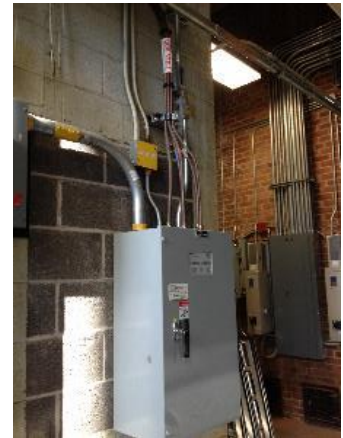
Image 14 – ATS 1 in Boiler Room

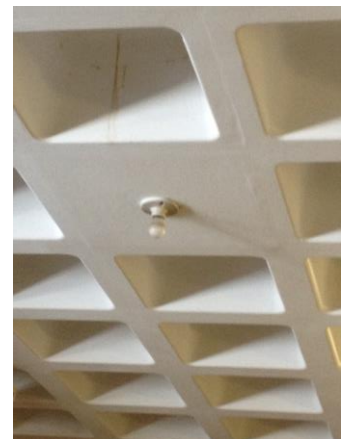
Image 15 – Emergency Only Light Fixture in Locker Rooms

1. Upgrade existing emergency lighting, panels and feeders to comply with code. Provide dedicated emergency closets with 2-hour rating to house new panels.

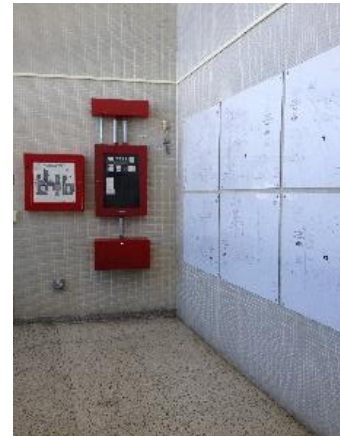
Image 16 – FACP in Main Lobby

1. Replace fire alarm control panel with new FCI E3 which is backwards compatible with the existing devices.

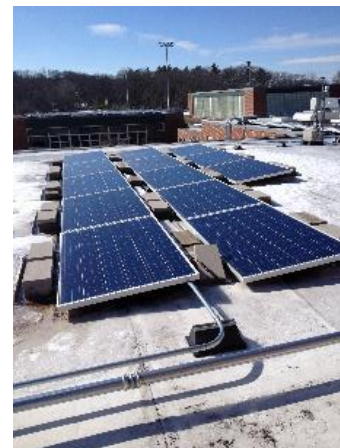
Image 17 – Roof PV Panels

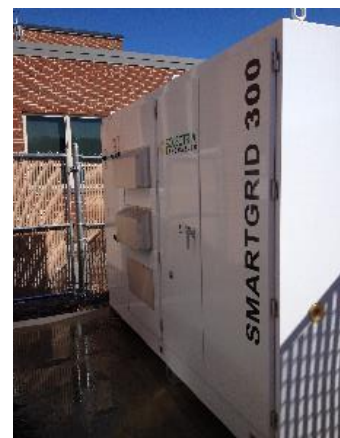
Image 18 – 300 Kw Exterior Inverter

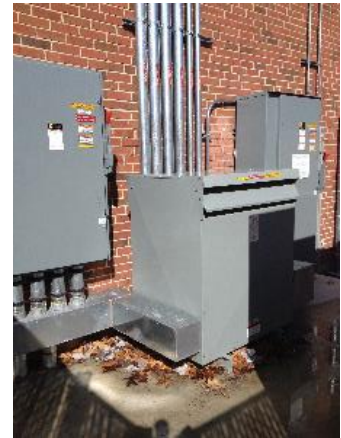
*Image 19 –Exterior 300 kVA Step-Down Transformer & Disconnect Switches*

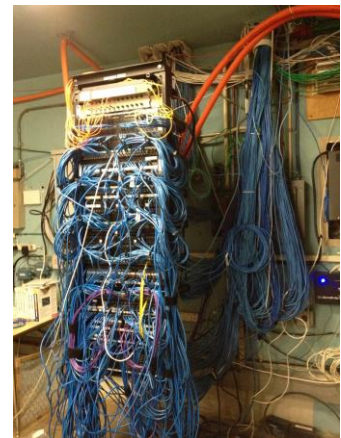
*Image 20 - IT/MDF Room Data Rack*

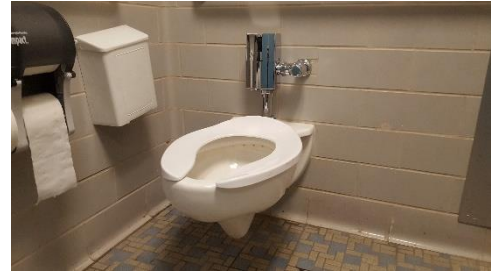
Water closets are wall hung vitreous china with automatic sensor flush valves (Image 1).

*Image 1 – Wall Hung Water Closet*

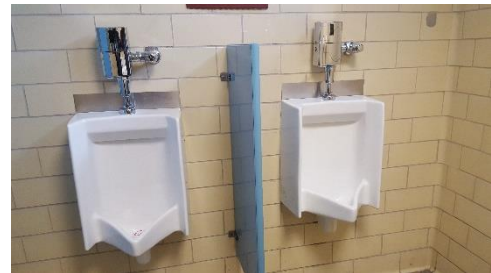
Urinals are wall hung vitreous china with automatic sensor type flush valves (Image 2).

*Image 2 – Wall Hung Urinal*

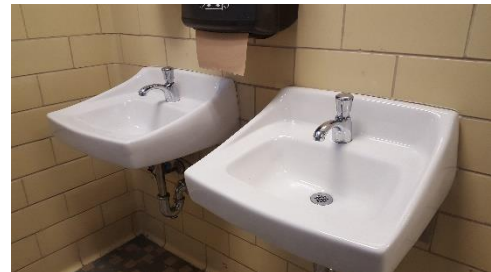
Lavatories are wall hung vitreous china. The lavatories are fitted with sensor type faucets (Image 3).

*Image 3 – Wall hung Lavatory*

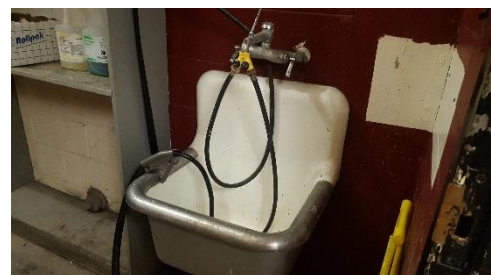
*Image 4 – Utility Sink*

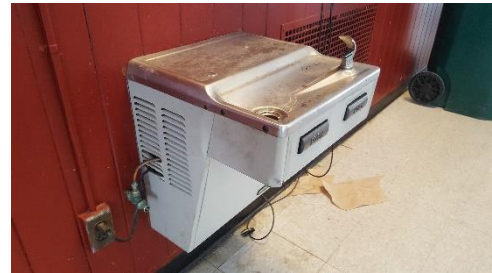
*Image 5 – Drinking Fountain*

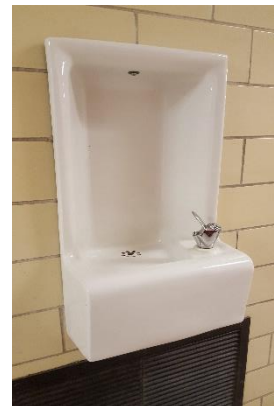
*Image 6 – Drinking Fountain*

Drinking fountains are a mix of stainless steel wall mounted push bar type and recessed vitreous china push button type (Image 5 and 6).

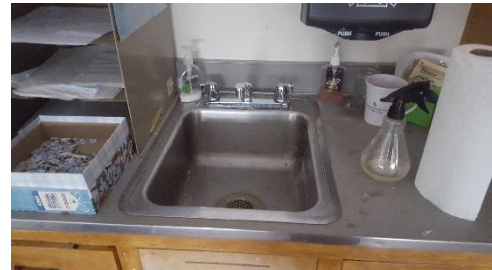
*Image 7 – Classroom Sink*

Classroom sinks are counter mounted stainless steel with hot & cold water handle faucets (Image 7).

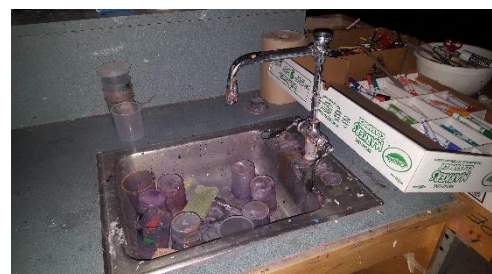
*Image 8 – Art Sink*

Art sinks are counter mounted stainless steel with hot & cold handle faucets equipped with a vacuum breaker and thermoplastic trough style sink with (2) wall mounted faucets. Art sinks are equipped with sediment traps. (Image 8, 9, & 10).

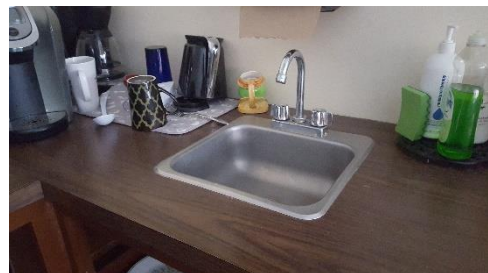
*Image 11 – Teacher's Lounge Sink*

Teachers' Lounge sink is a counter mounted stainless steel sink with hot & cold water handle faucet (Image 11).

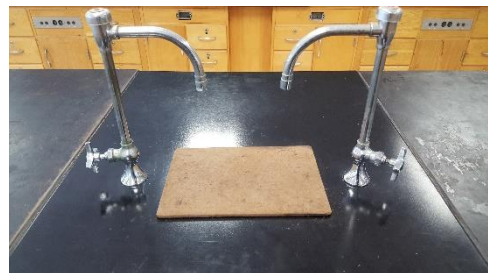
*Image 12 – Science Sink*

Science sinks are epoxy resin type with gooseneck faucet equipped with vacuum breakers. Sinks are not equipped with acid neutralization tanks or collection system (Image 12).

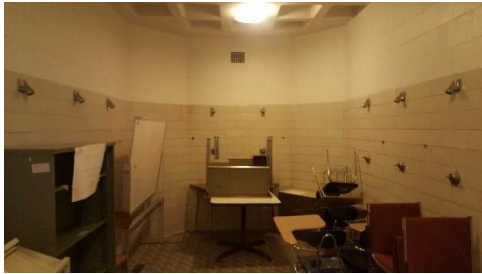
*Image 15 – Boys Locker Room Showers*

Locker room showers are surface mounted with metering shower valves. Water supply temperature to showers is controlled by master mixing valve located in recessed cabinet in locker area. Shower is no longer in use and is now utilized for storage (Image 14 & 15).

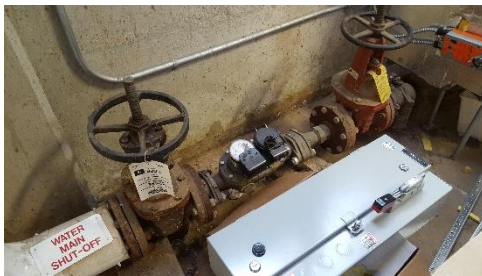
*Image 17 – Domestic Water Service & Meter*

The domestic water service is located in the Mechanical Room. The service appears to be 4" in size and includes a meter (Image 16).

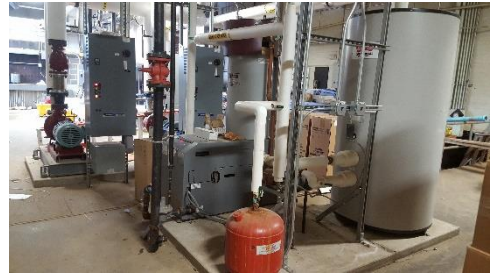
*Image 137 – Gas Fired Water Heater & Tank*

The building domestic hot water is generated through a gas-fired water heater. The water heater has a gas input of 1,000,000 BTUH. Hot water is stored in a 320 gallon tank. The hot water system is recirculated but the master mixing valve is not working (Image 17, 18, 19).

1. We recommend video inspection of existing drains to confirm integrity and correct pipe invert.
2. Provide new high-efficiency gas-fired domestic water heater once the existing water heater has expired.
3. Install new mixing valve.
4. Inspect hot water expansion tank for corroded fitting and leaks.
5. Provide reduced pressure backflow preventers at Janitor's closet soap dispenser.
6. Paint gas piping exposed to exterior.

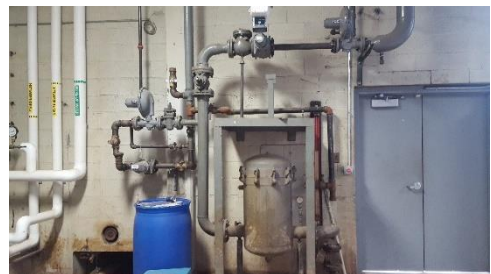
*Image 20 – Gas Service & Meters*

Building is serviced by natural gas. The gas meter is located along exterior of building. Gas service is 4" in size (Image 20).

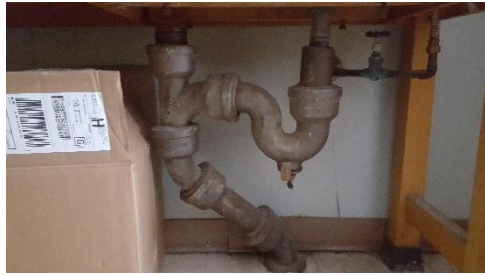
*Image 19 – Cast Iron Sanitary Piping*

In general, existing cast iron drainage piping can be re-used if sized appropriately. We recommend video inspection of existing drains to confirm integrity.
