# Parker Middle School

## **ARCHITECTURAL ASSESSMENT**

The building survey for this report was conducted on February 17, 2016.

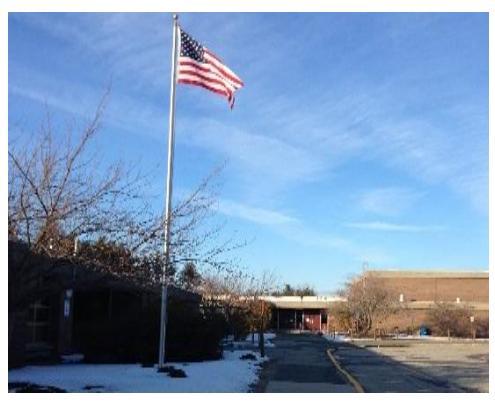
Image 1

There is a large parking area with designated accessible parking spaces located near a rear entrance, and two accessible parking spaces are located and on an accessible path to the front door (Image 1). The front entrance provides a ramp with handrails for accessibility (Image 4). Due to the steeply sloped landscape there are many areas and pathways around the building that are not accessible (Image 2 - 3). An enclosed lift provides access from the main level into the inner courtyard space and paved pathways provide access to areas within the courtyard (Image 5).

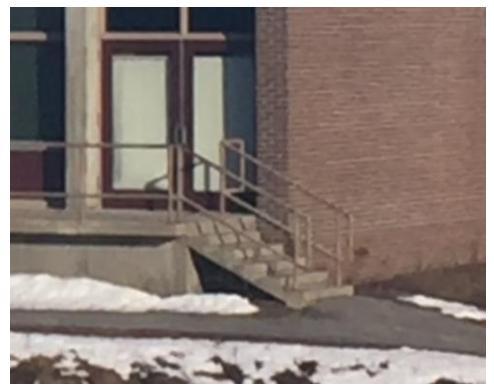
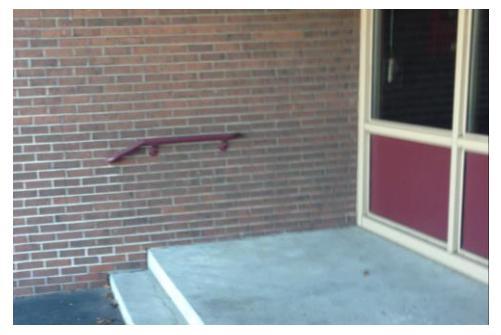
Many stairway handrails around the exterior of the building do not provide the proper handrail extensions (Image 6 & 7).

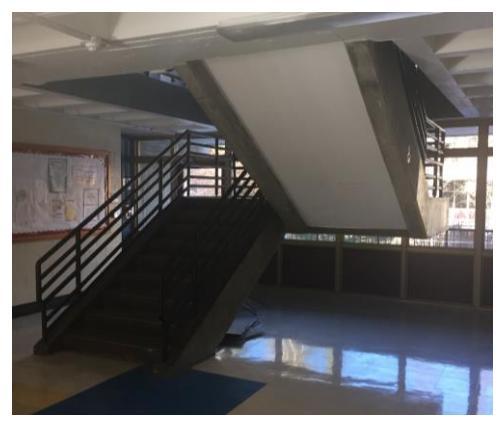
Image 8

The building includes barriers to accessibility, as it does not include an accessible route throughout the building. The ground level north and south classroom wings at the main building are only reachable by stairs or by exiting and reentering the building through the courtyard. The installation of elevators is required to connect these lower level floors to the main level (Image 8).

The stair way connecting the main level and the lower levels do not provide the correct handrail extensions or the required "cane detection" to prevent a visually impaired person from hitting their head on the stair riser or landing (Image 8).

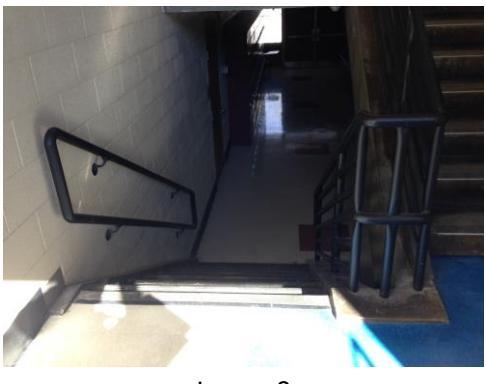
Image 9

In general, the handrails at each of the interior stairways do not meet the ADA / MAAB requirements (Image 9).

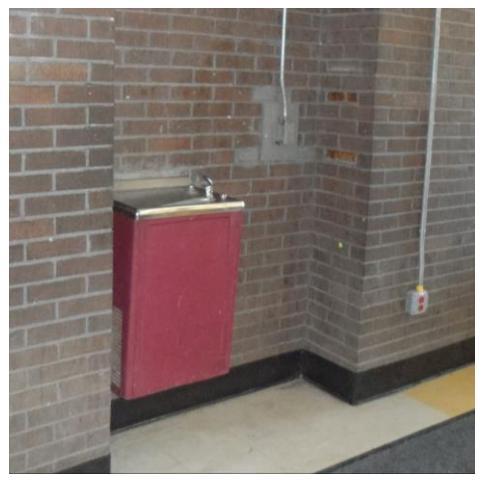
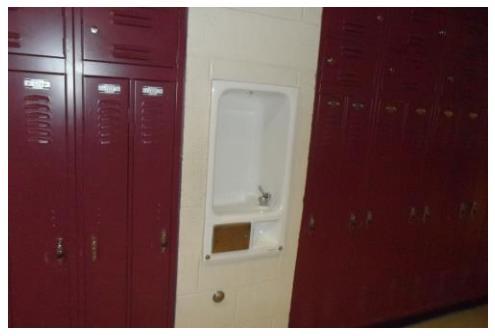
There are several drinking fountains throughout the building that are not accessible (Images 11 & 12).

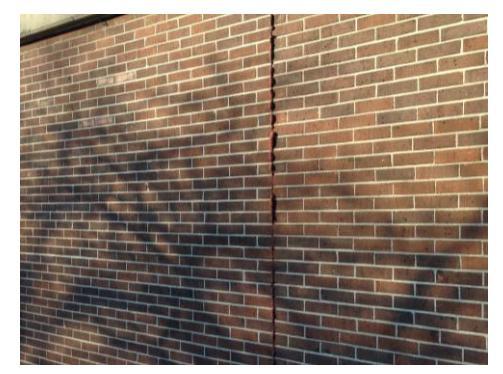
Image 16

- Exterior walls are mostly brick veneer w/CMU backup in fair condition. Some brick are showing moisture and sever cracking in contained areas (Image 14 & 15).
- Control joints are in fair condition throughout the • school. Boy's Locker Room uneven brick settle with ruptured joint (Image 16).
- Some precast concrete cantilevers are spalling and exposing rebar (Image 17).
- Pod classrooms are wood/vinyl cladding and are in fair condition. Some cladding is falling off the structure (Image 18).

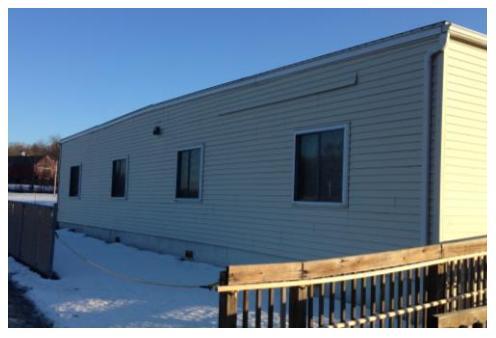
Image 18

The louvers are a combination of aluminum fin construction and simple steel mesh construction. There are vents and openings around the building that are in fair to poor condition and some have become nesting areas (Image 18).

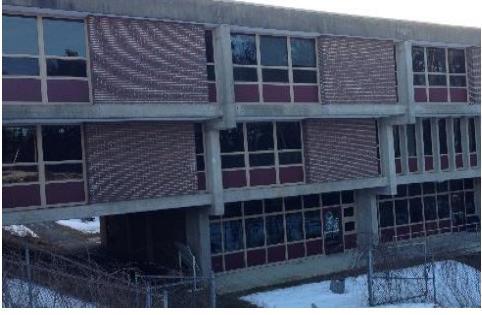
Image 19

• Aluminum-framed hopper/fixed windows throughout the school and Library addition are in good condition. The sealing at the windows appear to be in good condition (Image 19).

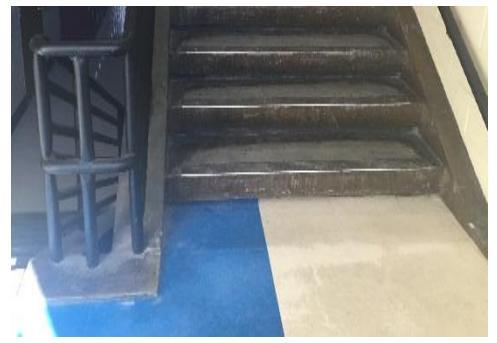
Image 22

- Sports resilient flooring system in gymnasium is in good condition.
- Corridors in original building have VCT floors in fair condition.
- Corridor stairs have metal treads in fair condition. Stairs do not have slip resistant membrane (Image 22).
- Classrooms, offices, and cafeteria have VCT generally in fair condition. Some classrooms VCT seams and tiles are popping or separating (Image 23).
- Toilet rooms have porcelain tile in fair condition.

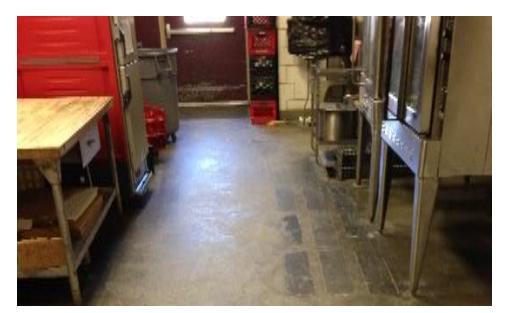
Image 24

- Locker rooms and athletic offices have sealed/painted concrete in fair condition.
- Library carpet is generally in fair condition.
- Custodial closets and storage rooms have sealed/painted concrete in fair condition.
- The kitchen and servery are exposed concrete with no slip-resistant flooring (Image 24).

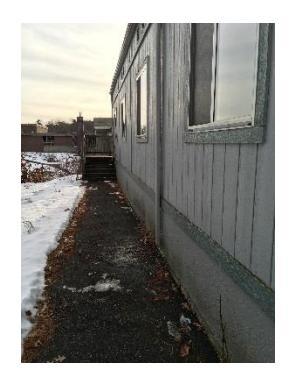
Image 4

The modular buildings are drained by downspouts that discharge at grade (Image 4). There was an addition constructed at the school in 2005. Stormwater runoff from the roof of the addition is collected in downspouts and piped underground to two drywells (Image 5). Stormwater runoff from the rest of the roof is likely collected and discharged into the stream.

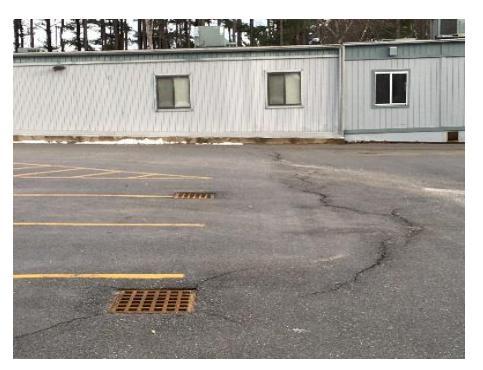
Image 5

The two drywells on ite are located in a parking lot on the west side of the building (Image 5). Stormwater runoff from the parking lot and driveway entrance are collected in catch basins and piped to the drywells for recharge.

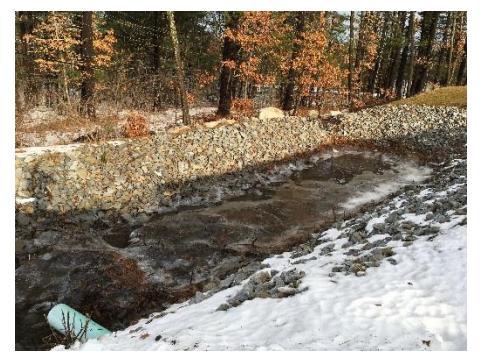
Image 6

Stormwater runoff from the parking lot along Crooked Spring Road is collected in catch basins and directed to a bioretention basin located between the parking lot and the wooded area (Image 6). The bioretention basin appears to overflow to the wooded area.

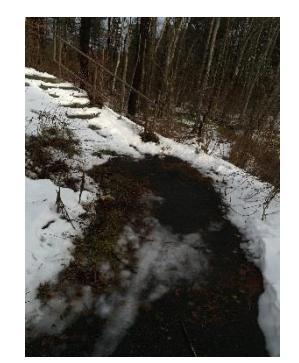
Image 12

Walkways onsite are asphalt and are generally in fair condition. The walkways around the modular building were iced over and difficult to walk on. The walkways along the northeast face of the building were snowy and icy and difficult to walk on (Image 12).

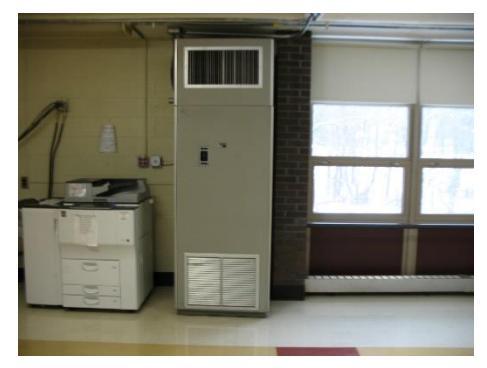
Image 1 – Teacher's Lounge Oversized Air Conditioner

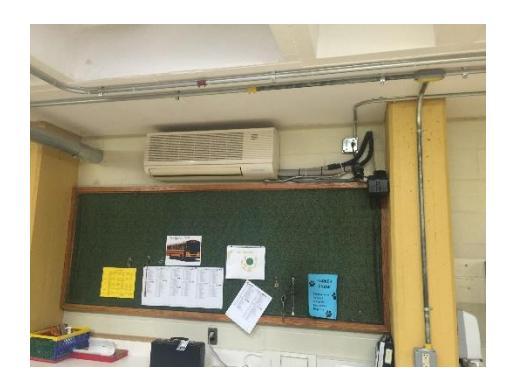
Image 2 – Classroom Ductless Air Conditioner

There are a few classrooms that are cooled by wall mounted ductless air conditioners or by portable air conditioners (Image 2).

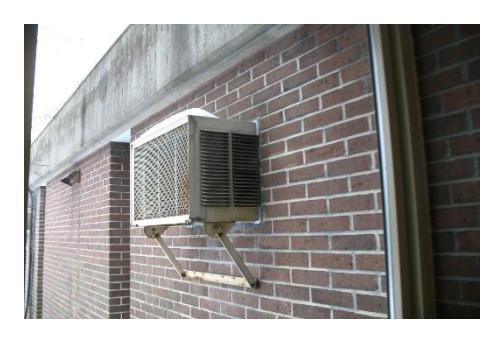
The Administration area is heated by hot water slope-top baseboard radiation. Each room has its own temperature control. The perimeter offices of the administration area are cooled by through the wall air conditioners (Image 9) and via wall mounted ductless air conditioners as part of a central VRF heat pump system. The main office is cooled by a wall mounted ductless air conditioner and ventilated by a propeller fan located in a transom window that communicates with the lobby. The main office is also heated by a horizontal unit heater and by slope-top baseboard radiation. There is no mechanical ventilation in any office.

Image 9 – Admin Area Air Conditioner

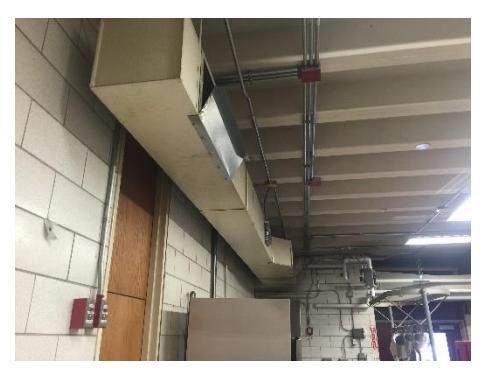
Image 12 – Kitchen Make-up Air Ductwork

The kitchen functions as a warming kitchen. The canopy hood does not Ansul fire suppression system (Figure 11). The hood is ducted to two roof fans with motorized dampers in each dedicated duct. Partial make-up air is supplied by both a ducted make-up air unit and a ducted unit ventilator (Figure 12). Within these units is a supply fan, hot water coil, face and bypass dampers, a filter rack and outside air/return air dampers. The remainder of the hood make-up air is transferred from the cafeteria via open doors to the cafeteria. The kitchen is heated by a small horizontal unit heater when the air units are not running. The kitchen office is heated and ventilated by a wall mounted unit ventilator and ventilated by a wall exhaust register.

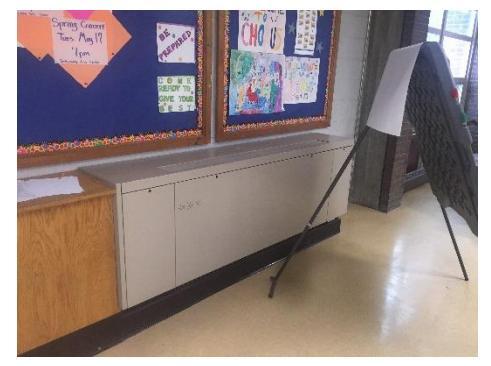
Single wall mounted vertical unit ventilators (Image 13) and pedestal type baseboard heat under the windows (Image 14) are provided in each classroom.

Image 13 – Classroom Unit Ventilator

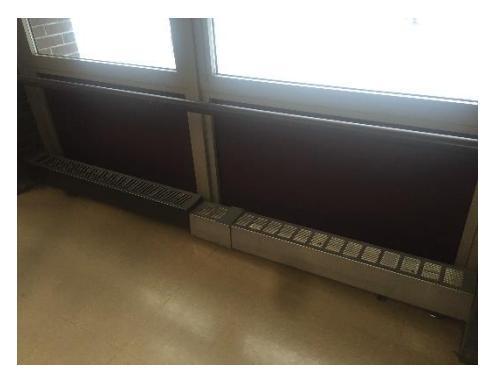
Image 14 – Typical Pedestal Baseboard

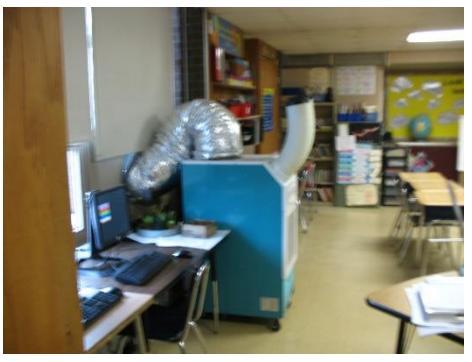
Image 15 – Portable Air conditioner

ventilation settings with actual room occupancy. Some of the classrooms are cooled by portable air conditioners that duct hot condenser air to a window (Image 15).

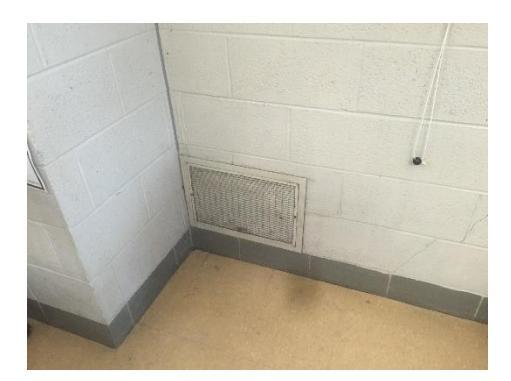
Image 16 – Tfypical Classroom Low Exhaust Grille

Each classroom is provided with a low wall mounted exhaust grille which communicates to a central roof mounted exhaust fan through a galvanized sheet metal duct collection system. (Image 16).

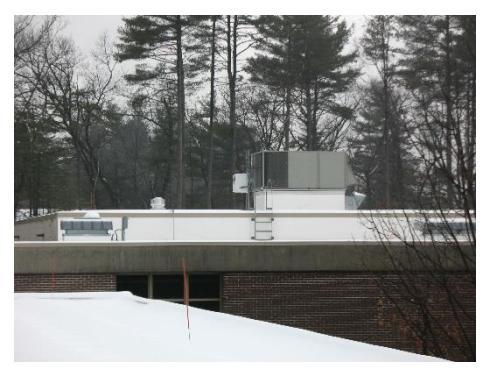
Image 17 – Library rooftop unit

The library is served by a 17.5 ton constant volume roof top unit which consists of a supply and exhaust fan, filter section, gas furnace and direct expansion cooling coil (Image 17) This roof top unit is associated with a galvanized sheet metal duct distribution system which delivers and returns conditioned air to and from the spaces via ceiling diffusers and grilles. The unit delivers a mixture of outside air and return air, which is then conditioned through the unit's gas furnace or DX cooling coil. The library is broken into 6 temperature zones. Duct mounted electric heating coils further heat/reheat the tempered air being supplied by the rooftop unit to their respective zones. Electric baseboard heat is run along the perimeter of the library as supplemental heat. The fresh air damper at the rooftop unit is controlled by CO2 sensors in the space to match fresh air damper ventilation settings with actual room occupancy.

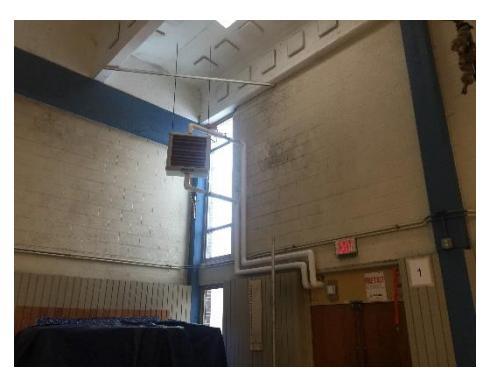
Image 18 – Gym Unit Heater

The main gym is now heated by two horizontal unit heaters (Figure 18). The gym was originally heated and ventilated by concealed Nesbitt vertical heating and ventilating units located in each corner of the gym (Figure 19). These H&V units are ducted to wall grilles (Figure 20). These units still have pneumatic damper operators. It appears as if these units are no longer operating.

1. Replace H&V units at gym corners and add general exhaust.

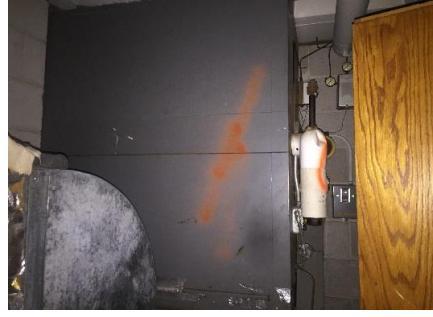
Image 19 – Gym H&V Unit

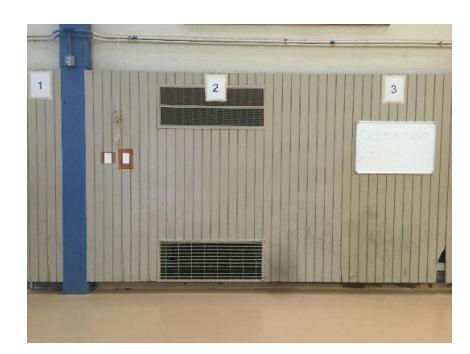
Image 20 – Gym H&V Unit Wall Grilles

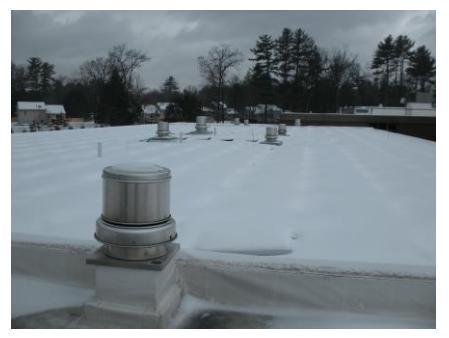
Throughout the building, general exhaust is provided through the use of roof mounted exhaust fans (Image 21). These fans serve areas such as toilet rooms, storage rooms, custodial closets, mechanical spaces and electric rooms. All the fans are associated with their own independent galvanized sheet metal duct collection systems and all terminate within the spaces with ceiling or wall mounted grilles. Overall the fans appear to be functioning. The fans appear to be have been replaced in the early 2000's and are in good condition.

Image 21 – Typical Roof Fans

Provide routine maintenance on all exhaust fans such as replacing belts and lubricating their motors and shafts. Replace fans as necessary.

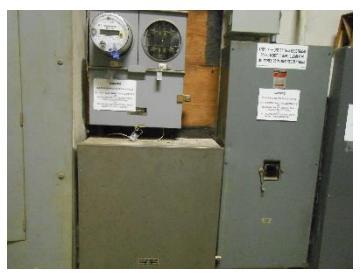
An 800 ampere, 277/480 volt, 3 phase, 4 wire service serves the building. The main service equipment is located within the building's boiler room. The service consists of an enclosed main breaker and main distribution panels. The equipment is of original vintage and manufactured by Westinghouse. New energy efficiency Powersmiths transformers have been provided throughout the building (Image 1 & 29)

Image 1 — Main Disconnect

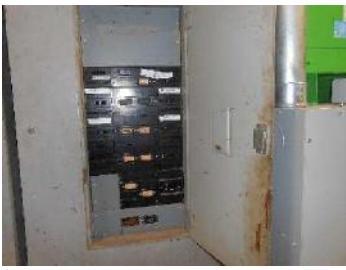
Branch circuit panelboards vary from original Westinghouse panelboards that are in poor condition to recently installed Cutler Hammer panelboards that are in good condition. There has been some additional branch circuitry added throughout the school (Image 2 & 3).

Image 2 — Original Panels

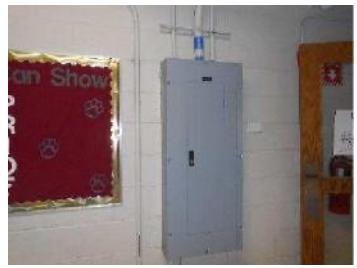
Image 3 — Updated Panel

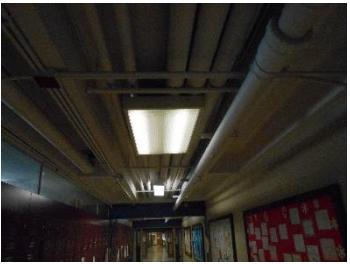
Image 4 — Corridor Lighting

Corridor lighting consists of surface mounted fluorescent fixtures with acrylic lenses. Corridor lighting is controlled via line voltage switches at the ends of the corridor (Image 4).

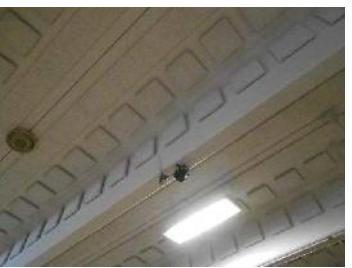
Gym lighting and cafeteria lighting consists of high output, 2x4 fluorescent high bays. Light levels seem adequate. It was noted that one fixture in the gym was not working (Image 6 & 8).

Image 6— Cafetorium Lighting

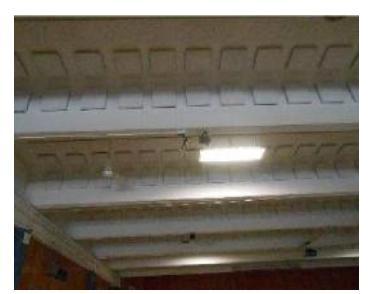
Incandescent track heads are used to light the area in the cafetorium for performances (Image 7).

Image 7 – Track Lights

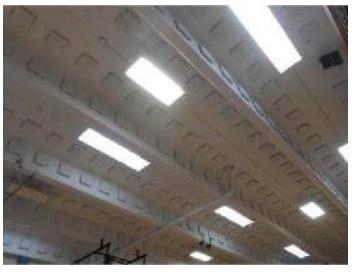
Image 8— Gym Lighting

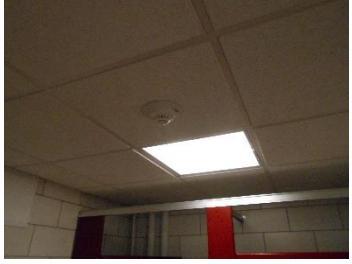
Toilet rooms contain ceiling mounted wraparound fixtures and 2'x2' recessed fluorescent fixtures. (Image 9).

Image 9— Toilet Rooms

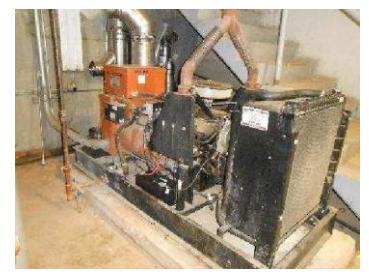
An interior natural gas Generac 97A02142 generator, 65 kW, 120/208 volt, is installed in the boiler room. The generator feeds an ASCO transfer switch and serves emergency lighting, as well as other loads. The emergency system does not comply with current electrical code as the emergency equipment is not separated from normal equipment. Exit signs are provided throughout the building (Image 15 & 16).

Image15 — Generator

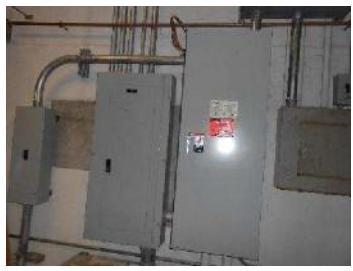
Image 16 — Automatic Transfer Switch

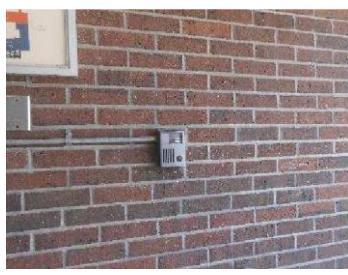
Image 25 — Aiphone Intercom

The building contains an Aiphone intercom door communication system at the main entry that is in fair condition (Image 25 & 27).

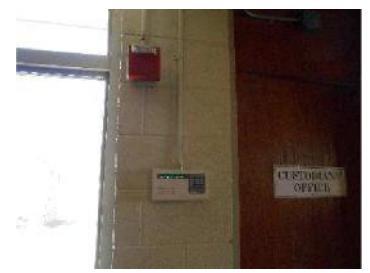
The intrusion system is a Honeywell system and is operational; however, appears to be in poor condition (Image 26 & 28).

Image 26 — Intrusion Keypad at Main Entrance

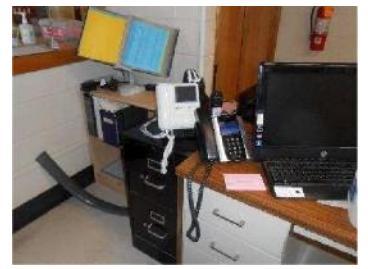
Image 27 — Intercom Master Station

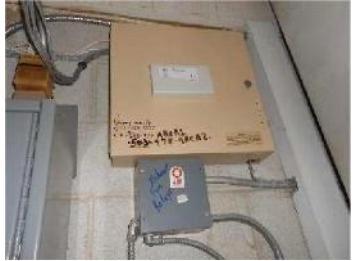
Image 28 — Intrusion System Control Panel

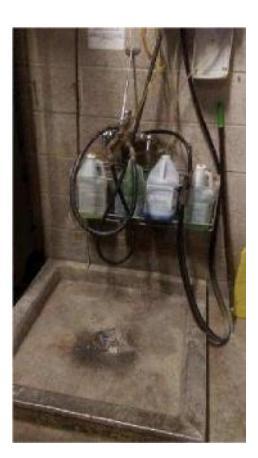
Image 4 — Janitor's Sink

Janitors sinks are floor mounted mop receptors. Faucets are equipped with vacuum breakers. (Image 4).

- Provide reduced pressure backflow preventers at Janitor's closet soap dispenser.
- Provide plaster traps at Art classroom sinks.

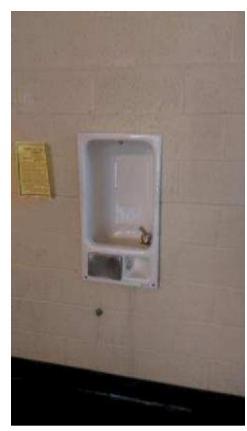
Image 6 — Drinking fountain

Drinking fountains are vitreous china recessed type (Image 6).

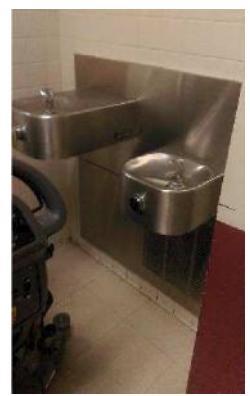
Image 7 — Electric Water Cooler

Electric water coolers are stainless steel surface mounted or stainless steel hi low fixtures with recessed chiller (Image 7 & 8).

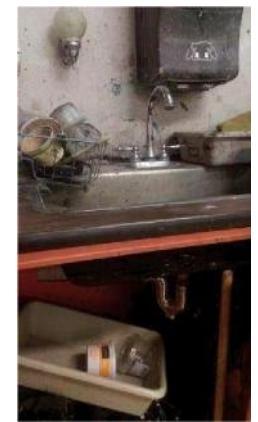
Image 8 — Art Room Sink

Art sinks are counter mounted stainless steel with dual lever faucets and are not equipped with sediment traps (Image 8).

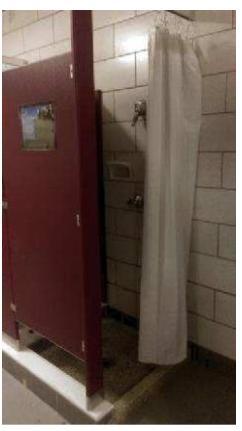
Image 10 — Shower

Showers include terrazzo bases with floor drains. Individual hot and cold water supplies feed each institutional shower head. Gang showers include single tempered water supplies and institutional shower heads. The tempered water is delivered from a master mixing valve (Image 10).

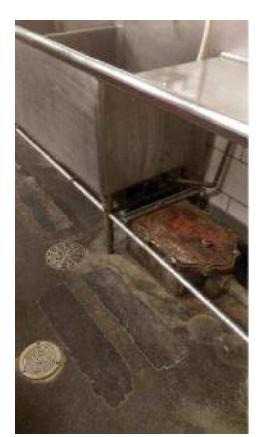
Image 11 — Kitchen Pot Sink

Kitchen area fixtures are in fair condition. The pot washing sink is piped to a floor mounted grease interceptor (Image 11).

- Provide acid resistant polypropylene piping for all acid waste from Science Classroom fixtures and direct the acid waste to an acid neutralization system.
- Local sewer may require Kitchen waste be directed to exterior grease trap.
- Install a high efficiency water heater including master mixing valve, recirculated hot water and expansion tank on cold water make-up line.

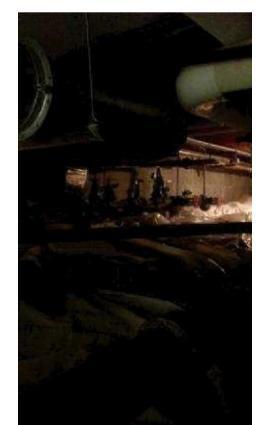
Image 12 — Water Service

The domestic water service is located in the Mechanical Room. The service appears to be 4" in size and includes a meter (Image 12).

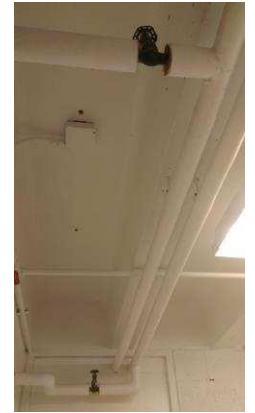
Image 13 – Water Piping

Piping is copper tubing with sweat joints. The majority of piping is insulated. In general, the original gate valves are in fair condition. In portions of the building that have been recently renovated the piping is insulated, labeled and the ball valves are ingood condition (Image 13).

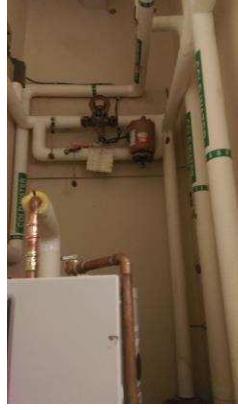
Image 15– Electric Water Heater

In a recently renovated area of toilet rooms, hot water is generated through a 9 kW electric water heater with a storage capacity of 20 gallons (Image 15).

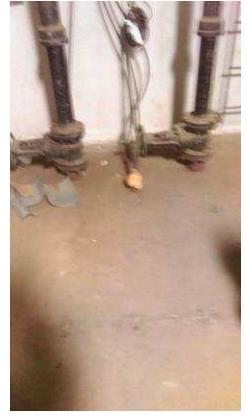
Image 17– Sewage Ejector

In the boiler room the floor drains are directed to a duplex sewage ejector installed in floor. The basin appears to be vented. Two (2) 4" pump discharge lines are valve at floor then combine and the line is directed to a gravity drain (Image 17).

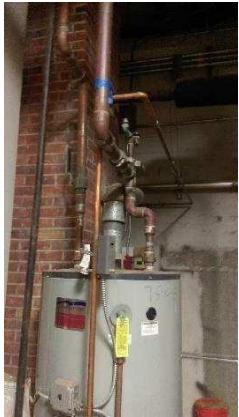
Image 14- Gas Water Heater

The main Building domestic hot water is generated through a gas-fired standard efficiency non-condensing storage tank type water heaters. The water heater has a natural gas input of 77,000 BTUH and a water storage capacity of 100 gallons (Image 14).

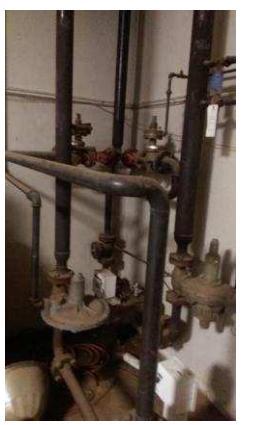
Image 16 - Gas Meter

Building is serviced by an elevated pressure natural gas service. The gas service, regulator and meter is located inside the Boiler Room. Gas service is 3" in size (Image 16).

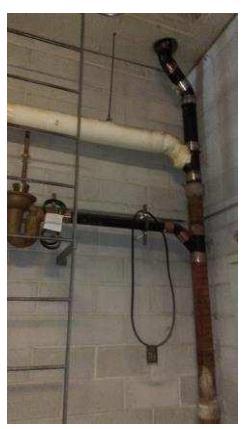
Image 18 - Repaired Rainleader

The flat roofs are collected by roof drains and interior cast iron rain leaders. The roof and drains are in fair condition. Portions of the horizontal rain leader piping is insulated. There is evidence of sections of the original cast iron rain leader piping which has been replaced (Image 18).

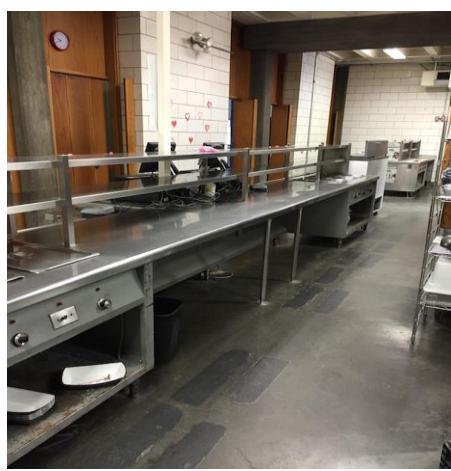
Image 1

The kitchen serves the typical school lunch program in two serving lines with two cashier terminals exiting at the center of the serving lines. The serving line is rather simple and equipped with hot wells but no cold wells. The serving lines' base cabinets (Image 1) are painted galvanized steel as was common at the time of the original installation but in modern installation the bases would be stainless steel. The concern with painted galvanized steel is that the paint becomes damaged and rust and corrosion set in.

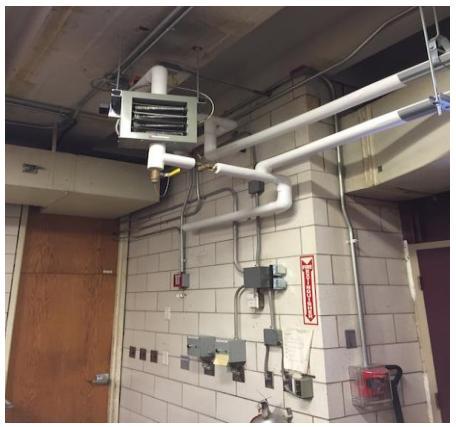
Image 3

The health code mandates all surfaces be smooth and easy to clean because deep cleaning of all the conduits and exposed heating system vents, lighting fixtures, and horizontal surfaces are not easy to clean (Image 3).

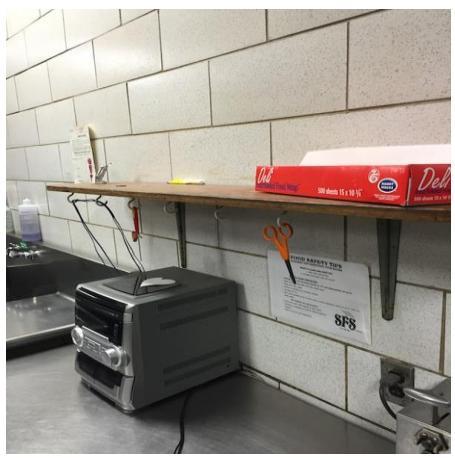
Image 6

Wall shelf Figure 6:

- 1. Eliminate all wood surfaces and add hand-washing sinks.
- 2. Add appropriate mobile worktables to provide for additional work surfaces.
- 3. Redeploy the dish room or eliminate the equipment from the dish room to provide for additional storage. Build a wall that is constructed of easy to clean materials
- 4. Consider installing a lay in washable ceiling and improve the lighting levels in the kitchen
- 5. Add a fire suppression system for the hood system and two-burner range.
- As complete refit of this kitchen will cost approximately \$425,000. There is very little here that can be saved.
