ARCHITECTURAL ASSESSMENT

101 Mill Row, also known as the Adams / Russell House was constructed in 1816 (Image 1 and 2) and is part of the Chelmsford Historic Commission (Image 3). The Adams / Russell House had been converted into office building space; at one time the Chelmsford Department of Health utilized the space. However, at the time of our study the facility was not being used. There was an addition added to the original 1816 building; the date of such construction is unknown.

The building survey for this report was conducted on February 17, 2016.

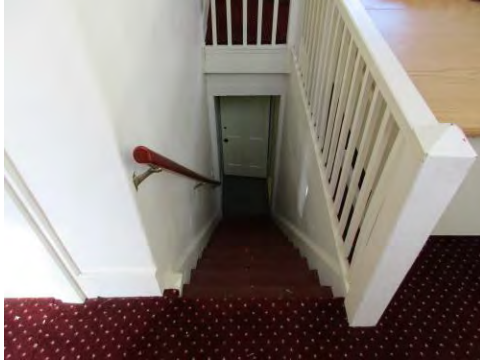
Image 4

The building includes significant barriers to accessibility as it does not include an accessible entrance or route throughout the building. The basement, first, second and third floors are only reachable by stairs which are not compliant (Image 4 & 5). Under a renovation project the front stair (Image 5) may be exempt given their historic nature. However, a fully compliant set of stairs and an elevator will be required to connect all floors providing services to the public or if considered work spaces.

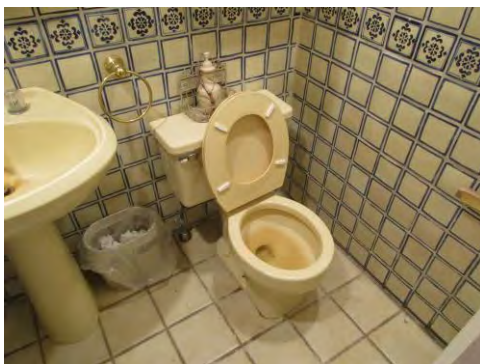
Image 7

The toilet rooms, as a whole, are not accessible. The spaces do not provide the required floor space area and fixtures are not ADA compliant (Image 7 & 8). A bathroom is located on each floor; each of these would need to be upgraded to meet accessibility requirements. Given the size of the existing restrooms, some removal of walls will be required to create an accessible space. The removal of tubs and showers in some of the restrooms will add necessary floor area to these rooms. Depending on the proposed use of the facility, additional restrooms may be needed to meet the intended occupancy and use.

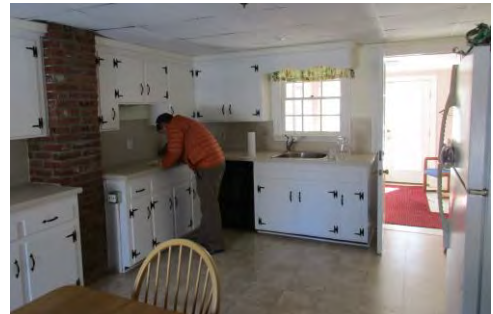
Image 9

A residential style kitchen exists in the facility (Image 9 & 10). Depending on the proposed use of the kitchen (if it remains) renovations will be needed to provide accessibility to counter tops, storage cabinets, sink, microwave, etc.

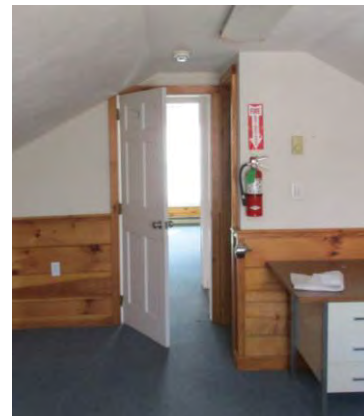
Image 11

Doors and doorways throughout the facility do not meet accessibility requirements. Most doors have knob hardware and door openings are not wide enough to meet requirements. Push / pull clearances are not met in most areas throughout the building (Image 11).

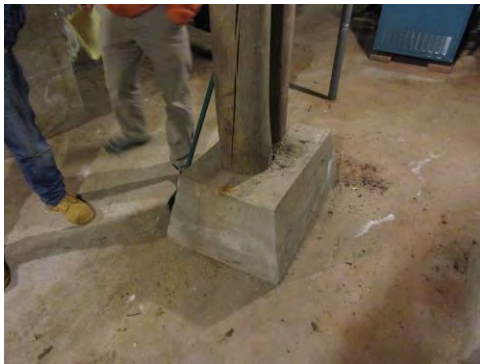
Image 12

Foundations consist of stacked field stone held together with concrete (Image 11). The exposed portion of the foundation walls are parged smooth. The newer addition has CMU block foundation walls. The foundation walls are generally in good condition. Repair work includes concrete piers (Image 12) having been added to older wood columns. It is unknown if there are footings below the piers or the newer CMU foundation wall. It is assumed that the stone foundation walls extend below grade to provide a footing for these walls. The extent and condition of these assumed walls is unknown.

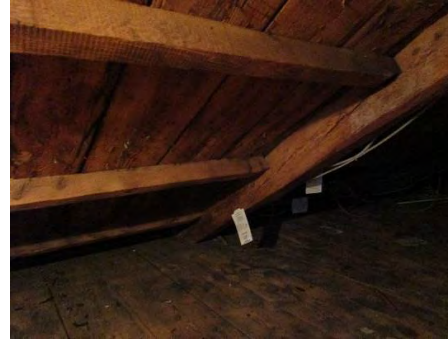
Image23

The roof is made up of architectural asphalt shingles. It is unknown if there is an ice and water shield underlayment. The roof structure consists of wood board sheathing, running with the roof slope, and horizontal wood purlins in between heavy timber roof truss joists (Image 23).

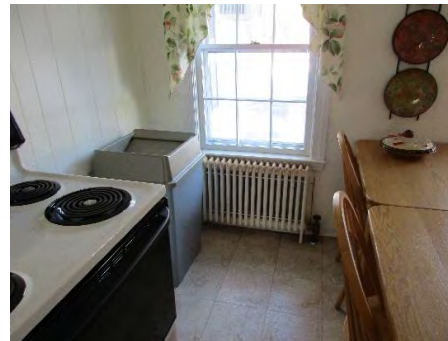
Image 25

- Some of the carpet has minor staining and wear throughout the building. (Image 24)
- The sheet vinyl in the kitchen is severely stained near the radiator, possibly from a leak at the radiator. Damage to the subfloor, if any, was unknown at the time of the survey (Image 25).
- In some of the rooms the carpet has a lot of wrinkles and humps in it. These are considered tripping hazards.
- In some of the bathrooms the floors have some staining.

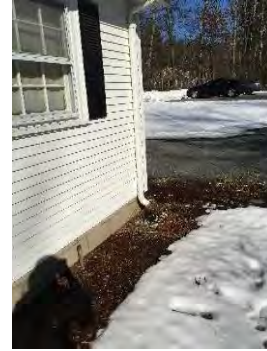
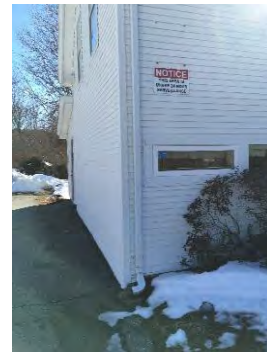
Stormwater runoff from the roof of the building appears to be collected in downspouts and discharged at grade (Image 1 and 2).

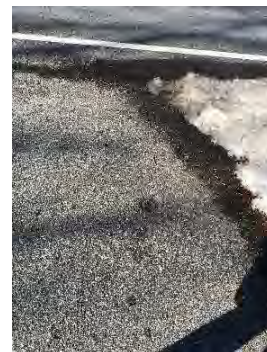
Image 3

A water valve was observed in the driveway along Mill Road which indicated the water service for the building is likely fed from a water main in Mill Road (Image 3).

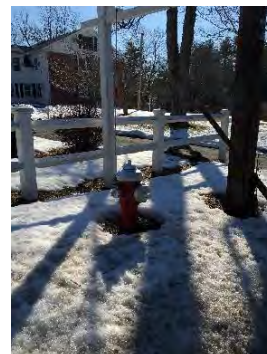
Image 4

A fire hydrant was observed in a landscaped area to the North of the building along Mill Road (Image 4). The hydrant likely connects to a water main in Mill Road.

There is a gas meter and generator located along the south face of the building behind landscaping (Image 4). A gas valve was observed in the driveway along Mill Road which indicated the gas service for the building is likely fed from a gas main in Mill Road (Image 5).

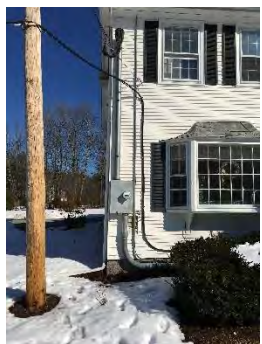
Image 7

A utility pole was observed onsite at the northwest corner of the building. Overhead wires run from a utility pole along Mill Road to the utility pole onsite. The overhead wires connect to the northwest corner of the building (Image 7).

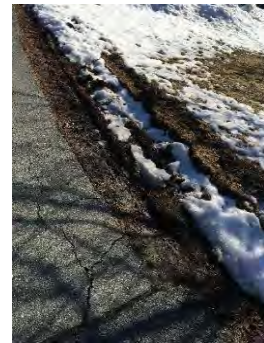
Image 10

The asphalt pavement within the site is in generally good condition with some areas of cracking and isolated areas of ponding/icing (Image 8 and 10).

- Regrade paved areas to prevent ponding which can lead to ice patches in the cold weather.
- Confirm site is ADA accessible.
- Install curb along driveway to prevent cars from driving onto lawn area.

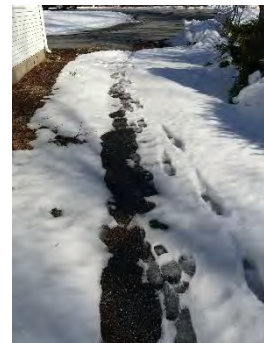
Image 11

The walkway onsite is asphalt and appears to be in good condition but was snow covered at the time of the site visit (Image 11).

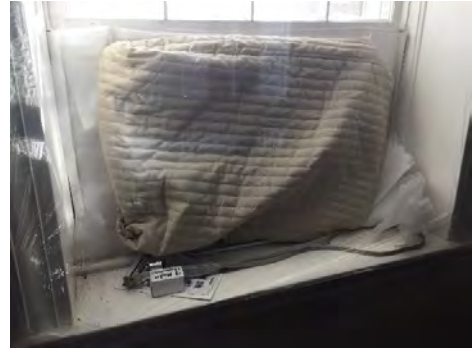
Image 1

The building is not provided with a cooling plant. The majority of the spaces are cooled by window air conditioners (Image 1). There is one wall mounted ductless air conditioner/heat pump that is served by a single condensing unit mounted at grade. This unit handles the kitchen area on the lower level (Image 2 and Image 3).

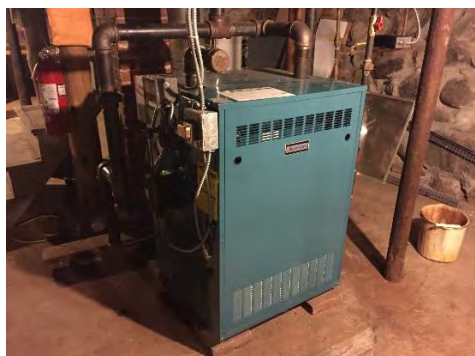
Image 4

There is one (1) gas fired cast iron fin tube steam boiler, manufactured by Burnham, model PIN7SNC-ME2 with an input capacity of 210 MBH and a gross output capacity of 168 MBH producing 5 psi low pressure steam. (Image 4) This boiler was installed in 2008 and is in good condition. The boiler is provided with dual low water cut-offs and all operating and safety controls. The boiler operates using its own controls. The steam distribution piping is a combination of schedule 40 black steel and copper piping. At the connection points between the two different metals there does not appear to be any die-electric fittings (Image 5). This piping system is insulated with what appears to be fiberglass insulation. The condensate return piping is schedule 80 black steel and is a gravity return system insulated with what appears to be fiberglass insulation. Some of the insulation is missing on some of the elbows and on some

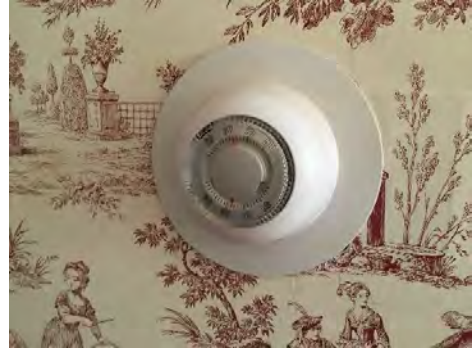
Image 9

The building is equipped with standalone controls and is not tied into the townwide building management system. Boiler operation is controlled through the use of a wall mounted dial type thermostat. All the radiators are controlled with either hand valves or thermostatic control valves. The electric heating elements are provided with wall mounted dial type thermostats. The one split cooling unit is provided with a digital thermostat (Image 9, 10 and 11).

- Install a DDC tied to Town Building Management System for optimal control.

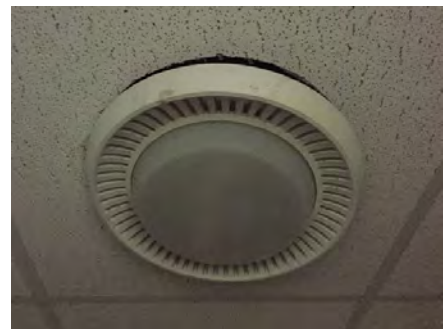
Image 12

Toilet rooms are exhausted through the use of ceiling mounted residential style exhaust fans, which exit the building. The exhaust fan appears antiquated and considerations should be given to replacing it (Image 12).

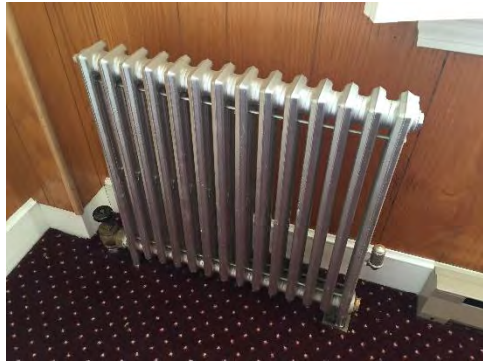
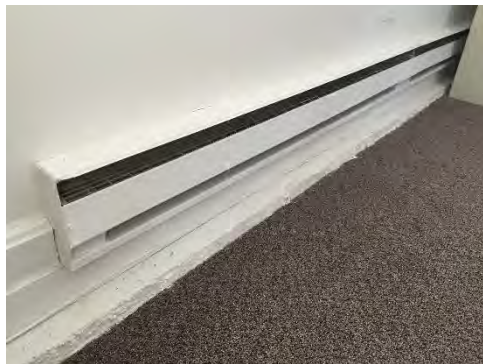
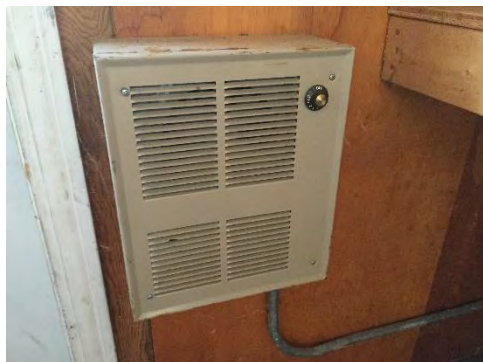
The general areas are provided with floor mounted cast iron radiators and supplemental electric heat (Image 13, 14 and 15). The supplemental electric heat has been added due to issues with the current steam system. The steam system may be having issues due to controllability. Consideration should be given to utilizing a service company to review the existing steam system and provide necessary components to remedy the situation due to the high expense of using electric heat.

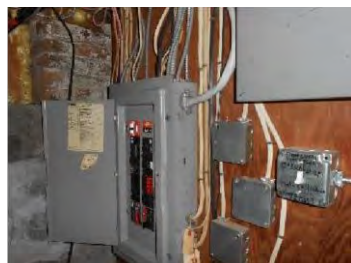
Image 5 – Old Main Service Equip.

The service enters an inline exterior meter socket to a 400 ampere rated, Crouse Hinds main distribution panel with a 400 ampere main circuit breaker. The service voltage is 120/208 volt, 3 phase, 4 wire. The old service main breaker Murray panel is back fed from the new main distribution panel. (Image 3, 4, & 5)

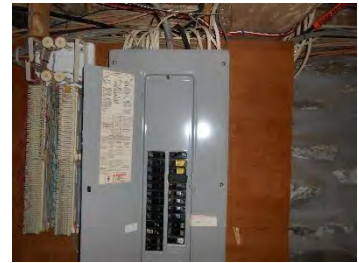
Image 6 – Panelboards

Branch circuit panel boards are located throughout the building to serve power, lighting, mechanical and technology loads (Image 6 & 7). Panelboards are manufactured by Siemens.

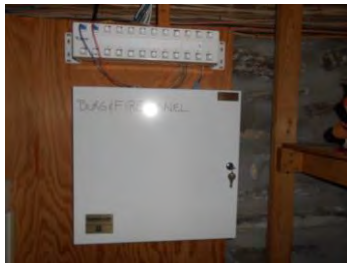
Image 16 – FA/Security Control Panel

The fire alarm system and security system are combined in one control panel provided by Magnum. System consists of smoke detectors or heat detectors in offices, hallways, corridors, kitchen and basement. Pull stations are provided at the exterior doors. No horn/strobes were found in the building (Image 16, 17, & 18).

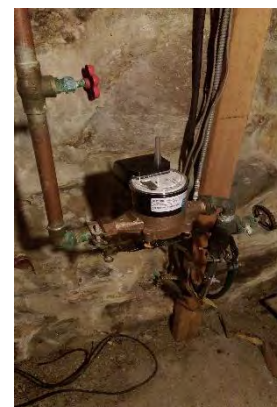
Image 6 – Water Meter

The domestic water service is located in the Basement. The service appears to be 3/4" in size and includes a water meter (Image 6).

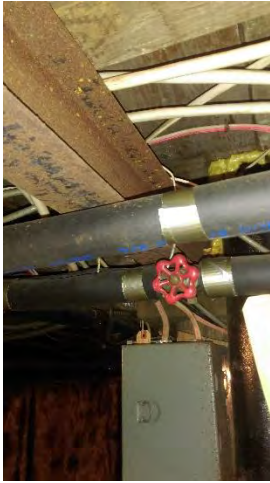
Image 7 – Water Piping

Piping is copper tubing with sweat joints. The majority of piping is uninsulated. In general, the gate valves are in fair condition (Image 7).

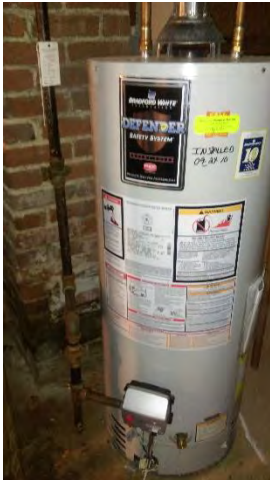
Image 8 – Water Heater

The main Building domestic hot water is generated through a gas-fired standard efficiency non-condensing water heater. The water heater has a natural gas input of 30,000 BTUH and a water storage capacity of 30 gallons (Image 8).

A thermostatic mixing valve is not provided for the building domestic hot water system. The domestic hot water system is not recirculated. There is no expansion tank on the cold water make-up to the water heater.

1. Plumbing fixtures meet current code for water conservation. However, new high-efficiency low flow fixtures could be installed to reduce water consumption.
2. In general, existing cast iron drainage piping can be re-used if sized appropriately. We recommend video inspection of existing drains to confirm integrity.
3. Install a high efficiency water heater including master mixing valve, recirculated hot water and expansion cold water make-up line.

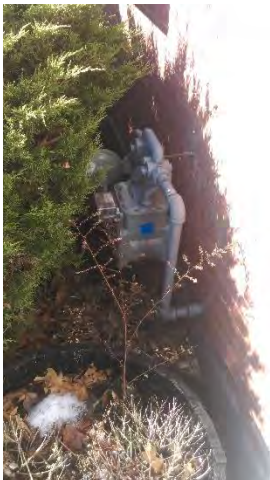
Image 9 – Gas Meter

Building is serviced by an elevated pressure natural gas service. The gas service, regulator and meter is located on the exterior in a caged area. Gas main distribution is 1-1/4" in size. (Image 9).
