Byam Elementary School

ARCHITECTURAL ASSESSMENT

The facility assessment for this report was conducted on February 17, 2016.

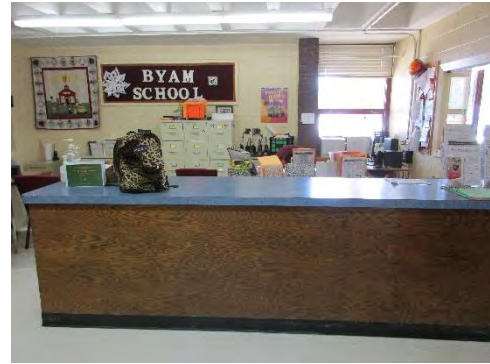
Image 4

The front office area provides a clear floor area for accessibility. Within this space a handicap person, adult or child, could be accommodated. However, the goal of the ADA and MAAB is to provide equal access and services in a more universal approach. With this intent the front desk should provide an area of the counter that meets the requirements for accessibility.

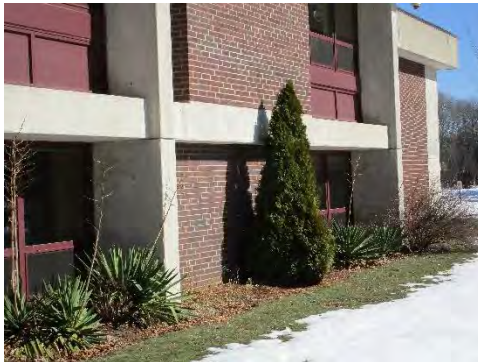
Image 15

The building is concrete frame with infill of brick and mortar exterior veneer and CMU backup. The precast concrete floor planks project past the exterior wall to form cantilevers above the first floor (Image 15).

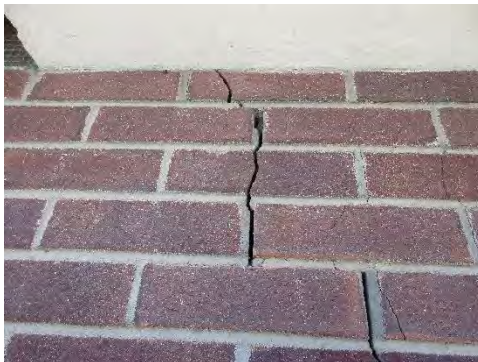
Image 16

- Several areas of severe cracking on the brick and mortar veneer (Image 16).
- Several areas where the precast concrete cantilevers are spalling and in some cases exposing the rebar (Image 17).
- Few locations where concrete window sills have cracked.
- Few locations where the steel lintel supporting the precast concrete band above the 2nd floor windows is rusting.
- There are several areas where the paint on the soffits are flaking and falling off, this may be due to moisture (Image 18).
- Maintenance of downspouts, roof overflow drains

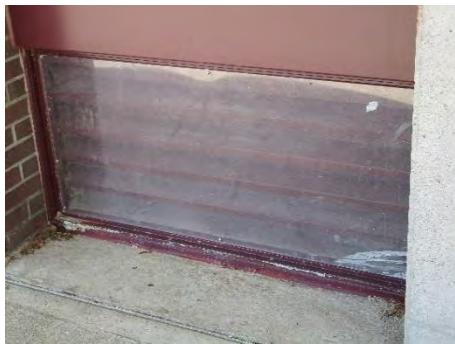
Image 23

- Intake louvers for the unit heaters in the classrooms are missing insect screens.
- Some of the lower steel grate louvers have become dented, damaged, and rusting.
- Plexi-glass is covering one of the louver vents (Image 23).
- Birds are nesting in louvers, soffit areas and other areas around the building structure.

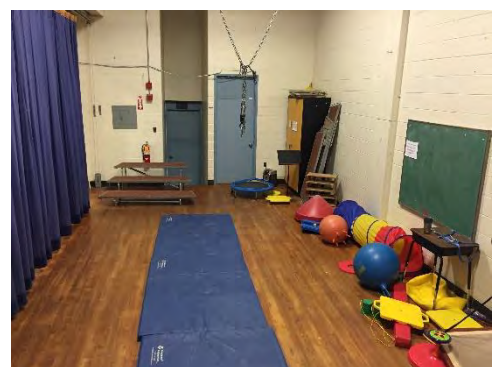
Image 27

- In most areas of epoxy painted concrete floor the paint is showing severe wear and is exposing the raw concrete (Image 31).
- The wood stage flooring is showing its age there are several areas of deep gouges, exposed raw wood and “spongy” or soft when walked on (Image 27).
- Carpeted areas such as the library appear to be in good condition.
- The Gym floor is in good condition.
- The quarry tile kitchen floor is in good condition but in need of proper cleaning.

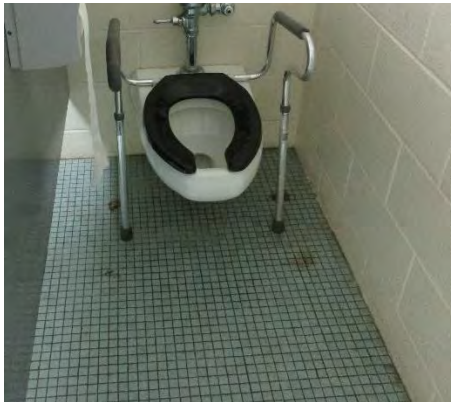
Image 29

- In general the VCT flooring throughout the school appears to have staining that may be associated with improper cleaning materials
- VCT at recessed entrance mat and other areas such as floor clean outs is lifting and cracking
- The topping on the stair treads is completely worn off exposing raw concrete. (Image 28)
- The 1"x1" ceramic tile and grout in all the bathrooms is very dirty. (Image 29)
- Marble thresholds that have cracked will begin to chip away over time and may result in a potential

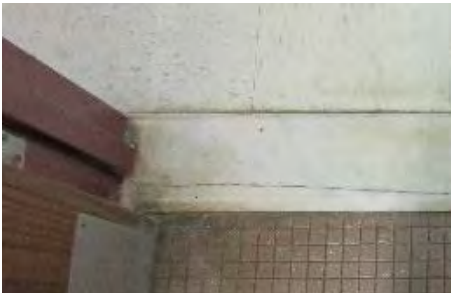
Image 30

tripping hazard (image 30).

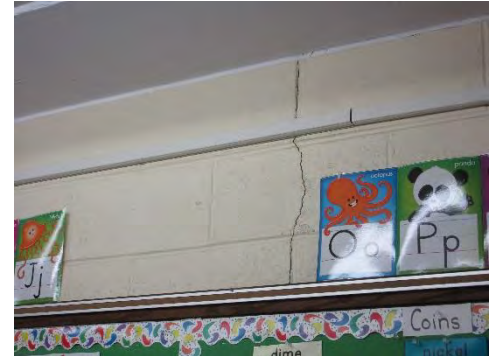
Image 31

- Several CMU walls have cracks that extend the height of the wall. Some of these occur at the corners, other cracks are located where CMU meets the poured in place concrete and some at the center span of the wall (Image 31, & 32).
- In some of the bathrooms the epoxy wall paint on the CMU walls is flaking off along the bottom 3'-0" of the wall (Image 32).
- In one of the gang bathrooms there is a large crack in the CMU wall behind the toilet (Image 34).
- In one of the gang bathrooms there is a large crack in the CMU wall behind the bank of sinks (Image 35).
- In some of the bathrooms cracks exist in the walls where plumbing fixtures were replaced.

- Some investigation of the cause and full extent of some of the cracking may be warranted; the cracking noted is not believed to be due to any structural issues. Repair of cracks is recommended.
- In the bathrooms where the epoxy paint is coming off the walls, review issues of moisture around the toilet fixture. Remove existing paint and repaint with new epoxy paint.
- Replace cracked CMU block and mortar.

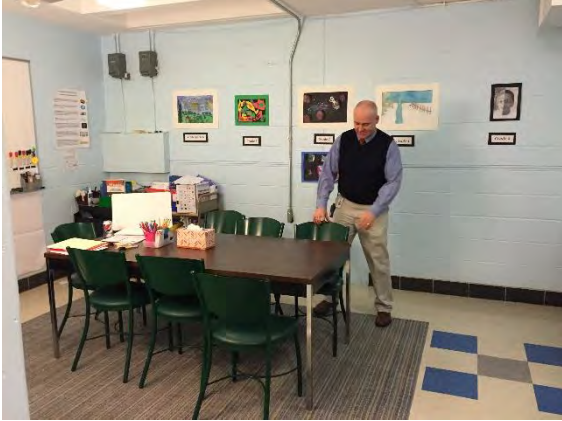
Image 38

- Adhered acoustical ceiling tiles have become loose and fallen off in several locations
- Some areas have staining along the concrete ribs.
- In the kitchen and kitchen support areas the 9"x9" ceiling tile is in very poor condition. Tiles are stained, missing and deteriorated. (Image 38)
- Lighting levels in corridor are low.

- Remove adhered acoustical tiles (some may have asbestos glue tabs) and replace with acoustical tiles or dropped ceiling
- Review source of staining on concrete ceiling. Patch and repair source and repaint concrete.
- Replace all kitchen and support area ceiling tiles. Kitchen area to have scrubbable ceiling tiles.
- Install additional light fixtures in corridor.

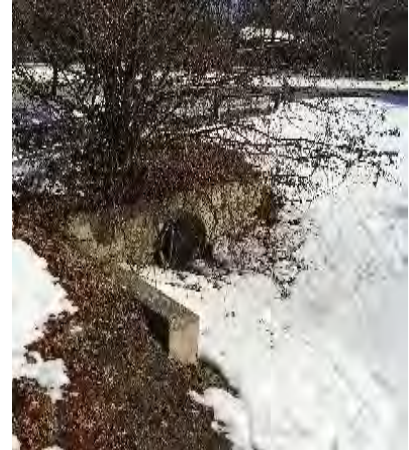
Image 1

The asphalt driveway crosses over a culvert (Image 1) which connects a small swale from the west side of the site to the wetlands along the eastern and northern side of the site.

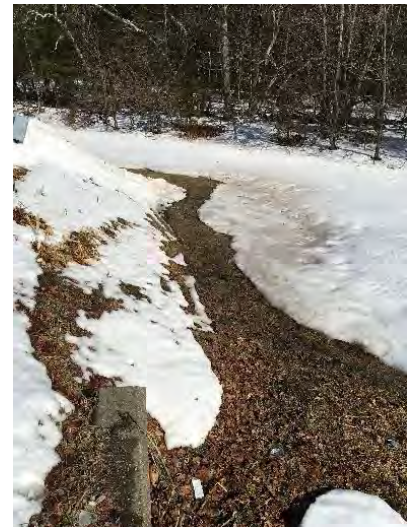
Image 2

Stormwater runoff from the parking lot is collected in catch basins and discharged through one of two headwalls which lead to the hydraulic connection (swale) to the wetlands (Image 2 and 3).

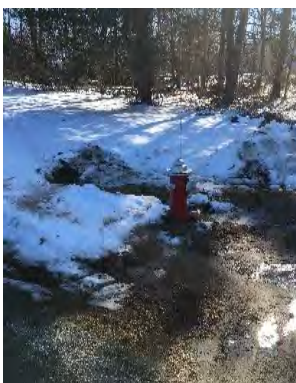
Image 7

Two hydrants were observed on site. One of the hydrants was located at the northwest corner of the building along the asphalt driveway (Image 7) and the other hydrant was located at the southeast corner of the building along the parking (Image 8). Record plans show a 6-inch water service from Maple Road through the eastern side of the site that runs to both hydrants.

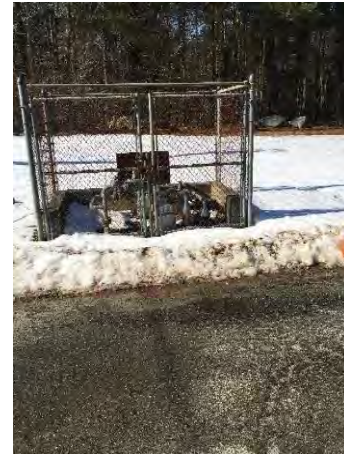
Image 9

There is a gas meter located along the asphalt drive at the northwest corner of the building (Image 9). That gas meter is not on the face of the building, it is located across the driveway from the building.

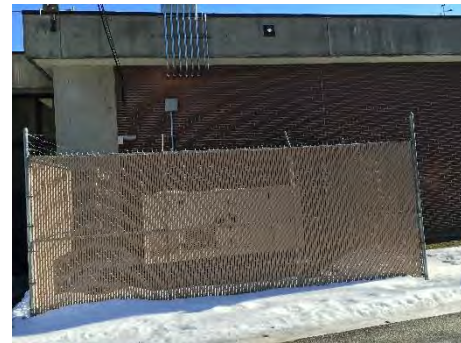
Image 10

There is a generator located along the northwestern face of the building adjacent to the gas meter (Image 10).

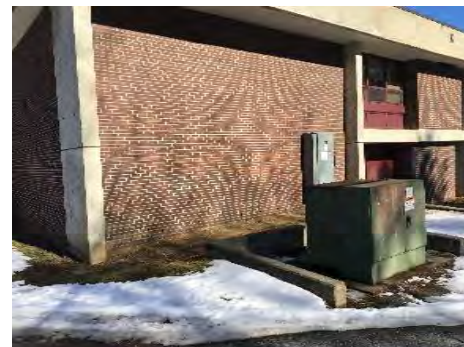
Image 11

There is a transformer located at the northwest corner of the building. The transformer had a sign posted on it indicating that the building has multiple power sources (Image 11).

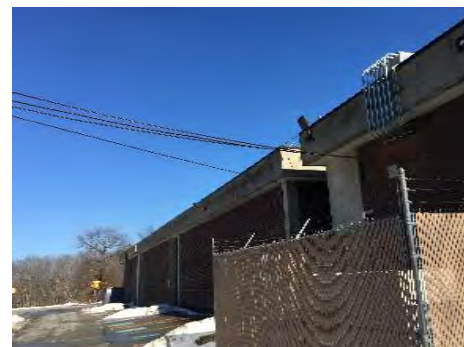
Image 12

Overhead wires were observed onsite connecting to the northwest face of the building from a utility pole to the northwest of the property (Image 12).

The asphalt pavement within the site is in generally fair condition with some areas of cracking. There are areas of ponding, mainly in the driveway around the school (Image 12 and 13).

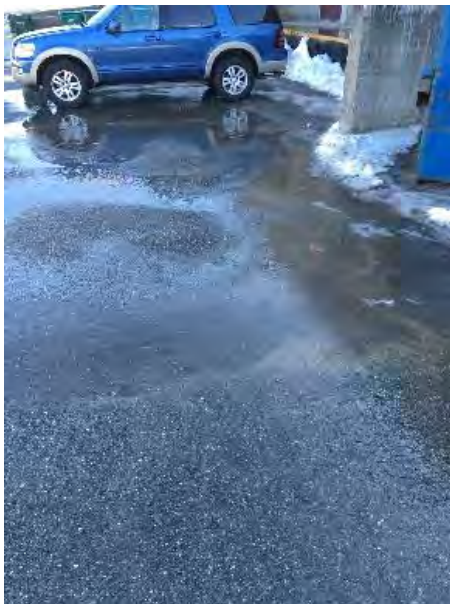
Image 14

Walkways onsite are asphalt and concrete and are generally in good condition (Image 14). Some of the accessible ramps on site have ponding (Image 15). There is a walkway from Maple Road to the school site that was not accessible at the time of the site visit because it was covered in ice.

There is concrete curb and vertical granite curb between the sidewalk on the southeast face of the building and the parking lot/driveway (Image 14 and 16). This concrete curb is in generally good condition and the vertical granite curb is in generally fair condition. The curb along the driveway entrance was covered in snow at the time of the site visit and no curb was observed. Sloped granite curb was observed along the driveway and parking areas. Limited areas of curb were exposed through the snow but the curb that was observed was in fair to poor condition (Image 17).

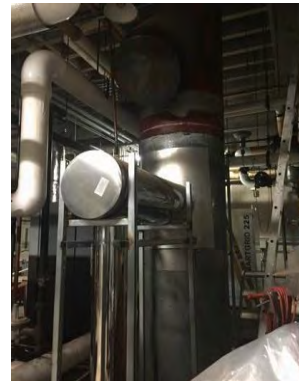
The Byam Elementary school is heated by a hot water boiler plant consisting of three (3) gas fired hot water boilers, hot water pumps, accessories, breeching, combustion air ductwork, and controls. The boilers were manufactured by Aerco, with an estimated heating capacity of 1,706 MBH output, and maximum input of 2,000 MBH each. The boilers were installed in 2002 and appear to be in very good condition. The boiler flue gases are vented through the use of a stainless steel breeching through the roof. Combustion air for the boilers is provided through the use of insulated sheet metal vent ducts (Image 1, 2, & 3).

Image 2 – Boiler Flue Vents

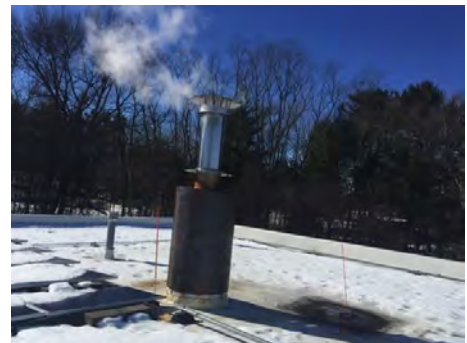
Image 3 – Boiler Breeching

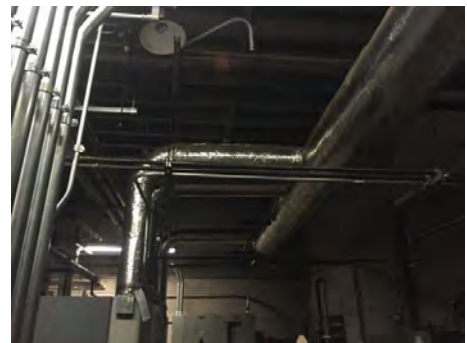
Hot water is distributed from the boiler to the buildings heating equipment by a pair of base mounted end suction hot water pumps that are equipped with VFD drives. The pumps appear to have been re-built in recent years with new motors; however the pumps appear to be nearing the end of their useful service life. The hot water piping and insulation located within the main boiler room appear to be in good condition. However, the majority of the hot water distribution piping and insulation are original to the building and in fair to poor condition (Image 4, 5, 6, 8, 9, & 10).

Image 4 – Hot Water Pumps

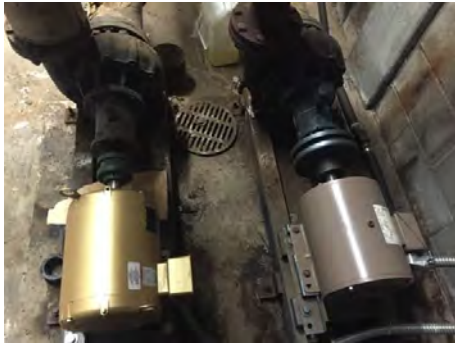
Image 5 – Hot Water Pumps

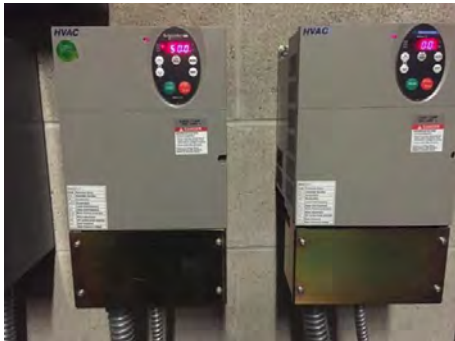
Image 6 – Hot Water Pump VFD Drivers

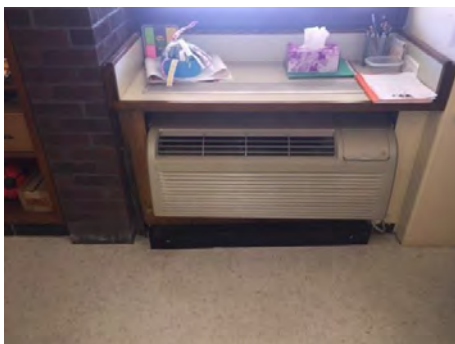
The offices are heated, ventilated and air conditioned by packaged thru wall air conditioning (PTAC) units with hot water heating coils. The PTAC units appear to be in fair condition. The offices with exterior walls are ventilated naturally through the use of operable windows (Image 7).

Image 7 – Admin. Office PTAC Unit

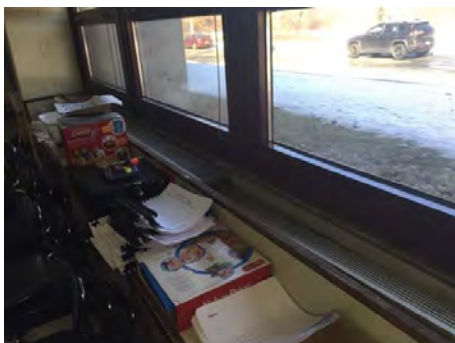
Image 8 – Perimeter Fin Tub Radiation

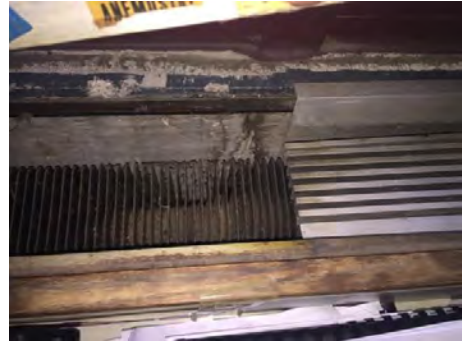
Image 9 – Fin Tube Radiation Heating

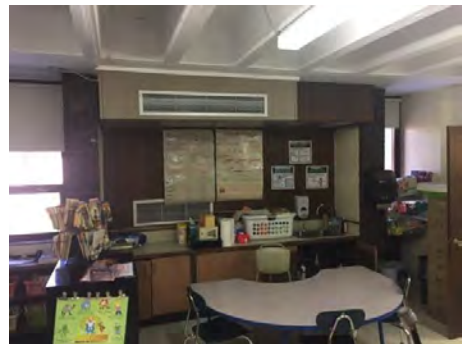
Image 10 – Typical Classroom Unit Ventilator

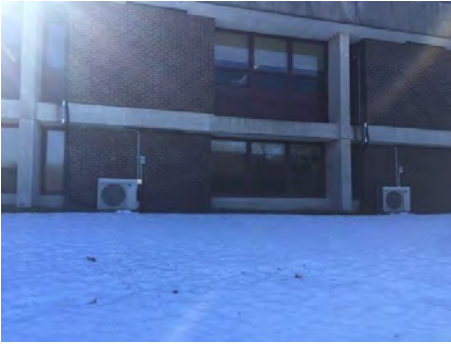
The majority of the building is not air-conditioned. Besides some of the Administration offices, which are served by PTAC units, the technology classroom is served by a ductless split system AC unit. The split system AC unit appears to have been installed in 2015 and was manufactured by Daikin (Model RKN24NMVJU), and has a capacity of 2 tons of cooling (Image 13).

Image 13 – Ductless AC Unit
Condensers

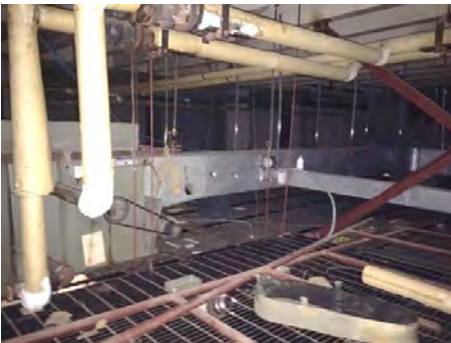
Image 15 – Kitchen Make-up Air Unit

- The Cafeteria H&V Unit and Kitchen Make-Up indoor air-handling unit located in the Mezzanine area above the Kitchen should be replaced.
- Rooftop exhaust air fans should continue to be maintained.

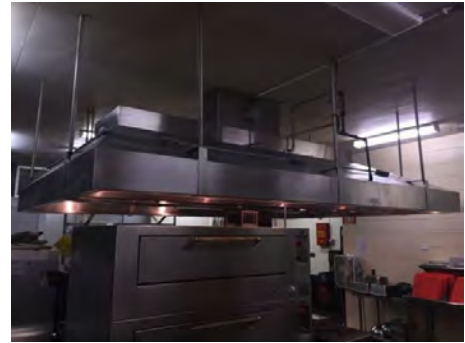
Image 17 – Kitchen Exhaust Hood

mounted exhaust fans. The majority of the exhaust fans appear to be in very good condition, with most appearing to have been recently replaced. The majority of exhaust fans were manufactured by Loren Cook or CentriMaster. The majority of the existing exhaust air ductwork appears to be original and past its useful expected service life (Image 17, & 22).

- Existing ductwork and air distribution devices should be cleaned.
- Existing cabinet unit heaters, hot water fin tube radiation, and convectors should be replaced; new hot water branch piping and valves with insulation should be provided.

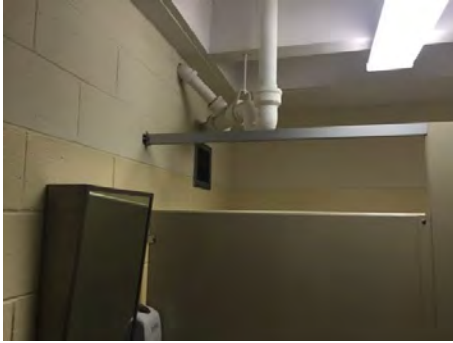
Image 21 – Restroom Exhaust Grille

The restrooms are heated by hot water convector units that appear to be in fair to poor condition. The restrooms are typically exhausted by ceiling or sidewall exhaust air grilles that are connected to exhaust air fans located on the roof. Some of the exhaust air grilles were soiled (Image 21).

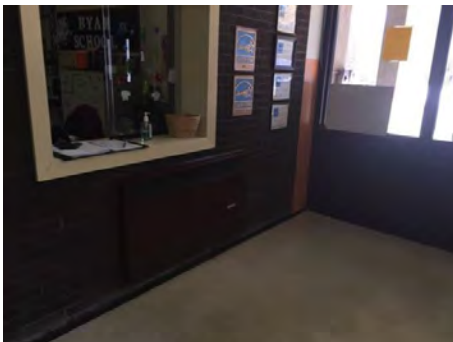
Image 23 – Entryway Hot Water Unit
Heater

The main entryways are heated by hot water convector units that appear to be originally installed equipment; some of the unit heaters show signs of corrosion on the cabinets. The majority of corridors are not provided with code required fresh air ventilation. The corridors are heated by a combination of hot water convectors and fin tube radiation that appears to be in poor to fair condition (Image 23, & 24).

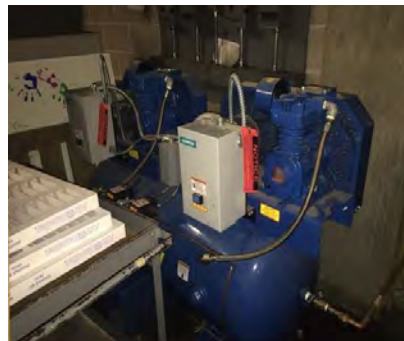
Image 25 – Pneumatic Compressor

systems installed for the existing H&V equipment that were not replaced during the recent renovation. The pneumatic compressor appears to be in good condition (Image 25, 26, & 27).

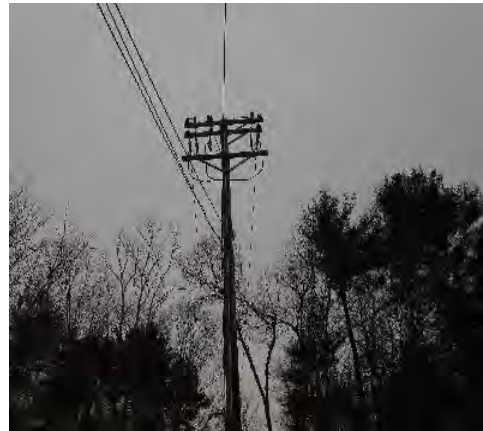
Image 1 – Utility Pole Riser

The service is fed from a utility pole riser to a utility company owned pad mounted transformer adjacent to the building (Image 1, & 2).

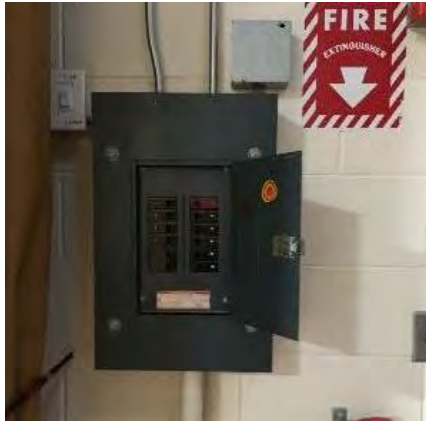
Image 4– Original G.E.P.B

Branch circuit panelboards vary from original General Electric panelboards that are in poor condition to recently installed General Electrical panelboards that are in good condition. There has been some additional branch circuitry added throughout the school. New power branch circuits

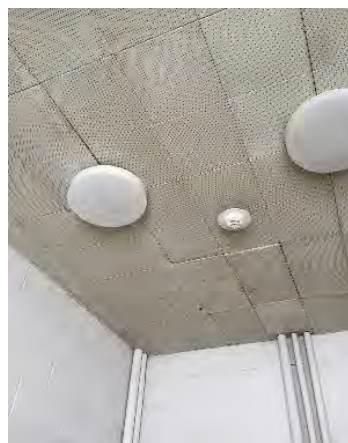
Image 12 – Toilet Lighting

Restrooms contain ceiling mounted fluorescent round fixtures with PLT lamps. Light levels in the restrooms are very low (Image 12)

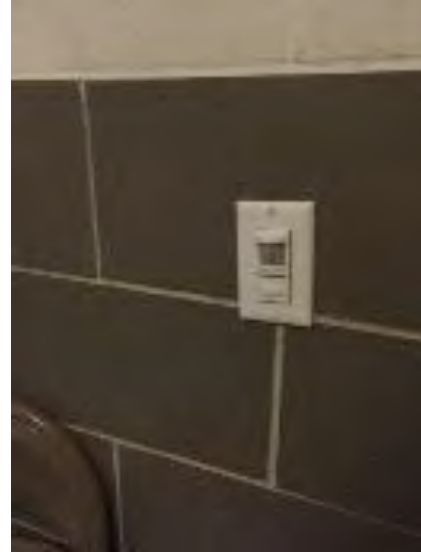
Image 13 – Occupancy Sensor

In general, most of the interior lighting is in fair condition. Most switching has been replaced with switch style occupancy sensors. Multiple rooms were noted that they did not get the occupancy sensor switch upgrade (Image 13).

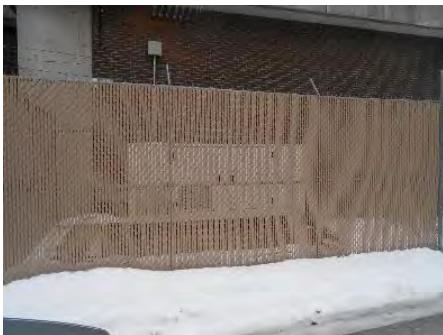
Image 18 – Generator

A recently upgraded diesel fired generator, 50 kW, 120/208 volt, in a weather-proof, sound attenuated enclosure is installed adjacent to the building within a fenced in enclosure. The generator feeds an ASCO transfer switch and serves emergency lighting, as well as other loads. The emergency system does not comply with current electrical code as the emergency equipment is not separated from normal equipment (Image 18, & 19).

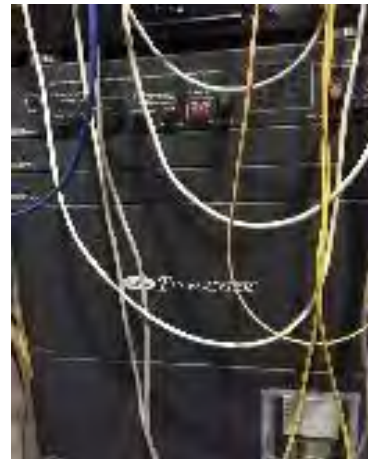
Image 27 – Paging System

A Rauland tele-center paging system head-end is located in the MDF room. A Valcom paging interface is used to interface the hosted system to the paging system and has been problematic (Image 27).

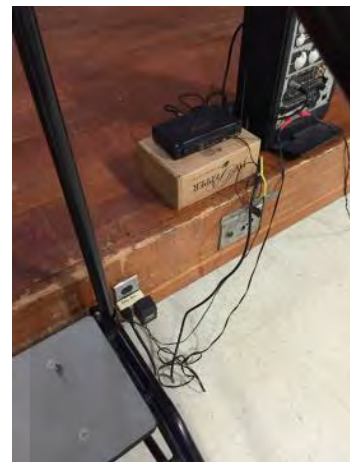
Image 28 – Portable Local Sound System

The cafetorium's existing Dukane local sound system is no longer in use. A portable system is used. The portable system is not tied into the fire alarm system which is a code requirement (Image 28).

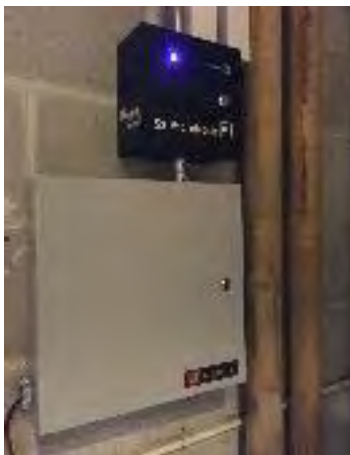
Image30 – A/U Control System

Access control is manufactured by S2 and there are micro-nodes located in the IDF closets to serve the access controlled doors (Image 31).

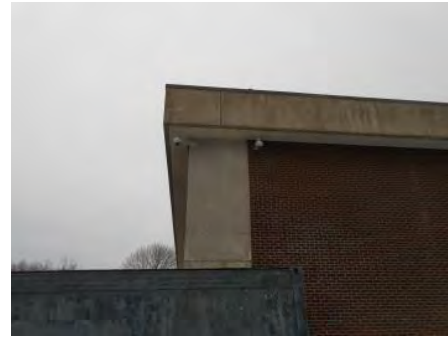
Image 31 – Access Controller

CCTV cameras are located on the exterior covering the building perimeter. They are connected to an S2 video management system; the head-end is located at the Central administration office (Images 32).

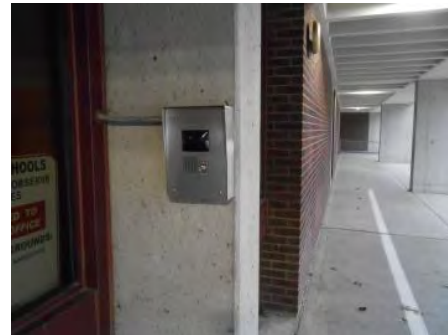
The building contains an Aiphone intercom door communication system at the main entry that is in fair condition (Image 33 & 35).

Image 32 – CCTV Camera

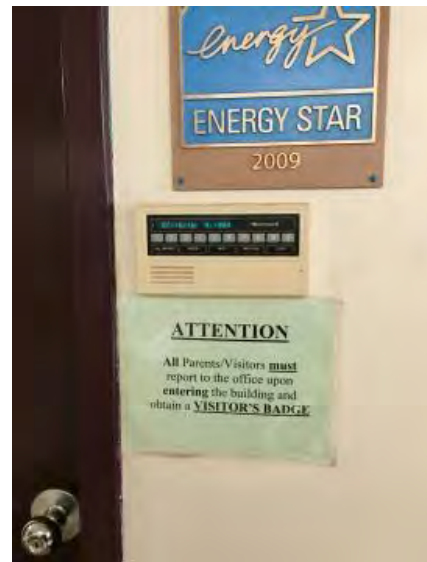
The intrusion system is a Honeywell system and is operational; however, appears to be in poor condition (Image 34 & 36).

Image 33 – Ai phone Intercom

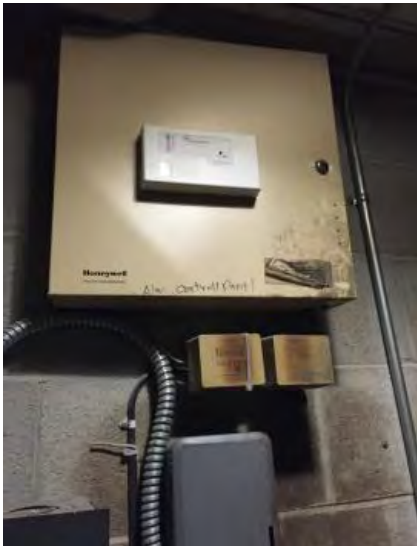
Image 35 – Intercom Master Station

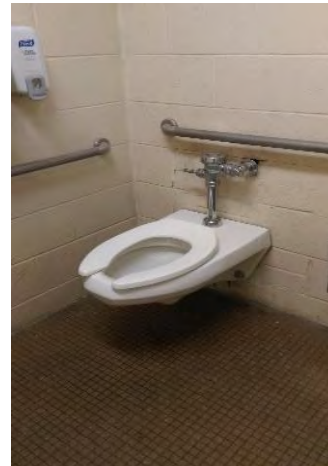
Water closets are wall hung vitreous china with manual flush valves (Image 1).

Image 1 – Wall Hung Water Closet

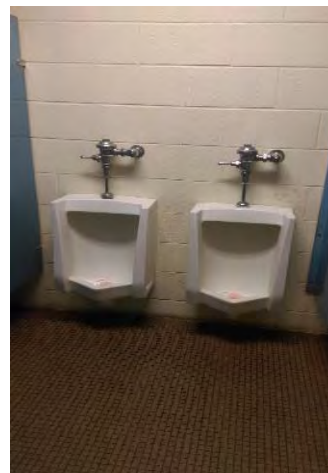
Urinals are wall hung vitreous china with automatic sensor type flush valves (Image 2).

Image 2 – Urinals

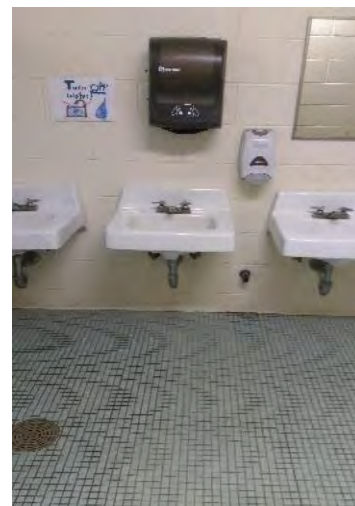
Lavatories are wall hung vitreous china. The lavatories are fitted with hot and cold water faucets (Image 3).

Image 3 – Wall Hung Lavatories

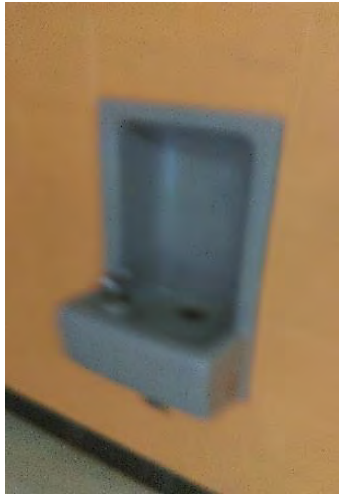
Drinking fountains are vitreous china recessed type (Image 4).

Image 4– Drinking Fountain

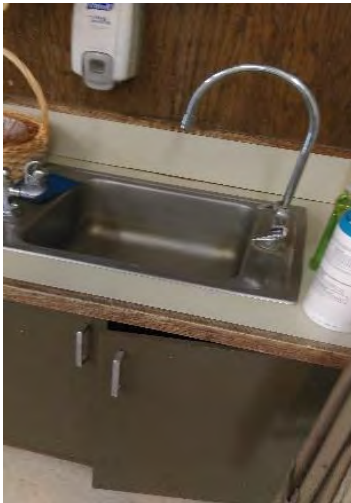
Classroom sinks are stainless steel drop-in type with hot and cold water faucet with gooseneck. Classroom sinks include a bubbler (Image 5).

Image 5 – Classroom Sink

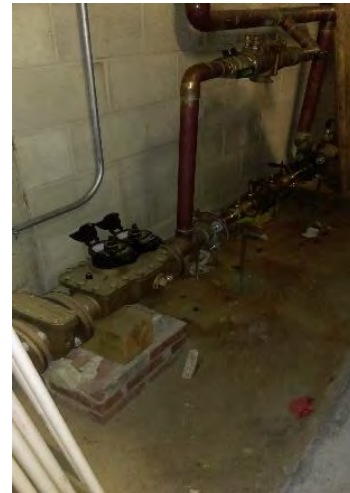
The domestic water service is located in the Mechanical Room. The service appears to be 4" in size and includes a meter and two (2) reduced pressure backflow preventers in parallel (Image 7).

Image 7 – Water Service

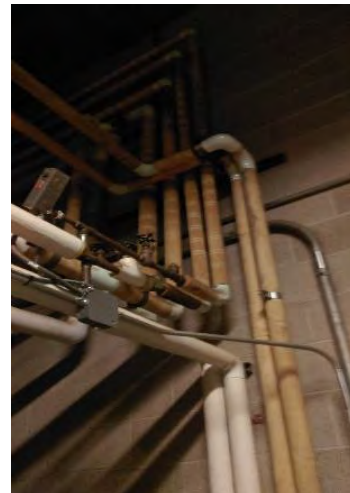
Piping is copper tubing with sweat joints. The majority of piping is insulated but not labeled. In general, the original gate valves are in fair condition (Image 8).

Image 8 – Water Piping

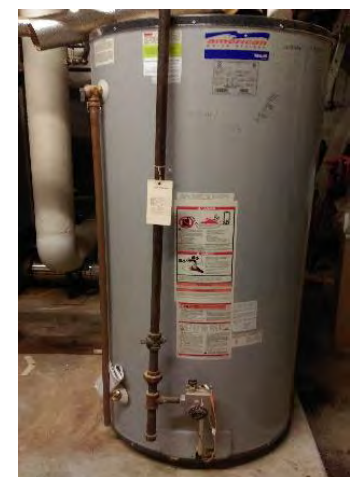
The main building domestic hot water is generated through a gas-fired standard efficiency non-condensing storage tank type water heaters. The water heater has a natural gas input of 77,000 BTUH and a water storage capacity of 100 gallons (Image 9).

Image 9 – Water Heater

- Provide reduced pressure backflow preventers at Janitor's closet soap dispenser.
- Local sewer may require Kitchen waste be directed to exterior grease trap.
- Install a high efficiency water heater including master mixing valve, recirculated hot water and expansion tank on cold water make-up line.
- Sanitary, waste, vent and storm drainage piping should be video-taped to determine condition.

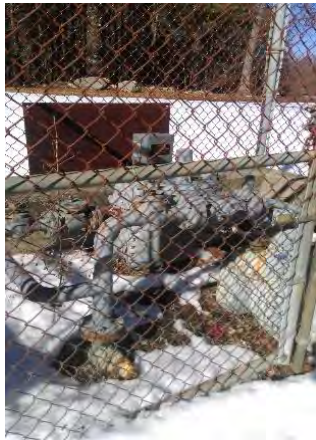
Building is serviced by an elevated pressure natural gas service. The gas service, regulator and meter are located on the exterior in a caged area. Gas service is 3" in size (Image 10).

Image 10 – Gas Service and Meter

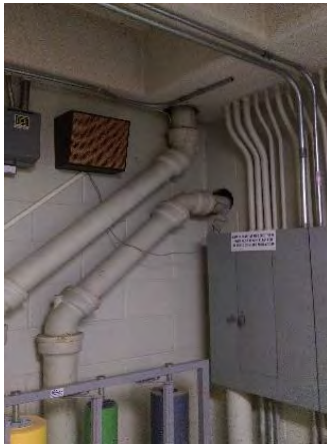
In general, cast iron is used for sanitary drainage. Piping and fittings above slab are no-hub with coupling joints and bell & spigot. Where visible, the cast iron pipe appears to be in fair condition. Smaller pipe sizes appear to be copper for waste (Image 11)

Image 11 – Sanitary Piping

In general, existing cast iron drainage piping can be re-used if sized appropriately. We recommend video inspection of existing drains to confirm integrity.

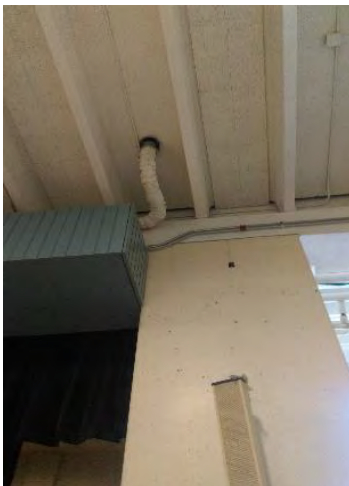
The flat roofs are collected by roof drains and interior cast iron rain leaders. The roof and drains are in fair condition. Portions of the horizontal rain leader piping is insulated (Image 12).

Image 12 – storm Piping

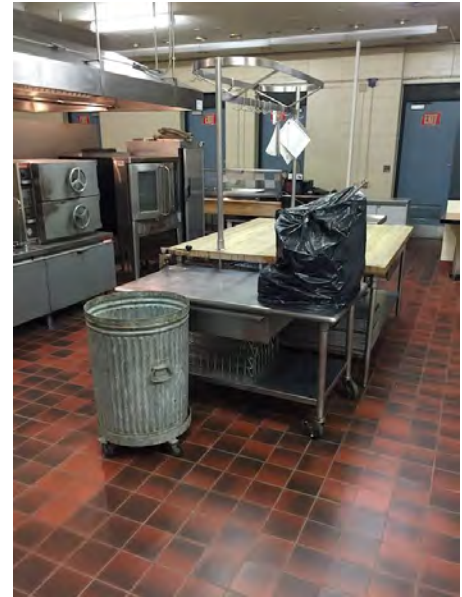
Image 1

General conditions (Image 1):

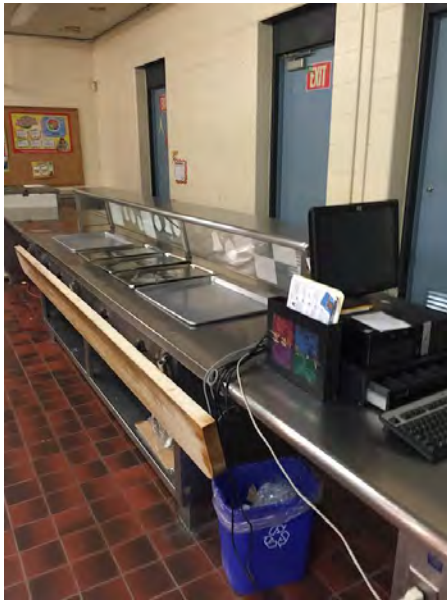
Image 3

Serving line (Image 3):
