Center Elementary School

ARCHITECTURAL ASSESSMENT

The building survey for this report was conducted on February 17-18, 2016.

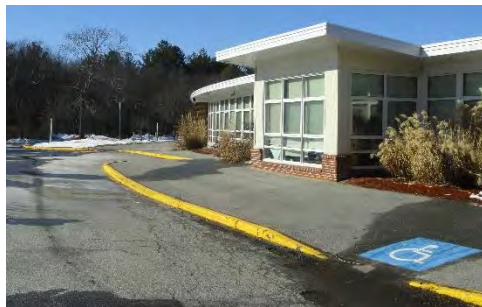
Image 6

The site provides accessible parking spaces, including van accessible spaces. A crosswalk with curb cut is provided. The curb cut appears to meet the slope; however, improvements to these should include a textured surface and improved drainage in this area. Some accessible curb cuts are not connected to crosswalks (Image 6).

- Correct drainage at curb cut areas to prevent pooling of water and icy conditions.
- Provide textured surface at curb cuts.
- Provide crosswalks at all curb cuts.
- Add extra width to sidewalks where curb cuts are located.
- Review door swings to provide clear floor area and push/pull clearance.
- Provide additional handrails at ramps.

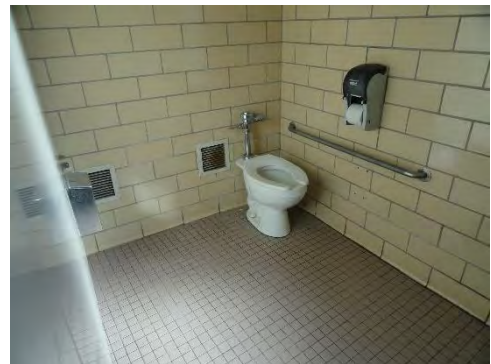
Image 9

- Provide new handrails with extensions or continuous wrap at ramps and stairs where extensions do not currently exist.
- Provide insulation or pipe protection at accessible sinks.
- Relocate stored items to allow access to the lift.
- Review heights of sinks and toilet accessories to verify that they meet ADA and MAAB requirements.
- Provide handrails per requirements (example: missing handrail Image 9).

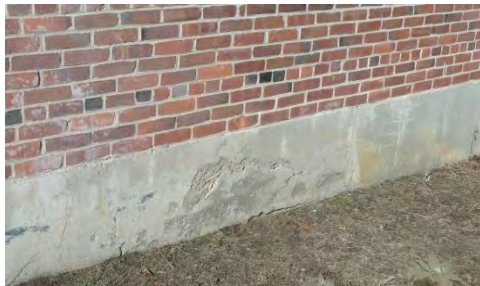
Image 13

- Cast in place concrete foundation has been parged and the surface is spalling in several locations (Image 13)
- A portion of the lower level is below grade with retaining foundation walls.
- Areas have vegetation and over growth around the base of the foundation walls.

- Remove vegetation to discourage roots and moisture from affecting the foundation structure.
- Continue to patch and repair areas where parging has occurred.

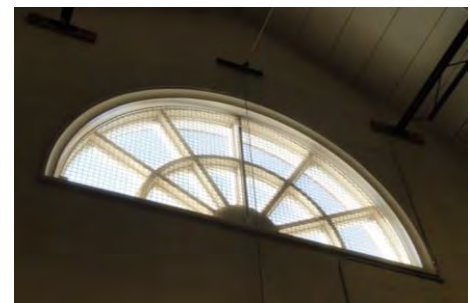
Image 19

- Insulated EFCO aluminum awning windows are in good condition.
- Most classroom window sills are ground face block sills or brick.
- Office and gym/cafeteria window sills are original rowlock brick. These brick window sills lack pan flashing and the mortar is cracking or pulling away from the wall.
- The large half-circle window at the gym appears to be original to the building. It is in good condition, but appears to be single-pane glazed (Image 19).

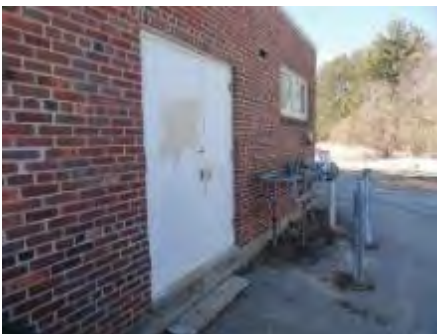
Image 22

- Main entrance doors and secondary entrances are aluminum storefront systems in good condition.
- Egress doors and maintenance entries are hollow metal doors and frames in fair condition with some dents and rusting (Image 21 & 22).
- The main entrance doors do not have a vestibule, which is not energy efficient.

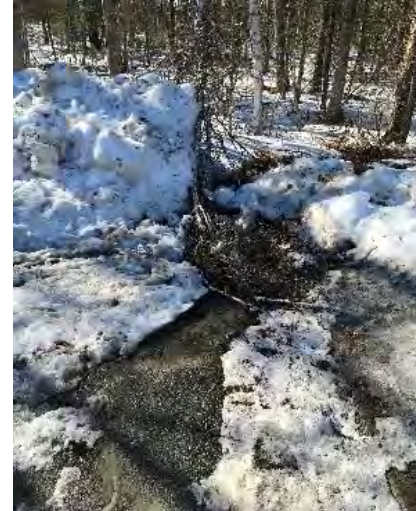
Image 1

There were no catch basins observed in the parking lot to the west of the building. The parking lot appeared to slope towards the northwest corner of the site. Snow covered the curb line so it is unclear if there is a curb or a catch basin in this corner of the parking lot (Image 1). Stormwater runoff may be collected or allowed to runoff of the site into the adjacent wetlands.

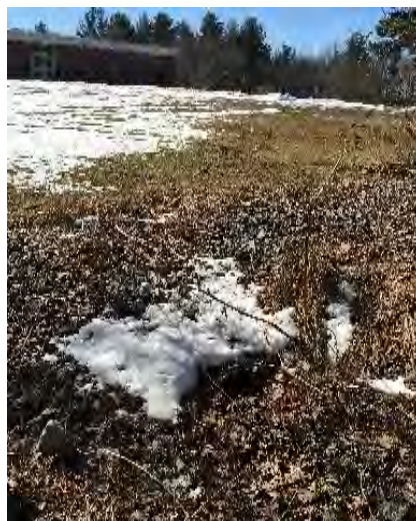
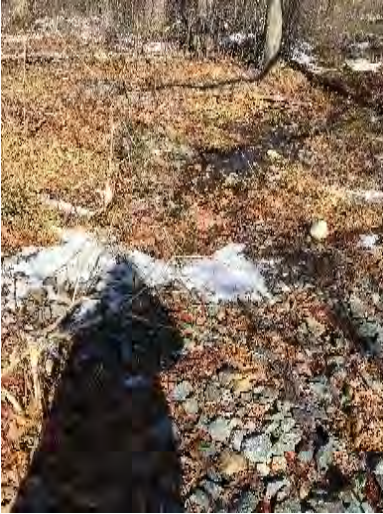
Stormwater runoff from some of the site appears to be collected below grade and discharged into the wetlands to the east of the site. An outlet pipe was observed on site directing water to the wetlands (Image 3 and 4).

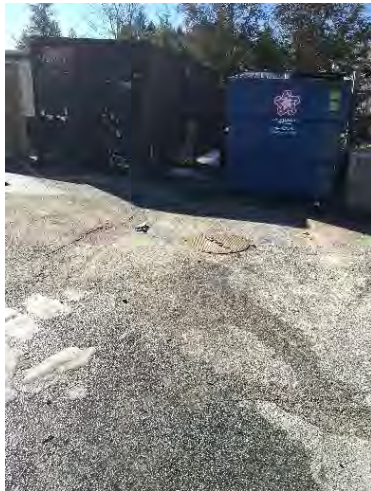
Image 5

There is a town sewer main in Billerica Road. Record plans show a sewer force main exiting the building along the east side and going under the driveway and connecting into the gravity main in Billerica Road. Sewer manholes were observed onsite in the same locations as shown on the record plans (Image 5).

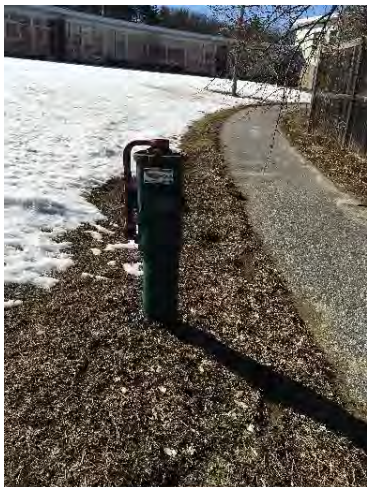
Image 6

A post indicator valve was observed in the lawn to the east of the site (Image 6).

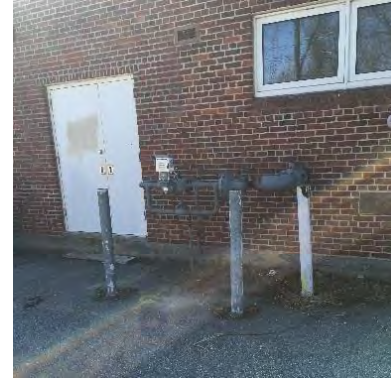
Image 7

There is a gas meter located at the center of the east face of the building (Image 7). A generator was observed along the paved driveway to the east of the site (Image 8).

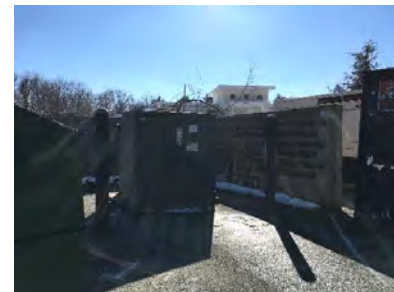
Image 9

There is a transformer located to the east of the building along the driveway (Image 9).

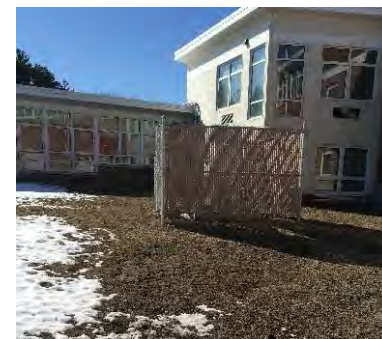
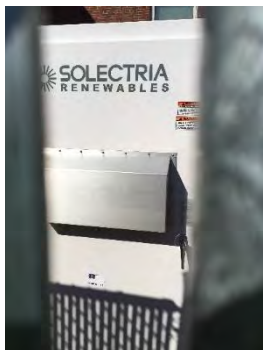
There appears to be a solar array on the roof of the building and there is solar energy equipment located in the lawn area long the southern side of the building (Image 10 and 11).

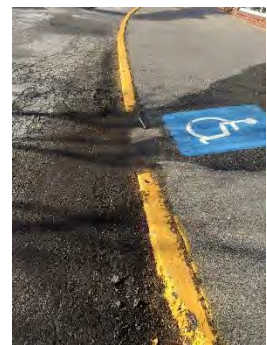
Image 14

Walkways onsite are asphalt or concrete and are generally in good to fair condition. There are some asphalt walks to the east of the building with ponding that has iced over (Image 13). Some walkways onsite appear not to be ADA accessible (Image 14).

- Mill and overlay sections of pavement where cracking/degradation has occurred.
- Regrade paved areas to prevent ponding which can lead to ice patches in the cold weather.
- Confirm walkways are ADA accessible.

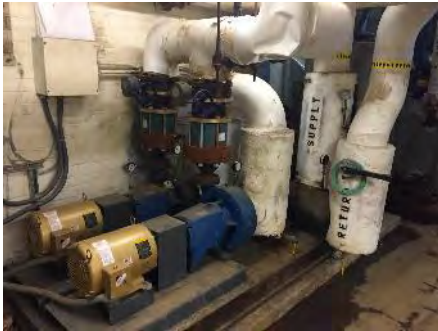
Hot water is distributed from the boilers to the building heating equipment by a pair of Bell & Gossett base mounted end suction hot water pumps with new 10 HP Baldor motors that are equipped with Yaskawa VFD drives. Two (2) vertical Extrol expansion tanks, air separator, and a new chemical shot feeder are also provided. Piping is schedule 40 black steel and copper with fiberglass insulation and all asbestos elbows have been removed. The hot water piping and insulation located within the main boiler room appears to be in good condition with slight damage to insulation at some elbows and valves. The distribution piping system is a two-pipe changeover system with pneumatic valves (Image 5, 6, & 7).

- The return inline pump is leaking at the impeller and shows signs of corrosion. This unit appears to be nearing the end of its useful service life.

Image 6 – Hot Water Pumps

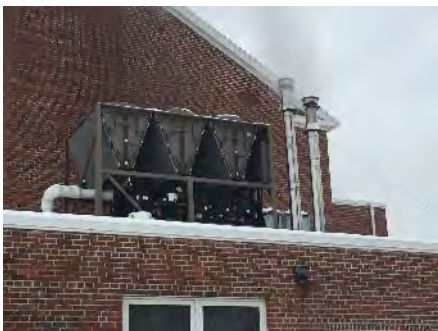
Image 8 – Air Cooled Chiller

Chilled water is distributed from the chiller to the building cooling equipment by the two-pipe changeover system through one (1) Bell & Gossett base mounted end suction hot water pump with a 7.5 HP Marathon motor that are equipped with a starter. The chilled water piping and insulation located within the main boiler room appear to be in good condition (Image 8).

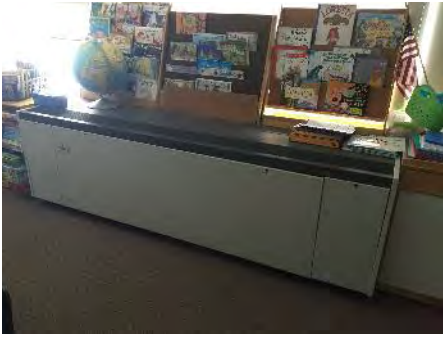
- The unit ventilators do not have control valves, face & bypass, or CO2 controls and are provided with pneumatic thermostats with only ON/OFF control and actuator control, resulting in problems with temperature control.

Image 11 – Classroom Unit Ventilator

The classrooms, Library, Art, Music, and Computer Rooms are heated, ventilated, and air conditioned by chilled/hot water coil floor mounted vertical unit ventilators. Ceiling suspended horizontal classroom unit ventilators are utilized in the Reading and Sped Rooms on the second floor. The unit ventilators are manufactured by MagicAire and appear to have been installed in 2014. There are approximately two (2) unit ventilators located on the first floor, fourteen (14) unit ventilators located on the first floor, and seventeen (17) unit ventilators located on the second floor, for a combined total of (33) unit ventilators. Ventilation air is introduced to each of these units through a wall-mounted louver. Some of the louvers appear to be in need of cleaning, repair, and/or replacement. Each unit is equipped with a chilled water coil, hot water heating coil, supply fan, and filter. The units are in very good condition. The classroom spaces are provided with exhaust systems to remove any outdoor air that is introduced through the unit ventilators which helps maintain a neutral pressure within the space. Most of the classrooms are served by central roof mounted exhaust fan systems (Image 11).

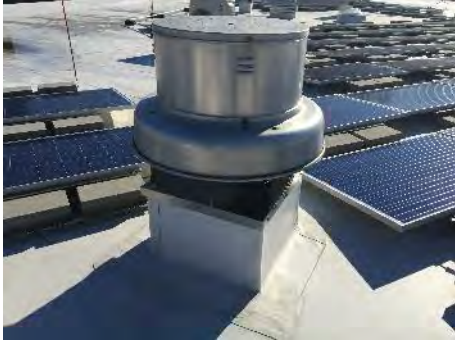
Image 15 – Roof Mounted Exhaust Fan

The majority of classroom spaces are exhausted through roof mounted exhaust fans. There are also dedicated exhaust fans which are roof mounted for areas such as the gang toilets, Kitchen hood, storage rooms and the large group spaces such as the Gym and Cafeteria. These areas utilize a galvanized sheet metal duct distribution system from the space to the roof mounted exhaust fans. There are approximately 13 roof mounted exhaust fans. The majority of the exhaust fans appear to be in very good condition, with most appearing to have been recently replaced. The majority of exhaust fans were manufactured by Loren Cook or CentriMaster. The majority of the existing exhaust air ductwork appears to be originally installed and past its useful expected service life (Image 15).

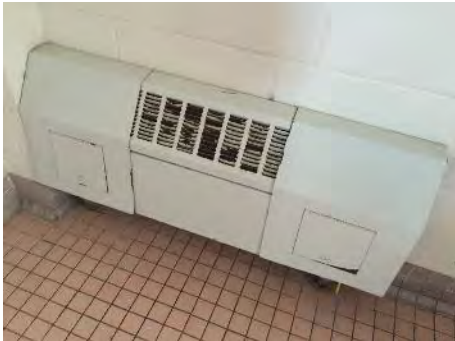
Image 16 – Restroom Convector

The restrooms are heated by hot water convector units that appear to be in fair to poor condition. The restrooms are typically exhausted by ceiling or sidewall exhaust air grilles that are connected to exhaust air fans located on the roof. Some of the exhaust air grilles were soiled (Image 16).

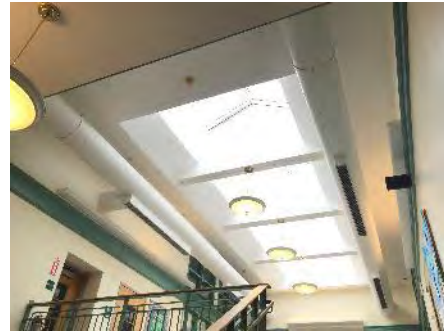
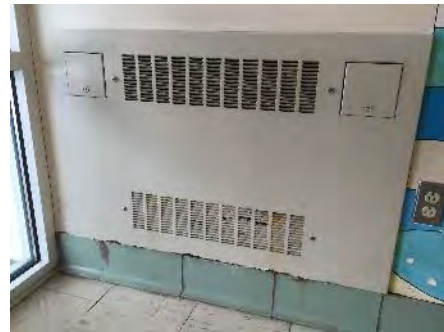
The main entryways are heated by hot water convector units that appear to be originally installed equipment; some of the unit heaters show signs of corrosion on the cabinets. The Lobby area and majority of corridors are served by an indoor air handling unit that is equipped with a chilled water coil, hot water heating coil, supply fan, and filter. FMC is currently in the process of replacing the unit actuators with new DDC type actuators. Supply air is ducted from the unit to each space through ceiling mounted supply air diffusers. The corridors are heated by a combination of hot water convectors and fin tube radiation that appears to be in poor to fair condition (Image 17, & 18).

- Hot water convectors, fin tube radiation, and unit heaters appear to be past their service life.

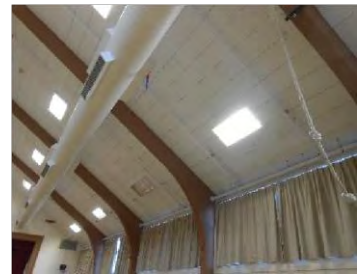
Image 7 – Gym Lighting

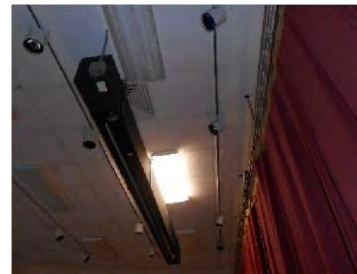
Image 8 – Platform Track Lights

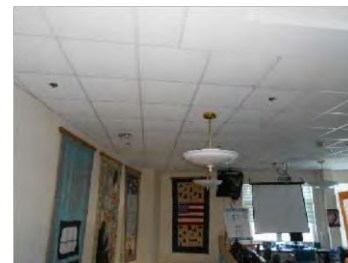
Library has recessed downlights, pendant bowl fixtures, and wall mounted indirect fluorescent fixtures (Image 10).

Image 10 – Library

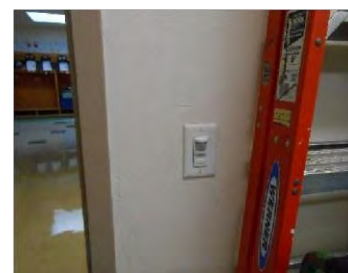
In general, most of the interior lighting is in fair condition. Most switching has been replaced with switch style occupancy sensors. Multiple rooms were noted to not have received the occupancy sensor switch upgrade (Image 11).

Image 11 – Occupancy Sensor Switch

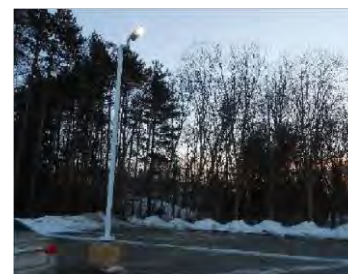
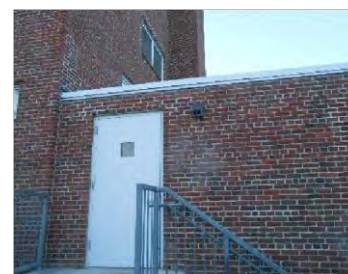
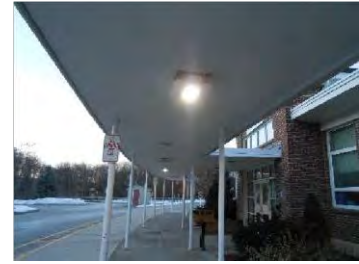
The site is lit with a combination of recently installed pole and building mounted LED flood lighting. Under the main canopy, existing lighting has been upgraded to LED lighting (Image 12, 13, 14, & 15). Some wall packs are HID type along with the recessed square fixtures at canopy of the main entrance.

Image 12 – Pole-Mounted LED Flood

Image 13 – Building Mounted LED Flood

Image 14 – Canopy LED Fixture

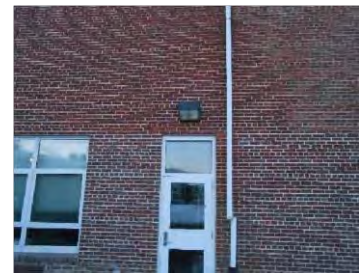
In general, the exterior lighting is in good condition with the exception of the HID fixtures. Exterior lighting is controlled via a time clock.

Image 15 – HID Wall Pack

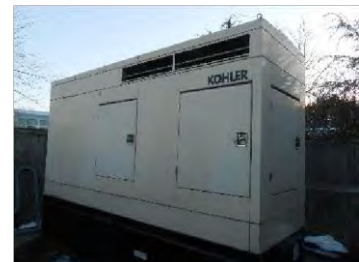
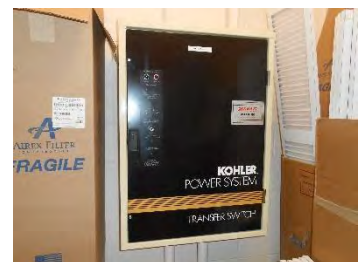
A recently upgraded diesel fired Kohler generator, 120/208 volt, in a weather-proof, sound attenuated enclosure is installed adjacent to the building within a fenced in enclosure. The generator feeds two Kohler transfer switches and serves emergency lighting, as well as other loads. Exit signs are provided throughout the building (Image 16, & 17).

Image 16 - Generator

Image 17 – Automatic Transfer Switch

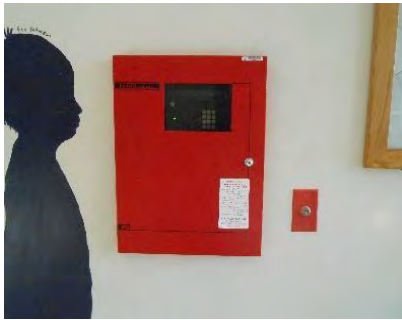
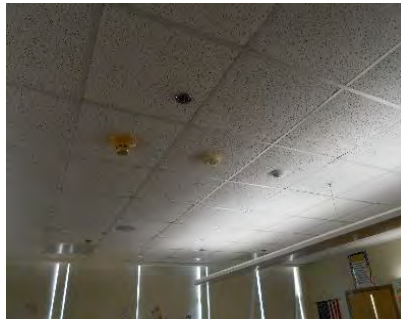
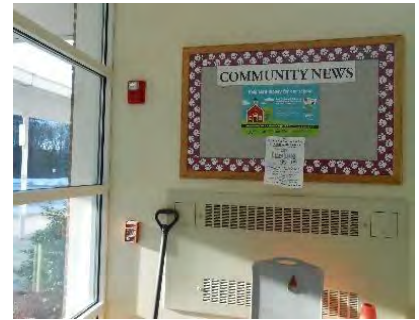
The fire alarm system consists of a conventional FCI 7200 Series control panel. The control panel is located in the lobby. Horn/strobes are ADA compliant and located throughout the school. Manual pull stations also seem to be compliant. Smoke detectors are provided in corridors and throughout the building (Image 18, 19, & 20).

Image 18 – Fire Alarm Control Panel

Image 19 – Smoke Detector

Image 20 – Pull Station & Horn/Strobe

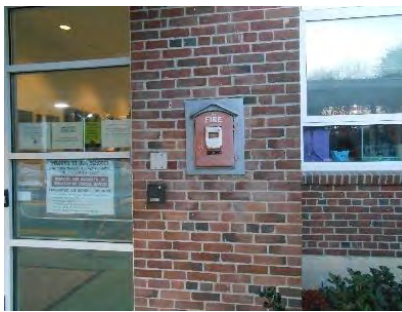
An exterior master box and knox box are located at the main entrance (Image 21).

Image 21 – Master Box & Knox Box

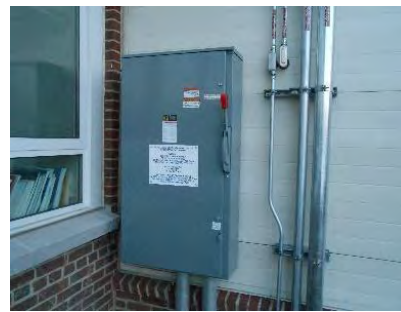
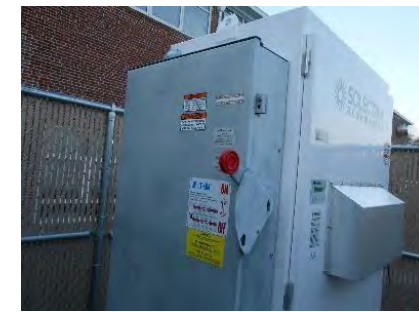
The facility contains a recently installed roof-mounted photovoltaic system with the inverters located at the exterior of the building on a pad (Image 22, & 23).

Image 22 – PV Disconnect

Image 23 – PV Inverters

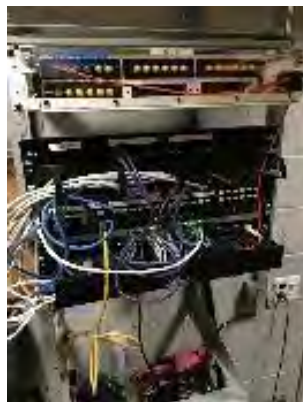
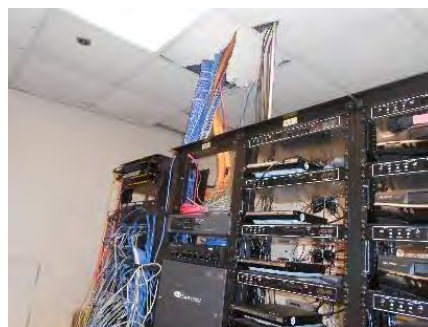
In general, data wiring is Cat5 throughout the building. IDF data racks are generally installed in existing storage or janitor closets, emergency branch circuits have been run to each rack. (Figure 24, Figure 25)

Image 24– IDF

Image 25 - MDF

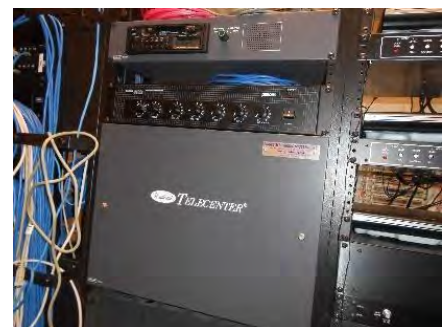
A Rauland tele-center paging system head-end is located in the MDF room. A Valcom paging interface is used to interface the hosted system to the paging system and has been problematic (Image 26).

Image 26 – Paging System

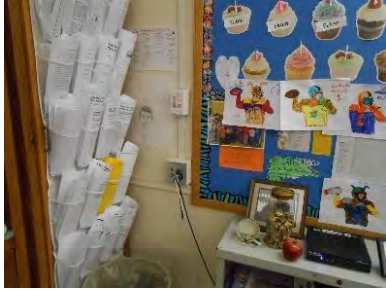
Most classrooms are equipped with A/U control systems for projector, document camera, and computer connections. Each also contains a sound reinforcement system. Projectors are ceiling mount type (Image 27).

Image 27 – A/UControl System

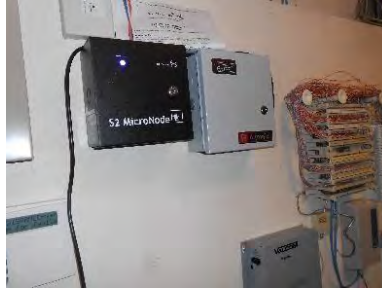
Access control is manufactured by S2 and there are micro-nodes located in the IDF closets to serve the access controlled doors. The system's head-end is located at the MDF room (Image 28).

Image 28 – Access Controller

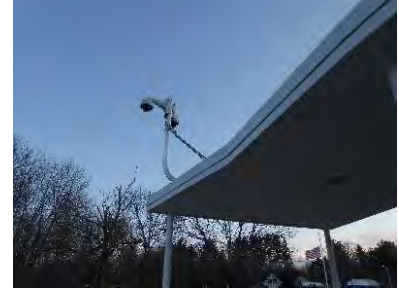
CCTV cameras are located on the exterior covering the building perimeter. They are connected to an S2 video management system; the head-end is located at the MDF room (Image 29).

Image 29 – CCTV Cameras

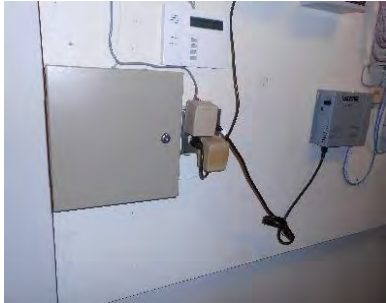
The intrusion system is a Honeywell system and is operational; however, appears to be in poor condition. Panel and keypad is located in the MDF room (Image 30).

Image 30 – Intrusion System Control Panel & Keypad

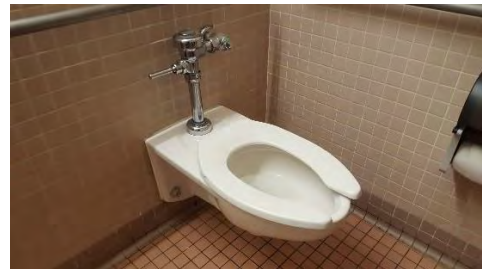
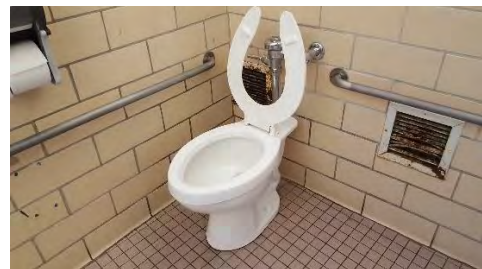
Image 1 – Wall Hung Water Closet

Image 2 – Wall Hung Water Closet

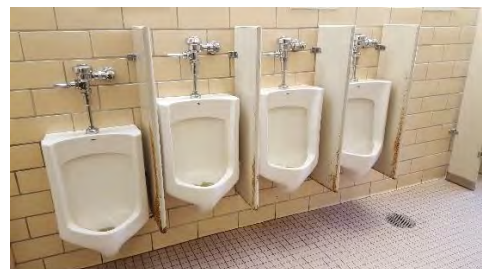
Urinals are wall hung vitreous china with manual flush valves (Image 3).

Image 3 – Wall Hung Urinal

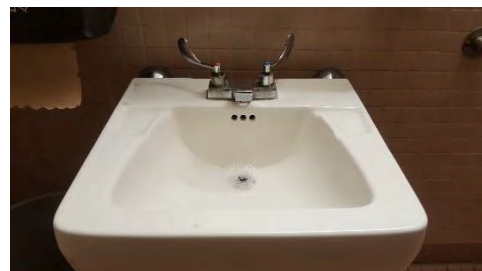
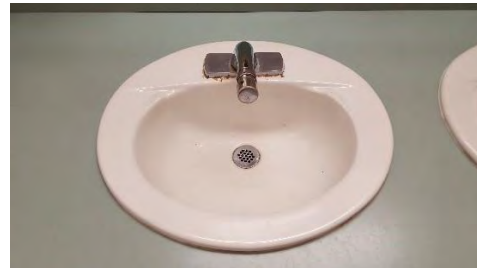
Lavatories are a mix of wall hung and counter mounted vitreous china. The lavatories are fitted with a mix of sensor type, metering, and hot and cold handle faucets (Image 4, & 5).

Image 4 – Wall Hung Lavatory

Image 5 – Counter mounted Lavatory

1. Plumbing fixtures meet current code for water conservation. However, new high-efficiency low flow fixtures (faucets & flush valves) could be installed to reduce water consumption. It should be confirmed that the existing water closets and urinals are compatible with current low flow flush valves.
2. We recommend video inspection of existing drains to confirm integrity and correct pipe invert. If pitch is determined to be shallow, we would not recommend low flow plumbing fixtures.
3. Provide new high-efficiency gas-fired domestic
4. water heater once the existing water heaters have expired.

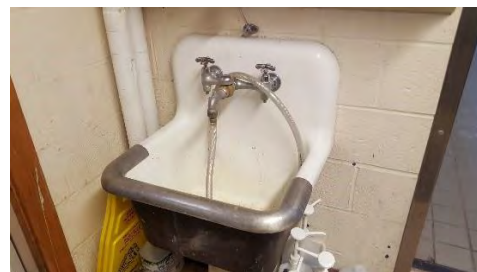
Utility sinks are wall hung enameled steel sink with wall mounted faucet. Faucets are equipped with vacuum breakers (Image 6).

Image 6 – Utility Sink

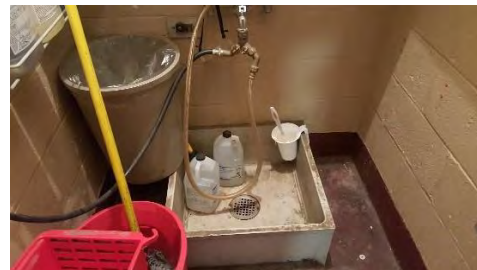
Service sinks are floor mounted mop receptors. Faucets are equipped with vacuum breakers (Image 7).

Image 7 – Service Sink

5. Provide reduced pressure backflow preventers at Janitor's closet soap dispenser.
6. Paint gas piping exposed to exterior.

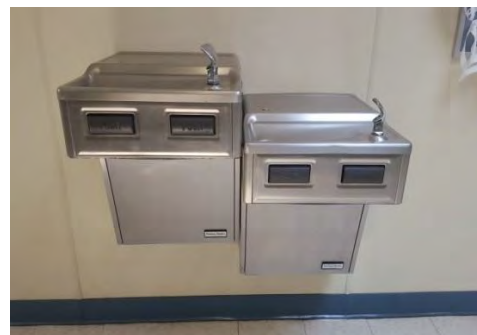
Drinking fountains are stainless steel wall mounted push bar hi-lo type (Image 8).

Image 8 – Drinking Fountain

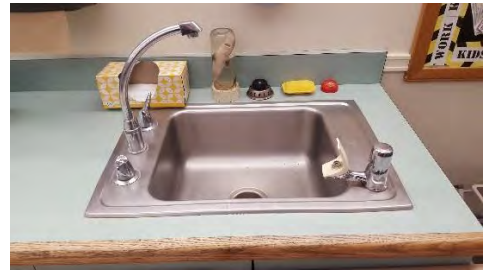
Classroom sinks are counter mounted stainless steel with hot & cold water handle faucets and a water bubbler (Image 9).

Image 9 – Classroom Sink

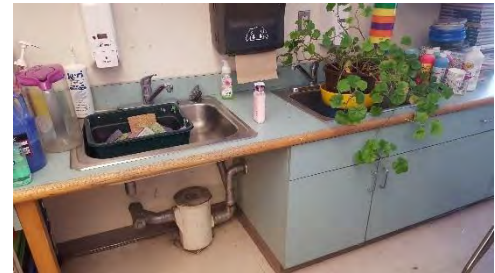
Art sinks are counter mounted stainless steel with single lever handle faucet. Art sinks are equipped with sediment traps (Image 10).

Image 10 – Art Sink

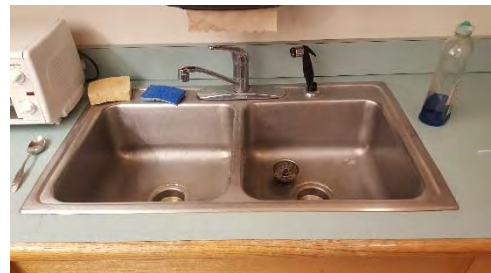
Teachers' sinks are counter mounted stainless steel sink with hot & cold water handle faucet (Image 11).

Image 11 – Teachers Sink

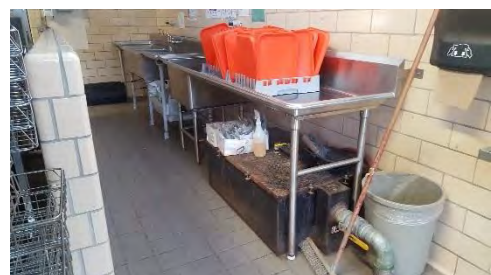
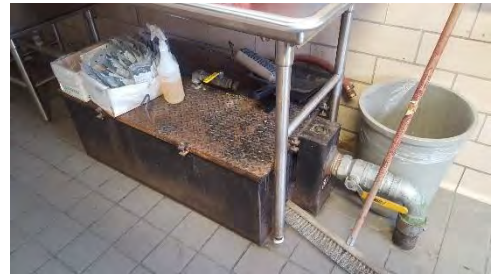
Kitchen area fixtures are in good condition. The pot washing sink is piped to a floor mounted grease interceptor (Image 12, & 13).

Image 12 – Pot Washing Sink

Image 13 – Grease Interceptor

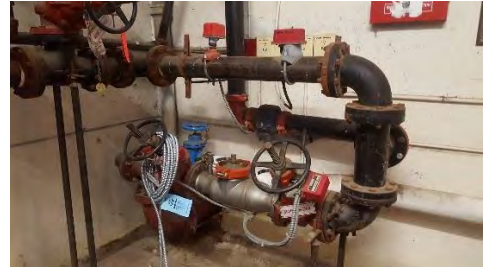
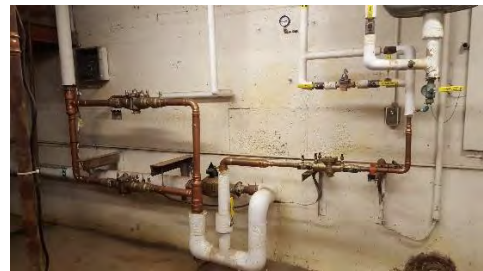
The domestic water service is located in the Mechanical Room. The service enters the building as an 8" and splits to a 4" Fire and a 3" Domestic and includes a meter (Image 14, & 15).

Image 14 – Domestic Water & Fire Service

Image 15 – Domestic Water Meter

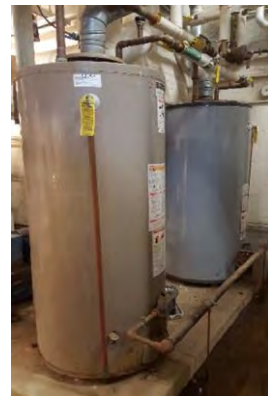
The building domestic hot water is generated through (2) gas-fired water heaters. Water heater-1 has a gas input of 77,000 BTUH and has a capacity of 100 gallons. Water heater-2 has a gas input of 75,000 BTUH and has a capacity of 100 gallons. Water heater-2 is not working. The hot water system is recirculated (Image 16, 17, & 18).

Image 16 – Gas Fired Water Heaters

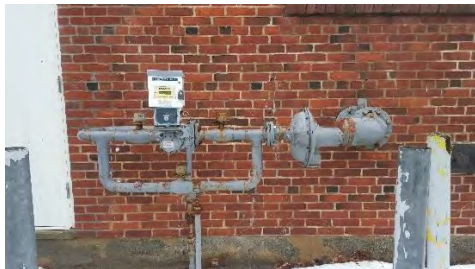
Image 19 – Gas Service & Meters

Building is serviced by natural gas. The gas meter is located along exterior of building. Gas service is 1" in size (Image 19).

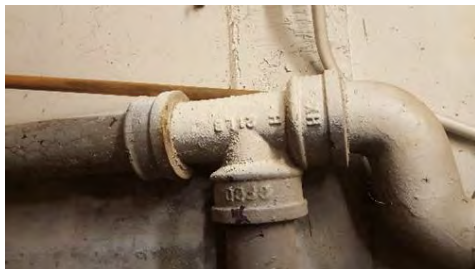
Image 20 – Cast Iron Piping

A duplex sewer ejector pit and sump pit is located in the Mechanical Room (Image 20, 21, 22, & 23).

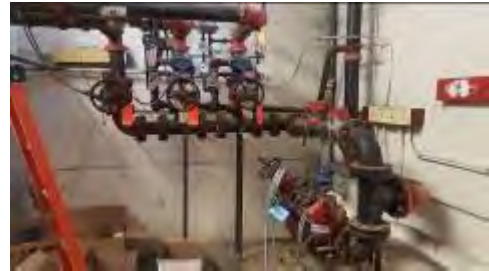
Image 2 – Wet Alarm Valves

The system includes (2) wet alarm valves, each with a main flow switch (Image 2).

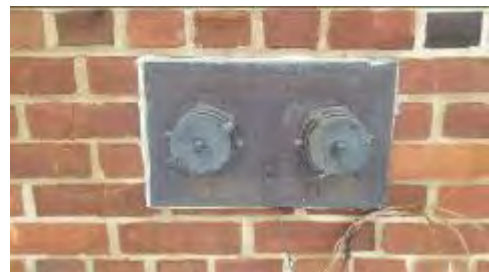
Image 3 – Fire Department Connection

The Fire department connection is a 4" Storz type. A water motor gong is located above the fire department connection (Image 3).

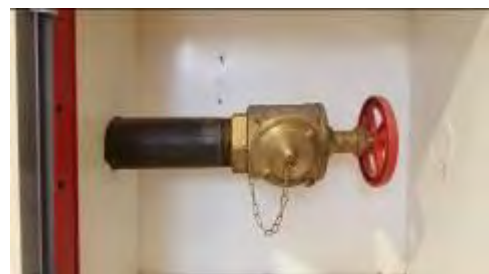
Image 4 – Fire Department Valves

Fire department valves are located throughout the building (Image 4).

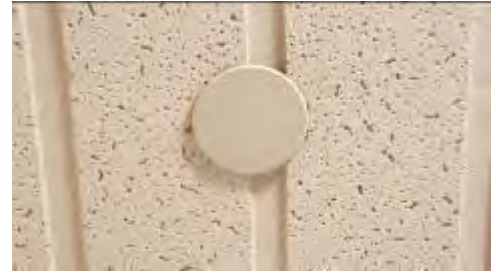
Image 5 – Concealed Sprinkler Head

Sprinkler heads are quick response type. In common areas sprinklers are fully concealed type (Image 5). Where no ceilings exist sprinklers are upright brass type (Image 6).
