# Chelmsford High School

## ARCHITECTURAL ASSESSMENT

The building survey for this report was conducted on February 16 - 17, 2016.

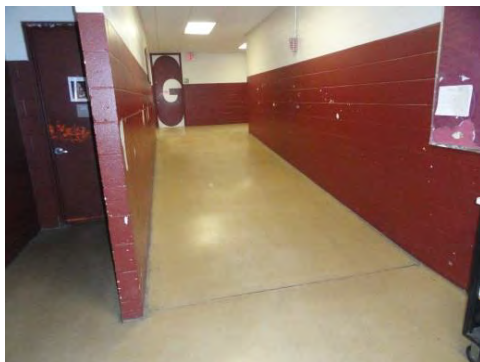
Image 7

The building includes some barriers to accessibility, as it does not provide an accessible route throughout the building and equal access to all spaces. The ramp the gym floor and performing arts wing is too steep per the current code and does not have railings as required for accessible ramps (image 7). Accessibility is provided to these spaces only by exiting and reentering the building. An elevator, lift or renovation to the interior ramp is required to connect these floors properly.

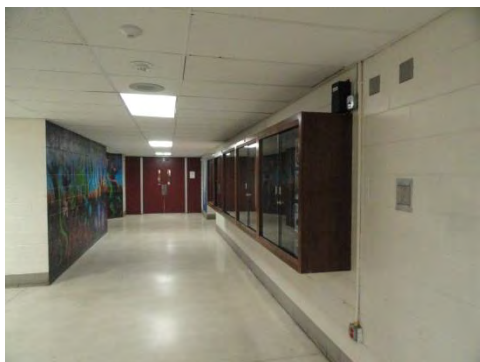
Image 8

- Multiple display cases and cabinets protrude from the wall, more than is allowed in the code. (Image 8)
- Many drinking fountains do not provide the required space below and proper height for

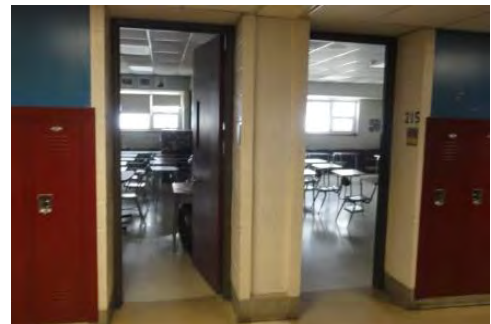
Image 10

- Multiple entries (classrooms, offices, etc.) do not have minimum clearance for pulling or pushing the door open if it has a closer. (Image 10)
- Stairs in the original building do not meet current rise and run requirements. (Image 13)

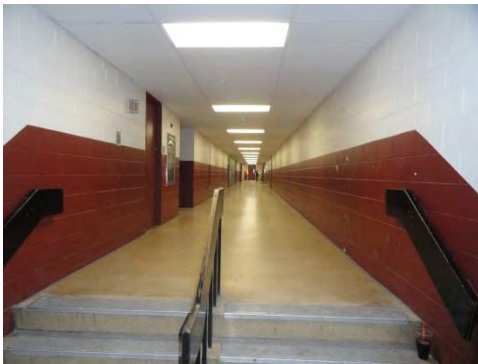
Image 14

- Some handrails do not extend as required by current code.
- Some handrails are not the required diameter or dimension from the wall as required by current code. (Image 14)

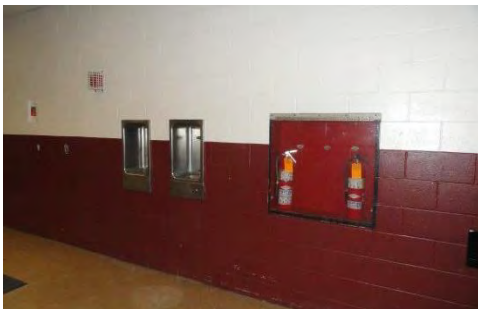
Image 15

someone to roll up with a wheelchair to use them (Image 15)

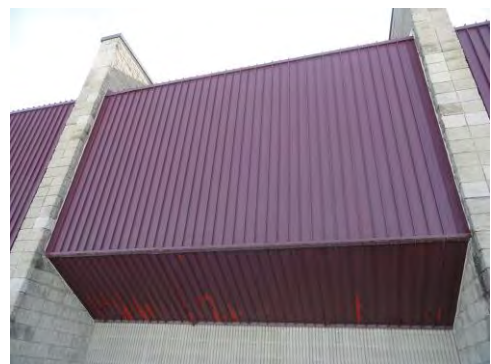
Image 20

- Most of the exterior walls are split-face block and in good condition.
- Accent metal panels are located at the front entrance (Image 1), and at the theater addition (Image 19). These panels are in good condition.
- Standing seam metal panel soffits at the gymnasium are losing their paint (Image 20).
- Some weeps in the CMU and split-face block walls have been blocked by debris or insects.
- Control joints are in fair condition throughout the school.

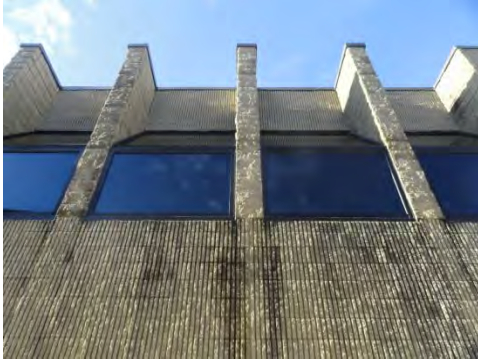
Image 21

- Aluminum-framed windows throughout the school and performing arts addition are in good condition. The sealing at the windows appears to be in fair condition.
- The shades are always drawn in the dressing rooms and attached toilet rooms to provide privacy, but don't allow natural light into the rooms.
- The window and door heads and sills on the north and west sides of the Performing Arts wing have gaps or cracked mortar at the lintel and/or sill. The lipped brick at the lintel doesn't sit properly in several locations.
- Windows at the gymnasium may not be flashed properly. Water runoff from the windows has stained ribbed block below them (Image 21)

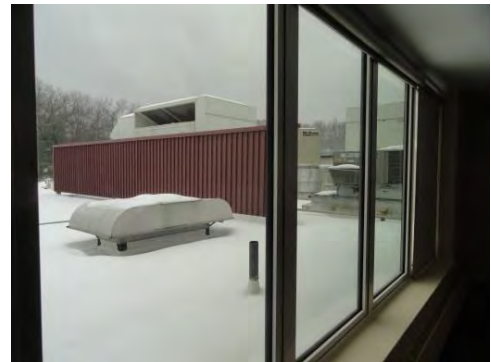
Image 23

- Several doors have thresholds that do not meet current codes for accessibility. (Image 22)
- Egress doors from the gymnasium have a step down immediately at the door. This is not acceptable per current accessibility codes and is not considered a safe egress. (Image 23)
- The painted finish on several metal doors has chipped off, which could lead to rusting
- Overhead door at the theater scenery room is in good shape.
- Special oversized doors at the wood shop appear to be in good shape

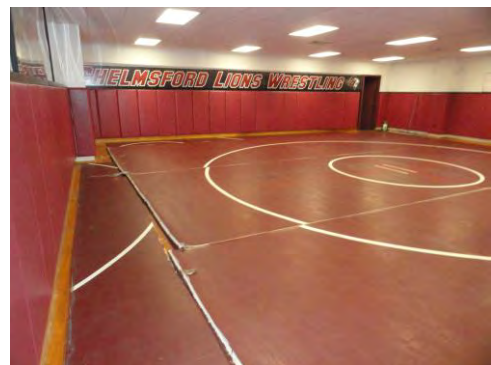
Image 28

- Sports flooring system in gymnasium with a faux wood finish is in fair condition. There are some locations with buckling and some missing seams. (Image 27)
- The flooring in the auxiliary gym is wood covered with wrestling mats. Both the wood floor and the mats are in poor condition (Image 28)
- Terrazzo floors in the corridors of the original building are in fair condition. Patching is noted in a few locations where door entries have been renovated (Image 29).
- Corridor stairs at the gymnasium have metal treads in fair condition. (Image 30)

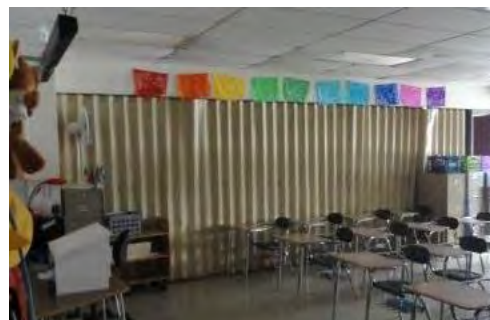
Image 36

- Folding partitions are in poor condition. These partition walls do not appear to be operable (Image 36).
- Corridor walls are largely painted CMU in good condition. (Image 37). There are many murals by students throughout the building, some require re-painting.
- Some CMU walls have step cracks or cracks at the joints that should be repaired
- Gypsum wallboard partitions are in generally good condition. (Image 38)
- Accent walls with split face block or ribbed block are in good condition. (Image 39)
- Vinyl wall base on many of the walls is very dirty and is peeling off the wall
- CMU walls have painted base that is water stained and dirty from floor cleaning

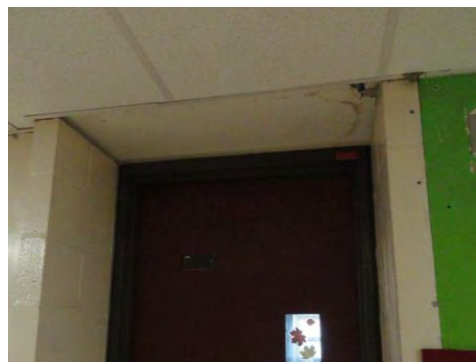
Image 40

- Acoustic ceiling tile and grid that are in the science classrooms are in good condition, they were recently replaced with renovations in those rooms.
- Acoustic ceiling tile and grid in the rest of the building is in fair condition, with select areas of staining due to water leaking above the ceiling.
- Some ceilings are cupping and show damage at the edges. Cupping may be due to humidity or moisture (Image 36).
- Gypsum soffit boards are generally in good condition throughout however, some locations show staining and peeling of paint (Image 40).

- Replace damaged ceiling tiles and investigate the source of water or moisture.
- Where stains exist on soffits remove and replace gypsum soffits
- Investigate moisture and humidity levels in classrooms and spaces that have cupping ceiling tiles.

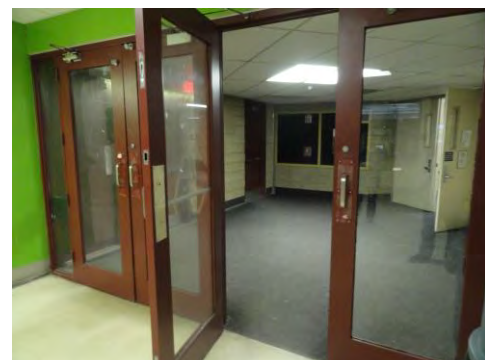
Image 44

Most classroom doors have vision panels and lever hardware. These doors are in generally good condition however, many do not meet the push / pull clearance required by the accessibility codes. Doors in the corridors have vision panels and panic hardware. Most of these doors are on hold opens that are tied to the fire alarm system. Many of the kick plates on these doors are rusting. This rusting in areas that are not exposed to weather is often a result of floor cleaning methods. A few doors throughout the facility still have knob hardware or pulls that do not meet accessibility code requirements. Some doors have surface mounted hardware that extends below the center of the door and interferes with the clear surface requirements of the door. In other locations the height of the push / pulls were noted as non-compliant (Image 44).

- Replace rusting kick plates and review floor cleaning methods to prevent continued buildup of water and chemicals on the base of the doors
- Replace any remaining non-compliant door knobs with lever hardware
- Review the installed heights of door pulls and reinstall at correct heights where required
- Where renovations are planned, consider removing one or two lockers at each side of the classroom doors to provide the proper push / pull clearance for accessibility
- Where door hardware is surface mounted and is located below the center of the door, replace doors with hardware that is integral to the door system

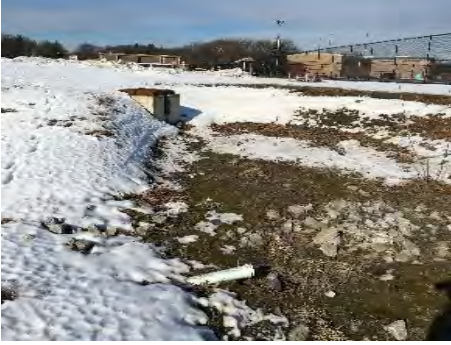
Image 5

There is a bioretention basin east of the school between the parking lot and tennis courts. Inlet pipes were observed entering a sediment forebay from the west side of the basin. Stormwater then overflows into the bioretention (Image 5). There is an outlet control structure located along the west side of the bioretention basin (Image 5). It is not clear where the bioretention basin overflows.

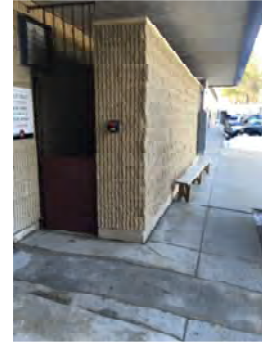
Image 9

There is a gas meter located on the north face of the building by the staff parking. The meter is behind a partial wall (Image 9 and 10). Dig safe markings show the gas service coming through the staff parking but does not continue to the roadway. The gas service for the building may connect to the gas main in Richardson Road, Graniteville Road, or Old Westford Road.

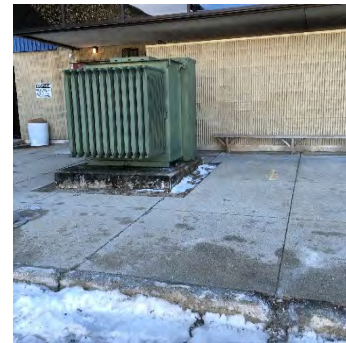
Image 10

There is a transformer located to the north of the building along the teacher parking lot (Image 10). Electrical services enter the building along the north face near the mechanical and electric rooms.

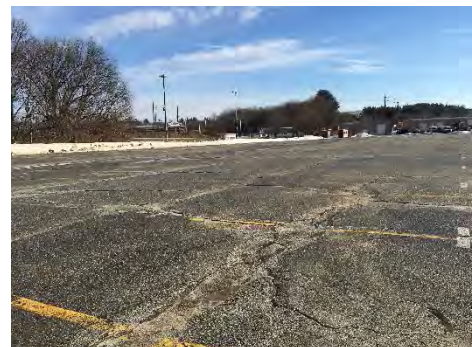
Image 11

The asphalt pavement within the site is in generally fair condition with some areas of cracking and degradation (Image 11).

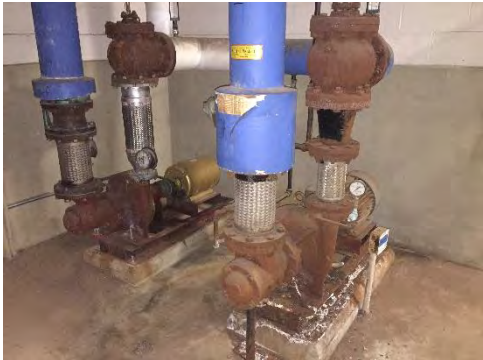
Figure 3 – Hot Water Pumps

through the roof and terminates with a rain cap. Combustion air is directly ducted to each boiler from a wall mounted louver. (Figure 2) This ductwork is insulated with fiberglass insulation. Heating hot water is circulated throughout the building with base mounted end suction pumps. (Figure 3) The system has four base mounted Bell & Gossett pumps. Two pumps serve the fin tube and unit ventilators and the other two for duct mounted hot water re-heat coils. Therefore there are two separate hot water loops that travel throughout the building. Both loops are tied together for emergency purposes in the event the pumps fail. Currently each pump set only has one pump operating while the other pump is non-functional. The non-functional pumps have been disconnected and abandoned in place. The two functioning pumps are equipped with variable frequency drives however system modulation is not being provided and both loops are being driven at constant speed. (Figure 4) For the new Auditorium addition there are two inline Taco pumps which tie into the existing hot water system. There are no variable frequency drives associated with these pumps therefore they operate at constant speed. There is no ventilation being provided in the boiler room which is not code compliant.

- There is a lot of corrosion occurring on the exposed piping and flanges within the boiler room. This may cause piping failures in the future.
- The air separator associated with the hot water system does not have an air vent.
- There are no pressure gauges on one set of pumps.
- There is no stand-by pump for each pumping sets.
- One of the existing functional pumps appears to be having a bearing issue due to the noise being generated from the impeller casing. Also this pump does not have a premium efficiency motor nor is it inverted duty which is required for pumps with variable frequency drives. This may be why the bearings are beginning to fail.

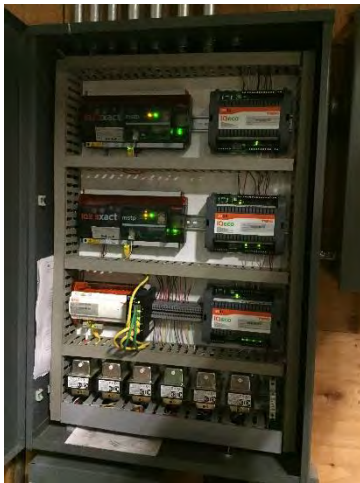
Figure 5 – ATC/DDC Control Panel

The building is served by Novar/Trend Tridium Niagara based direct digital controls. This is town wide system which was just installed in 2015. The new control system provides combination temperature sensors/CO2 sensors in each classroom which provides demand control ventilation. In the boiler room, the Trend system monitors HWS temp, HWR temp, OA temp and boiler alarms. The Trend system controls pump start/stop and speed and split air conditioner start/stop. The boilers are sequenced and operate via the standalone Aercro boiler management controller. Boiler faults are picked up by the Trend system. Utility type spaces and toilet rooms are controlled by local controls with no night setback capability. The boiler plant is equipped with an automatic outdoor air reset control function which provides energy savings when the building load does not require high temperature water due to warmer outdoor conditions. (Figure 5)

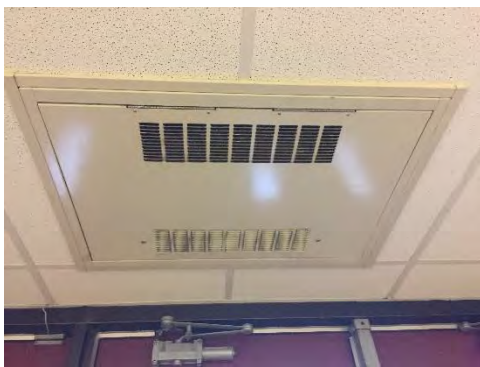
Figure 6 – Entryway Cabinet Unit Heater

The common areas such as Corridors, Vestibules, Restrooms and Lobbies are all heated and ventilated via local roof top units that serve that general area. The corridors and vestibules are provided with supplemental heat through the use of wall/ceiling mounted cabinet unit heaters and fin tube radiation. Each component is controlled via a wall mounted thermostat which communicates back to the Delta control system. (Figure 6)

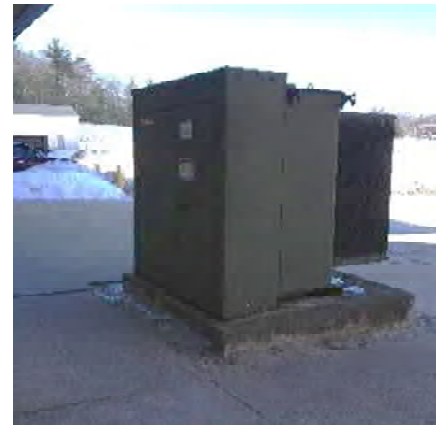
Figure 1 – Pad Mounted Transformer

The primary service runs underground into a pad mounted transformer behind the receiving area. Secondary service runs underground between the transformer and a 3,000 ampere, 277/480 volt, 3 phase, 4 wire switchboard. The switchboard has integral C/Ts and a main breaker. The two distribution sections consist of fusible switches.

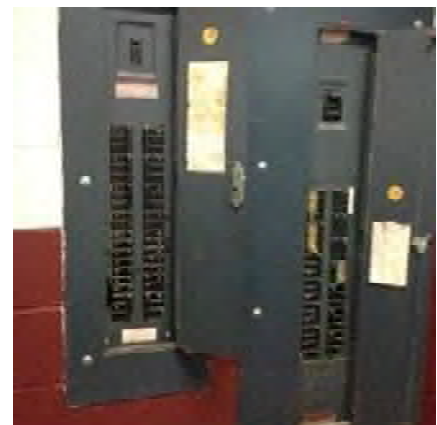
Figure 3 – Typical Original GE panels

The switchboard manufactured by GE, is original to the building and is in poor condition. Most local and remote GE panelboards are also original and are generally full and in poor condition. Panels are of the breaker type and generally located within electric closets. Stepdown transformers have been replaced with newer Powersmiths ultra efficient units.

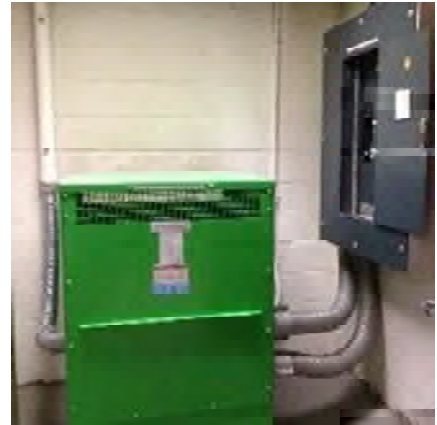
Figure 4 – New Transformer

The newer transformers, in some instances, infringe on the code required working clearances for adjacent panelboards.

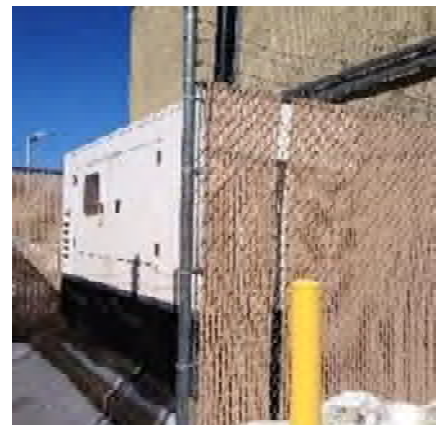
Figure 15 – Exterior Generator

The generator and transfer switches were installed during 2005 and are in good condition. The emergency transfer switch and emergency panels feeding emergency lighting at the school are not housed within 2-hour rated dedicated rooms and therefore are not in compliance with current codes.

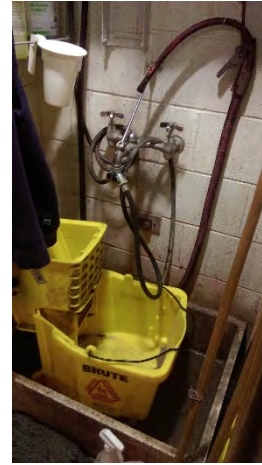
Figure 4 – Janitor's Sink

Janitors sinks are floor mounted mop receptors. Faucets are equipped with vacuum breakers. (Figure 4)

3. Provide reduced pressure backflow preventers at Janitor's closet soap dispenser.
4. Local sewer may require Kitchen waste be directed to exterior grease trap.
5. Current Code requires emergency fixtures be supplied with tepid water. Hot and cold water should feed a mixing valve to blend water to tepid temperatures supplying the emergency showers and eyewashes.

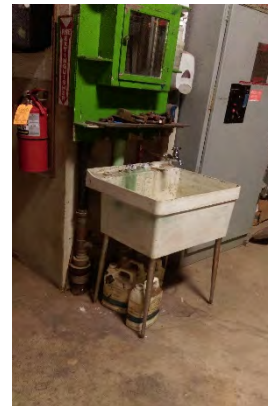
Figure 5 – Utility Sink

Utility sinks are floor mounted molded plastic sinks with deck mounted faucet. Faucets are not equipped with vacuum breakers. (Figure 5)

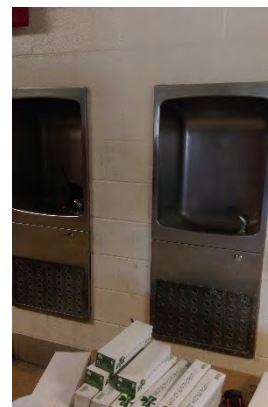
Figure 6 – Drinking Fountains

Drinking fountains are stainless steel recessed type. (Figure 6)

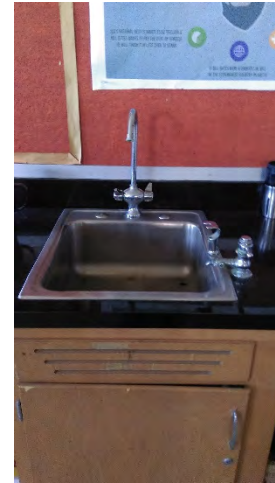
Figure 7 – Classroom Sink

Classroom sinks are stainless steel drop-in type with gooseneck faucet and bubbler. (Figure 7)

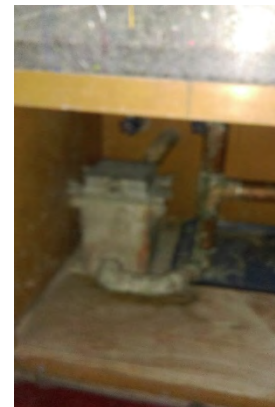
Figure 8 – Plaster Trap

Art sinks are molded stone wall mounted type deep 2 bowl sinks or epoxy countertops with integral bowls utilizing hot and cold faucets and are equipped with plaster traps. (Figure 8)

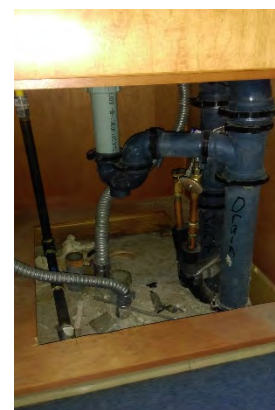
Figure 9 – Science Sink Piping

Science sinks are epoxy resin type with gooseneck faucet equipped with vacuum breakers. Science sinks are fed with non-potable hot and cold water and the drainage is acid resistant polypropylene piping. The drainage is directed to an acid neutralization system. (Figure 9)

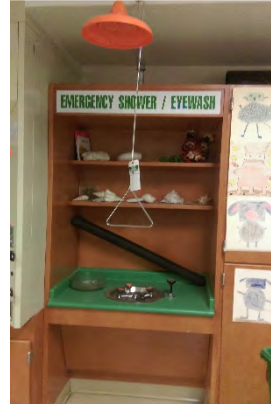
Figure 10 – Emergency Shower/Eyewash

Science classrooms include emergency showers and eyewashes. It appears as though the emergency fixtures are fed with cold water only. (Figure 10)

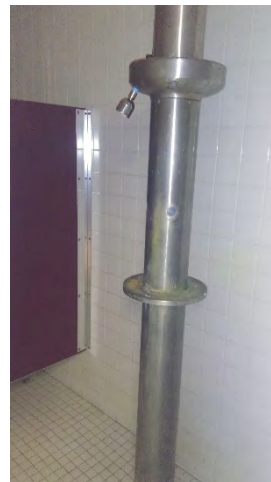
Figure 11 – Shower

Showers include surrounds and tiled floor with floor drains. Individual tempered water supplies feed each stainless steel column type shower heads. The tempered water is delivered from a master mixing valve. (Figure 11) (Figure 12)

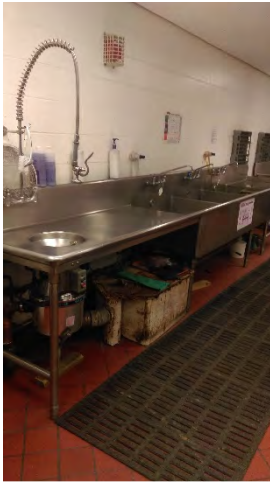
Figure 13– Pot Wash Sink

Kitchen area fixtures are in fair condition. The pot washing sink is piped to a floor mounted grease interceptor. (Figure 13)

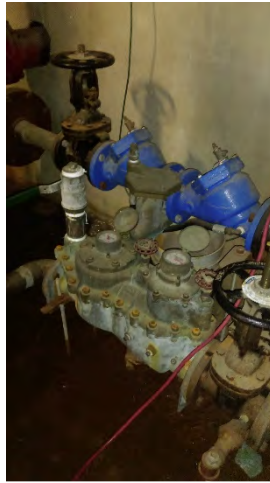
Figure 14– Water Meter

The domestic water service is located in the Mechanical Room. The service appears to be 4" in size and includes a meter. (Figure 14)

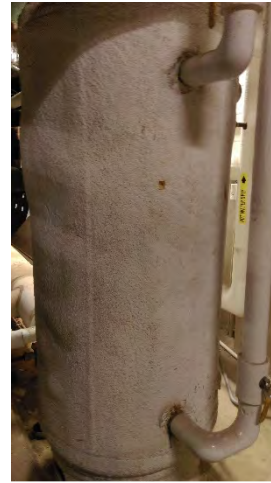
Figure 15 – Domestic Storage Tank

The main building domestic hot water is generated through a gas-fired high efficiency, condensing water heater with auxiliary storage tank. The water heater has a natural gas input of 400,000 BTUH and a water storage capacity of 100 gallons. (Figure 15)

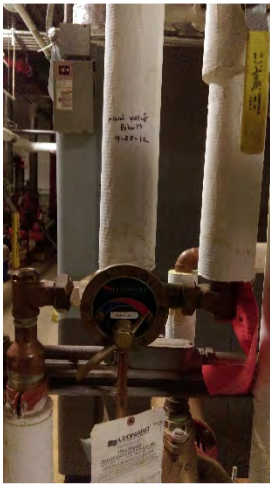
Figure 16 – Mixing Valve

A thermostatic mixing valve is provided for the building domestic hot water system. The domestic hot water system is recirculated. (Figure 16)

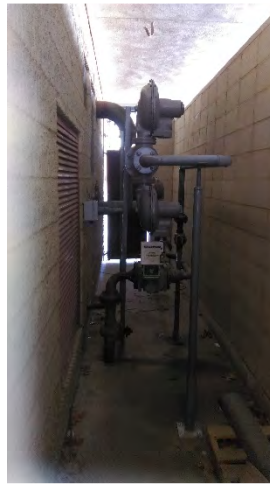
Figure 17 – Gas Service

Building is serviced by an elevated pressure natural gas service. The gas service, regulator, and meter is located outside the Boiler Room. Gas service is 4" in size. (Figure 17)

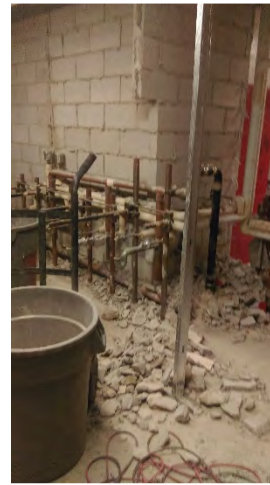
Figure 18 – Drainage Piping

In general, cast iron is used for sanitary drainage. Piping and fittings above slab are no-hub with coupling joints and bell and spigot. Where visible, the cast iron pipe appears to be in fair condition. Smaller pipe sizes appear to be copper for waste. (Figure 18)

1. Plumbing fixtures meet current code for water conservation. However, new high-efficiency low flow fixtures could be installed to reduce water consumption in the Toilet Rooms not being renovated at the time of visit.
2. In general, existing cast iron drainage piping can be re-used if sized appropriately. We recommend video inspection of existing drains to confirm integrity.

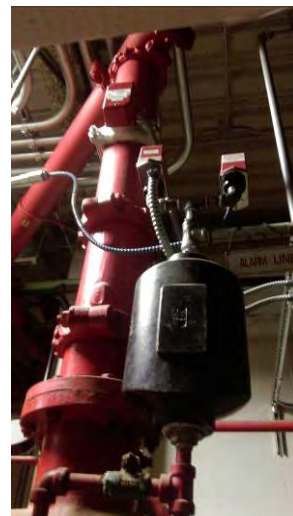
Figure 2 – Dry alarm Check

The system includes a wet alarm check valve and a dry pipe alarm check valve with flow switches. (Figure 2)

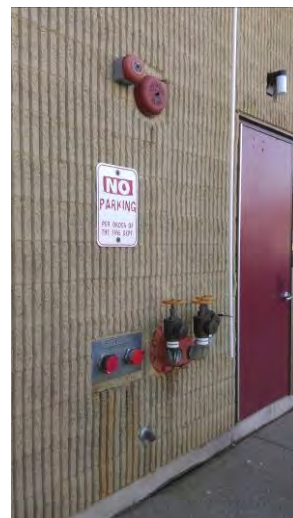
Figure 3 – FDC and Test Header

The Fire Department connection is a Siamese type. A water motor gong and electric bell is located above the Fire Department connection. The 3-way fire pump test header is also located on the exterior wall. (Figure 3)

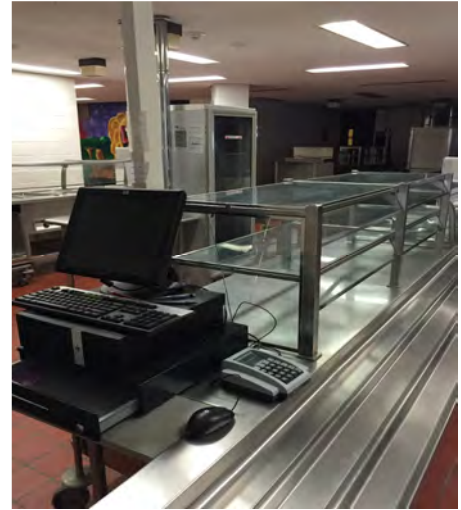
Figure 1

- The glass at the end of the unit is cracked.
- The guards are antiquated and no longer meet the latest standards for sneeze guard protection.

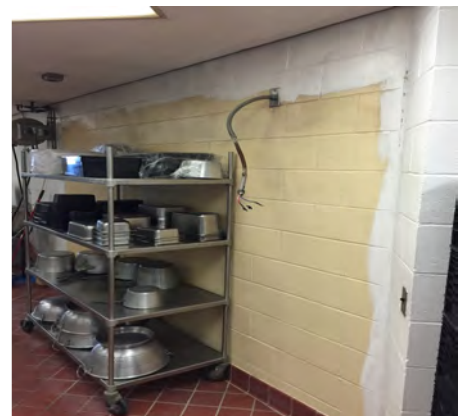
Figure 3

- Adjacent to the storage rack there appears to be a space where a piece of equipment was located. The equipment has been removed and the power for it is still in place. It is not clear if the power feed seen here is still live. If still live this is a hazard and it must be corrected immediately.
