# Harrington Elementary School

## ARCHITECTURAL ASSESSMENT

HARRINGTON ELEMENTARY SCHOOL  
ARCHITECTURAL ASSESSMENT

CHELMSFORD FACILITIES ASSESSMENT

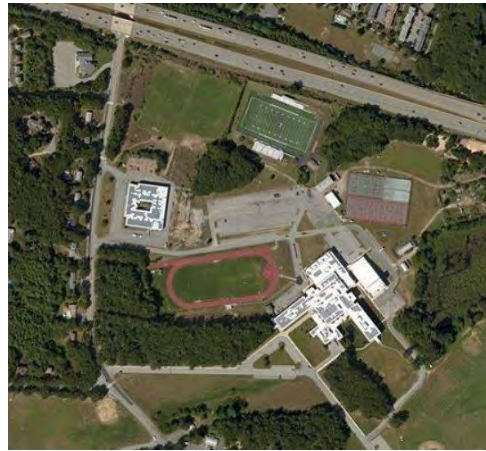
Image 1

The school is located at 120 Richardson Road and was designed by The Architects Collaborative in 1967. (Image 1). The building shares the campus with the Chelmsford High School. Recent upgrades include the mechanical systems and new boilers, window replacement in 2004 and complete reroofing in 2011.

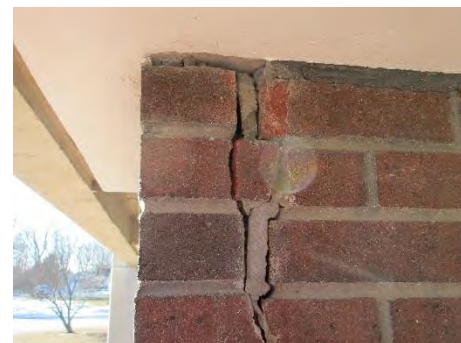
Image 17

- There are several areas of severe cracking on the brick and mortar veneer. (Image 16, 17, 20, & 21). This condition should be investigated further to determine if moisture is getting behind the brick or if other stresses are causing the brick to fail in these areas.

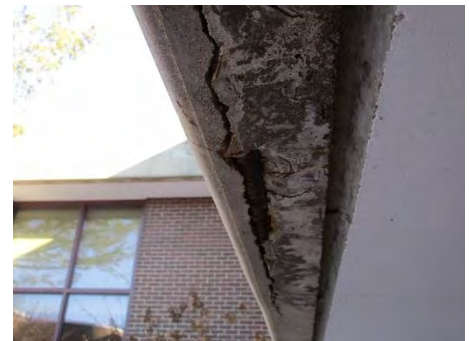
Image 24

- There are a few areas where the steel angle supporting the precast concrete band above the second floor windows is rusting. (Image 24)
- There are several areas where the paint on the soffits are flaking and falling off.

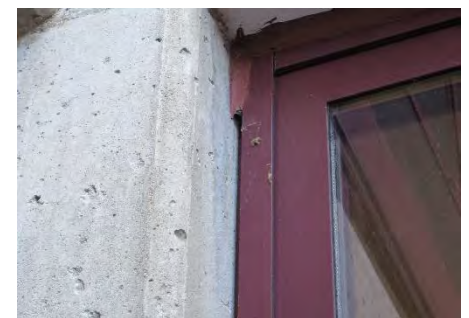
Image 25

- There are window locations where the caulking is missing and the backer rod is exposed or missing. (Image 25)
- Some concrete window sills are cracking

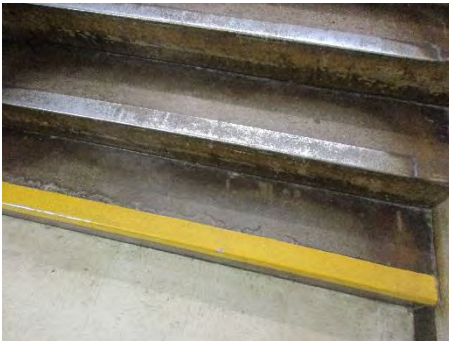
Image 35

- There are areas of cracking and chipping of the VCT flooring around the school. (Image 34).
- The topping on the stair treads is completely worn off exposing raw concrete. (Image 35)

- Remove and replace broken and damaged VCT tiles.
- Remove what is left of the existing topping on the stair treads and install raised rubber tile on the stairs
- Clean all ceramic tile floors and grout joints in bathrooms and kitchen
- Repair chipped and broken floor tiles.
- Replace drain covers as needed.
- Remove non-slip flooring strips in the kitchen and replace with non-slip mats or replace 6x6 tile with quarry tile with a greater slip resistant surface
- Review the cause for the lifting of the VCT tile in the cafetorium. Repair and replace tile.
- Replace stair treads on stairs that lead to the stage area.
- Replace existing stage flooring with a resilient wood flooring system.
- Where walls have been removed grind surface and install flooring to match existing. (image 38)
- Repair epoxy floor surfaces or painted concrete surfaces to protect concrete floors

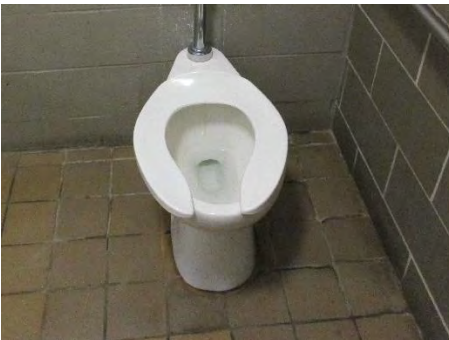
Image 36

- The 6"x6" quarry tile in all the bathrooms is very dirty and the grout joints have become stained. (Image 36). This is typical in all bathrooms.
- Tile around floor drains in restrooms has chipped and broken

- Where walls were removed in restrooms to provide accessibility the flooring is uneven and the flooring material inconsistent. (image 36)
- The non-slip strips that have been added to the kitchen floor near the sink and other wet areas has peeled and is lifting off the floor. These loose strips could cause tripping and the worn strips will no longer function as anti-slip material. (image 39)

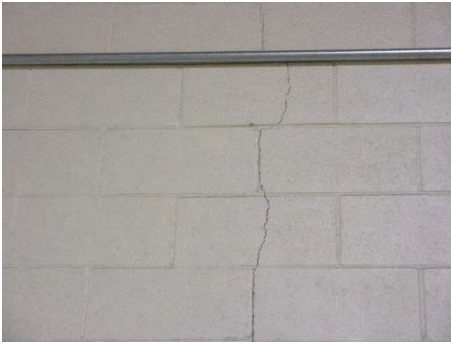
Image 42

- In some of the rooms the cmu walls have severe cracking in the corners or along the face of the cmu wall (Image 42 & Image 43)
- In locations where walls have been removed the wall has not been refinished to match existing.

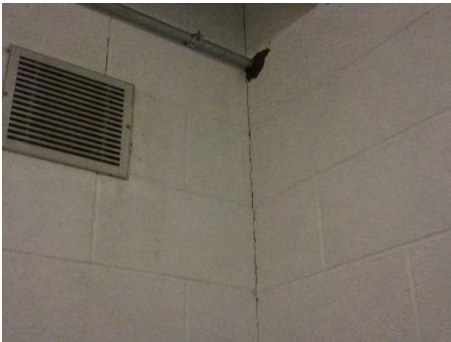
Image 43

- In a few areas in the building there are some separation cracks where poured in place concrete walls meet CMU walls. (Image 43)
- Folding partition walls are in fair condition and not used as operable walls. These walls do not provide the sound separation between classrooms that a permanent wall would have.
- In many locations where pipes penetrate walls or floors the holes have been left open. Where these holes connect occupied spaces to storage areas, or are between the floor and ceiling filling the holes with fire safe materials is required (image 45).
- Improper cleaning methods have left walls stained. This is especially evident at the base of walls and in restrooms

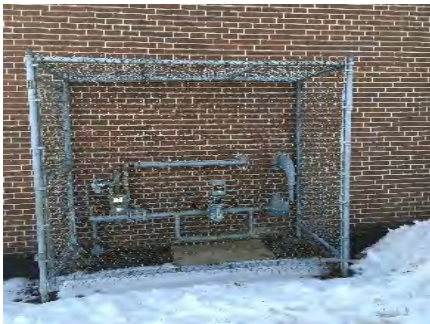
Image 7

There is a gas meter located along the north face of the building near the eastern corner (Image 7).

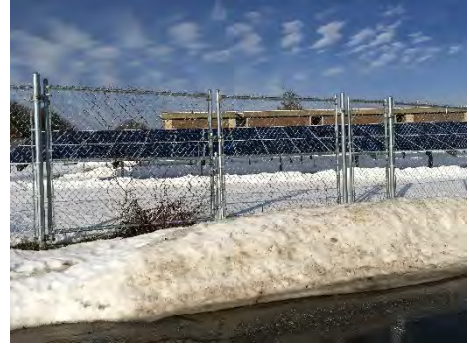
Image 9

Harrington Elementary School along the east face of the building (Image 9).

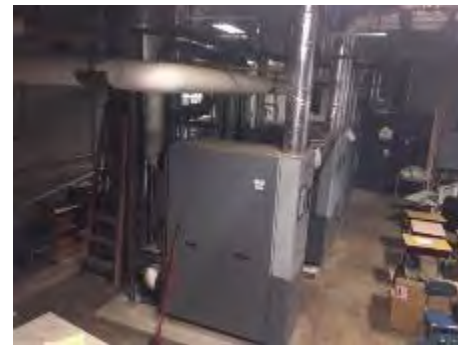
Image 1 – Hot Water Boilers

The Harrington Elementary School is heated by a hot water boiler plant consisting of three (3) gas fired hot water boilers, hot water pumps, accessories, breeching, combustion air ductwork, and controls. The boilers were manufactured by Aerco, with an estimated heating capacity of 1,706 MBH output, and maximum input of 2,000 MBH each. The boilers were installed in 2002 and appear to be in very good condition. The boiler flue gases are vented through the use of a stainless steel breeching through the roof. Combustion air for the boilers is provided through the use of insulated sheet metal vent ducts. (Image 1, 2 & 3)

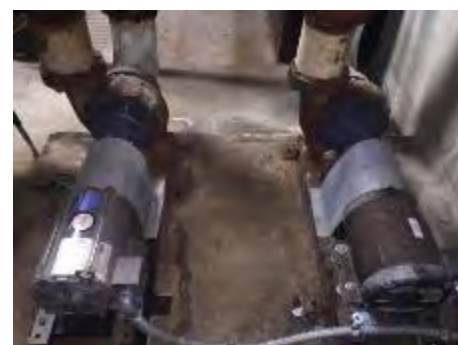
Image 4 – Hot Water Pumps

Hot water is distributed from the boiler to the building heating equipment by a pair of base mounted end suction hot water pumps that are equipped with VFD drives. The pumps appear to have been re-built in recent years with new motors; however, the pumps appear to be nearing the end of their useful service life. The hot water piping and insulation located within the main boiler room appears to be in fair condition. However, the majority of the hot water distribution piping and insulation located throughout the building is original to the building and in fair to poor condition. (Image 4, & 5)

- Existing hot water supply and return piping outside of boiler room should be replaced with new insulated piping.
- Alternatively, existing hot water piping system should be drained and pressure tested and faulty valves and pipe sections should be replaced and insulated. Damaged piping insulation should be replaced.

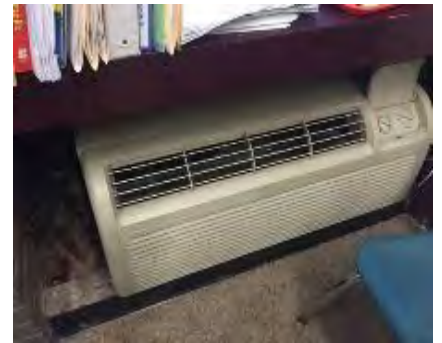
Image 6 – Administration Office PTAC Unit

The offices are heated, ventilated and air conditioned by packaged thru wall air conditioning (PTAC) units with hot water heating coils. The PTAC units appear to be in fair condition. The offices with exterior walls are ventilated naturally through the use of operable windows. (Image 6)

- A high efficiency AC system should be installed to replace the administration PTAC units.
- Mechanical ventilation should be provided for the following interior areas of the buildings: Administration interior offices, Library interior office, and Teacher’s SPED Workroom.
- The ATC system should be further upgraded to replace all remaining pneumatic controls with new DDC controls.

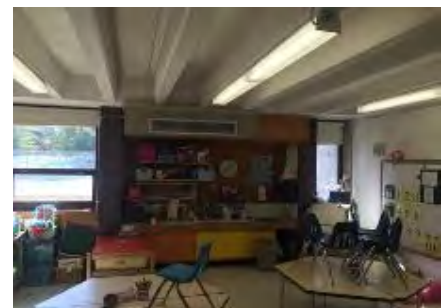
Image 7 – Typical Classroom Unit Ventilator

Ceiling suspended horizontal classroom unit ventilators are utilized for the heating and ventilation requirements of the majority the classroom spaces. The unit ventilators are manufactured by MagicAire and appear to have been recently installed in 2013. There are approximately fourteen (14) unit ventilators located on the first floor and nineteen (19) unit ventilators located on the second floor, for a combined total of (33) unit ventilators. Ventilation air is introduced to each of these units through a wall-mounted louver. Some of the louvers appear to be in need of cleaning, repair, and/or replacement. Each unit is equipped with a hot water heating coil, supply fan and filter. The units are in very good condition. The classroom spaces are provided with exhaust systems to remove any outdoor air that is introduced through the unit ventilators which helps maintain a neutral pressure within the space. Most of the classrooms are served by central roof mounted exhaust fan systems. The majority of classrooms with exterior walls also have perimeter hot water fin tube radiation. The fin tube radiation appears to be originally installed equipment and is generally past its expected useful service life. Some of the fin tube radiation enclosure grilles are damaged and dirty. (Image 7, 8, 9, & 10)

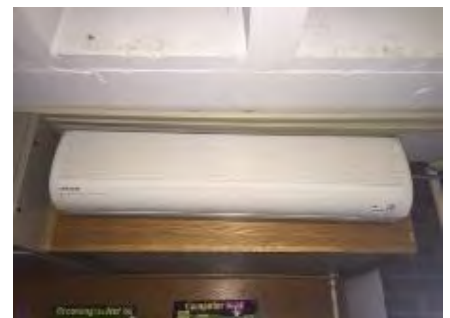
Image 11 – Ductless AC Unit  
(Technology Class Room)

The majority of the building is not air-conditioned. Besides some of the Administration offices, which are served by PTAC units, the technology classroom is served by a ductless split system AC unit. The split system AC unit appears to be have been installed in 2013 and was

manufactured by Sanyo. The unit appears to be in good condition. (Image 11)

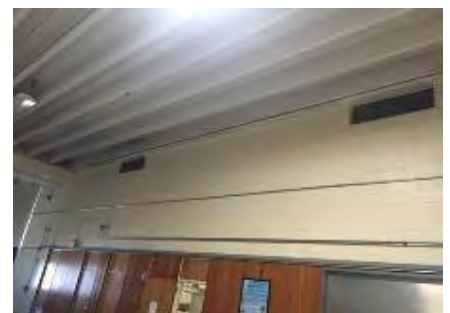
Image 12 – Cafeteria Supply  
Diffusers

be originally installed equipment that is over 50 years old, in poor condition and past their expected useful service life. Galvanized sheet metal ductwork is distributed from the airhandling units to sidewall diffusers in the Cafeteria and ceiling diffusers in the Kitchen. The Cafeteria has low wall return grille and the Kitchen has a kitchen exhaust hood. The kitchen exhaust hood is connected to a roof mounted exhaust air fan. The exhaust air fan and hood appear to be in good physical condition. (Image 12, 13, & 14)

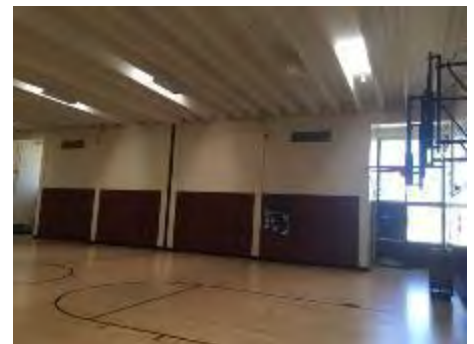
Image 15 – Gym Sidewall Supply Diffusers

The Gym is served by two (2) indoor heating and ventilation units that are located in the adjacent Gym storage room. The H&V units are ceiling suspended units. The units each have a hot water coil, supply fan and filter section and were manufactured by Herman Nelson/American Air Filter. Galvanized sheet metal ductwork is distributed from the airhandling unit to the Gym. Supply air diffusers are located on the sidewall, and low floor return air registers are installed in the gym. The indoor air-handling units and associated ductwork appears to be originally installed equipment that is over 50 years old, in poor condition and past their expected useful service life. (Image 15, 16, & 17)

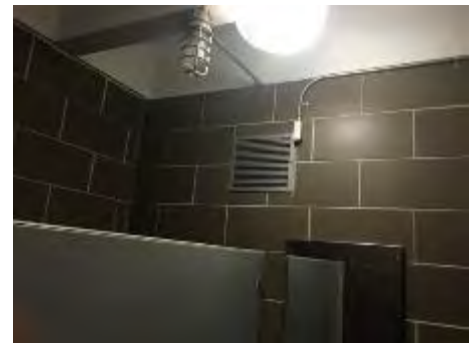
Image 18 –Restroom Exhaust Grille

The restrooms are heated by hot water convector units that appear to be in fair to poor condition. The restrooms are typically exhausted by ceiling or sidewall exhaust air grilles that are connected to exhaust air fans that are located on the Roof. Some of the exhaust air grilles were soiled. (Image 18)

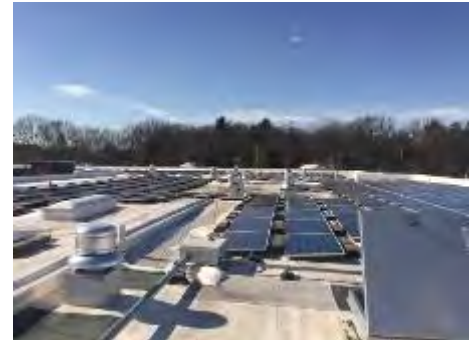
Image 19 – Roof Exhaust Air Fans

The majority of classroom spaces are exhausted through roof mounted exhaust fans. There are also dedicated exhaust fans which are roof mounted for areas such as the gang toilets, kitchen hood, storage rooms and the large group spaces such as the Gym and Cafeteria. These areas utilize a galvanized sheet metal duct distribution system from the space to the roof mounted exhaust fans. There are approximately 34 roof mounted exhaust fans. The majority of the exhaust fans appear to be in very good condition, with most appearing to have been recently replaced. The majority of exhaust fans were manufactured by Loren Cook. The majority of exhaust ductwork appears to be originally installed ductwork that is past its expected useful service life. (Image 19)

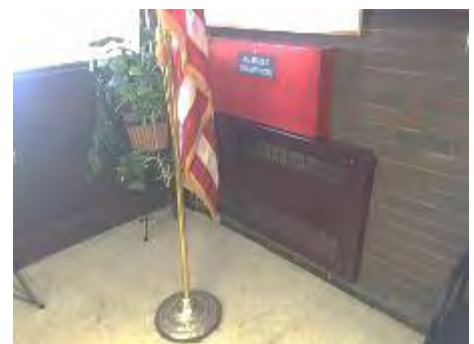
Image 20 – Entryway Hot Water Unit Heater

The main entryways are heated by hot water convector units that appear to be originally installed equipment; some of the unit heaters show signs of corrosion on the cabinets. The majority of corridors are not provided with code required fresh air ventilation. The corridors are heated by a combination of hot water convectors and fin tube radiation that appears to be in poor to fair condition. (Image 20, & 21)

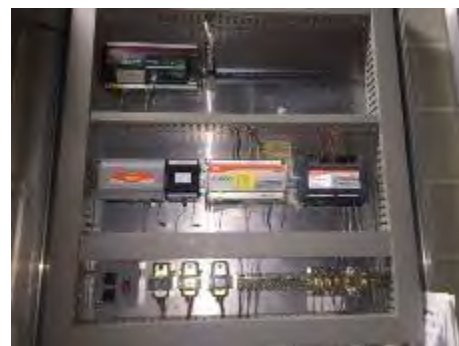
The majority of the building HVAC systems and the heating plant are controlled by a combination DDC (direct digital control) and pneumatic control system. The ATC control system was upgraded during the 2013 HVAC system renovation project. The DDC/ATC system was manufactured by Trend Controls and installed by FMC Control Technologies. The Control system has a DDC (direct digital control) front-end controller, DDC equipment controllers, and network type thermostats. The majority of the renovated heating and ventilation system have DDC controls. However there are still some pneumatic control systems installed for the existing H&V equipment that were not replaced during the recent renovation. The pneumatic compressor appears to be in good condition. (Image 22, & 23)

Image 23 – ATC Controls and Control Panel

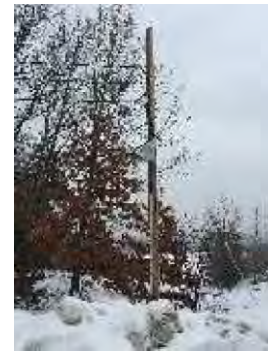
Image 1 — Utility Pole Riser

The service is fed from a utility pole riser on Richardson Road to a utility company owned pad mounted transformer adjacent to the building (Image 1 & 2).

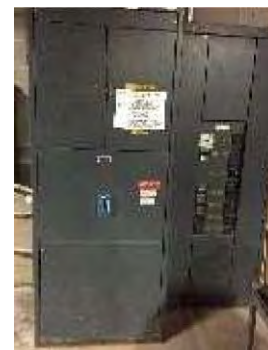
Image 3 — Main Switchgear

A 1,200 ampere, 120/280 volt, 3 phase, 4 wire service serves the building. The main service equipment is located within the building's boiler room. The switchboard consists of a main/C.T. cabinet and a main distribution section, distribution style construction. The equipment is of original vintage and manufactured by General Electric. No ground was observed at the building's main water service, which is a code requirement (Image 3, 4, & 5).

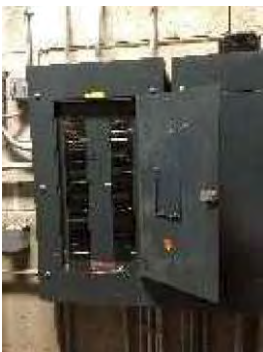
Branch circuit panelboards vary from original General Electric panelboards, that are in poor condition, to recently installed General Electrical panelboards that are in good condition. There has been some additional branch circuitry added throughout the school. New power branch circuits are installed in color coded conduits, "Blue" (Image 6, 7, 8, & 9).

Image 6— Original G.E.P. 8

We recommend replacement of all the electrical systems for this facility under a renovation program.

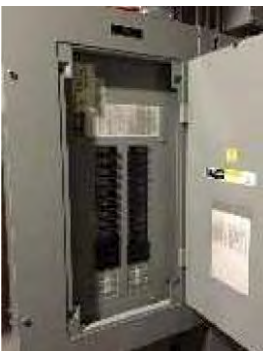
Image 7— Updated G.E.P. 8

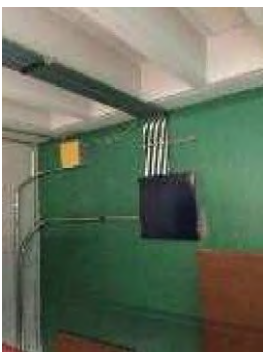
Image 8— New Branch Circuit Install

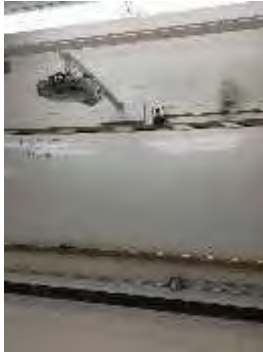
Image 9 – New Receptacles Installed

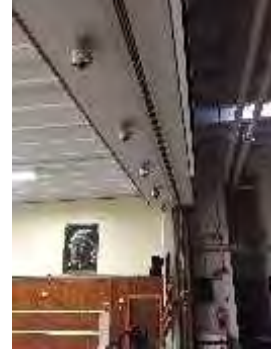
Incandescent track heads are used to light the platform in the cafetorium for performances (Image 13).

Image 13 – Platform Track Lights

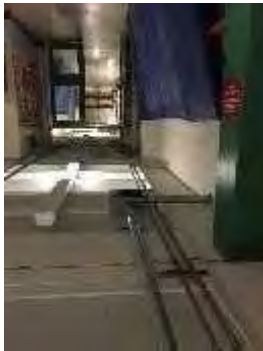
Corridor lighting consists of surface mounted fluorescent fixtures with acrylic lenses and other surface mounted cylinders and sconces. Corridor lighting is controlled via line voltage switches at the ends of the corridor. (Image 10)

Image 10 – Corridor Lighting

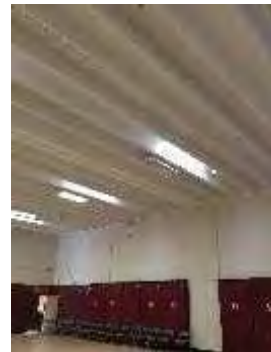
Gym lighting and cafeteria lighting consists of high output, 2x4 fluorescent high bays. Light levels seem adequate. It was noted that one fixture in the gym was not working (Image 12, & Image 14).

Image 14 – Gym Lighting

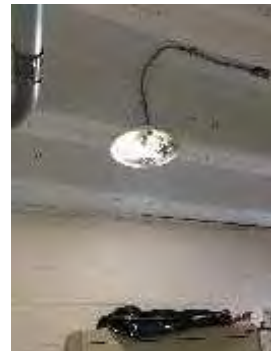
Restrooms contain ceiling mounted fluorescent round fixtures with PLT lamps; many lenses are broken on these fixtures. Light levels in the restrooms are very low (Image 15).

15 – Example of Damaged Lenses

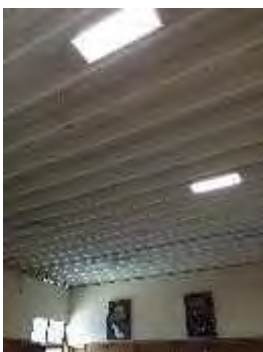
Image 12 – Cafetorium Lighting

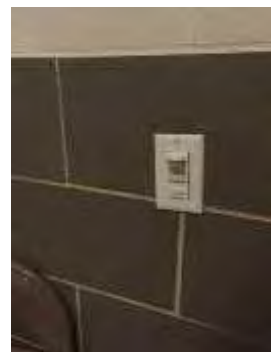
In general, the interior lighting is in poor condition. Most switching has been replaced with switch style occupancy sensors. Multiple rooms were noted as not having received the occupancy sensor switch upgrade (Image 16).

Image 16 – Occupancy Sensor Switch

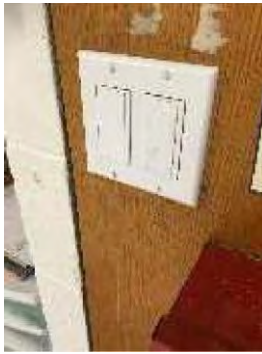
Classroom lighting consists of surface mounted fluorescent fixtures with acrylic lenses. Light levels appear adequate in the classrooms. Each classroom has been equipped with a wireless Lutron occupancy sensor and two low voltage switches that control a line voltage power pack (Image 11, & Image 17).

Image 17—Typ. Low Voltage Classroom Switches

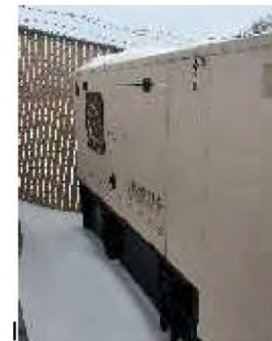
A Caterpillar P110E fired generator, 100 kW, 120/208 volt, in a weather-proof, sound attenuated enclosure is installed adjacent to the building within a fenced in enclosure. The generator feeds an ASCO transfer switch and serves emergency lighting, as well as other loads. The emergency system does not comply with current electrical code as the emergency equipment is not separated from normal equipment (Image 22, 23, & 24).

Image 22 — Generator

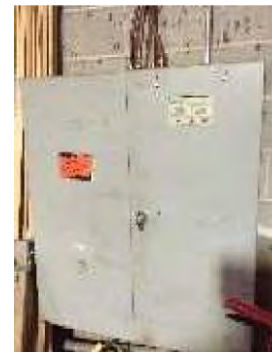
Image 23 — Automatic Transfer Switch

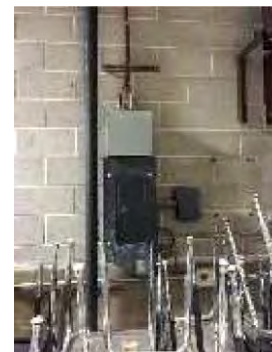
Image 24 — Emergency Panel

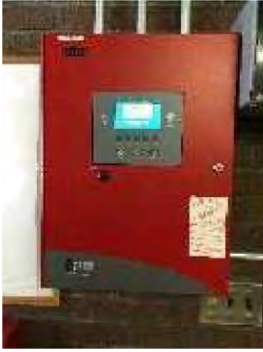
The fire alarm system consists of an addressable FCI S3 Series control panel. The control panel is located in the lobby. Horn/strobes are ADA compliant and located throughout the school. Manual pull stations also seem to be compliant (Image 25, 26, & 27).

Image 25— Fire Alarm Control Panel

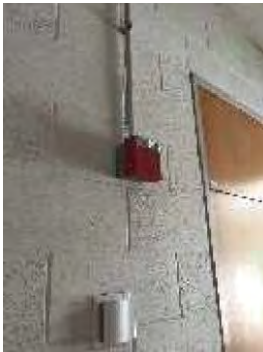
Image 26— Horn/ Strobe

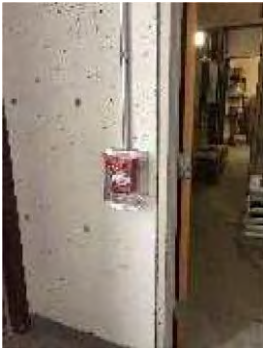
Image 27 - Pull Station

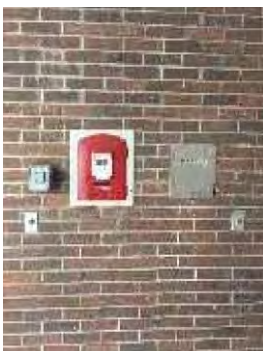
An exterior master box #32 and Knox box are located at the main entrance (Image 28).

Image 28— Master Box & Knox Box

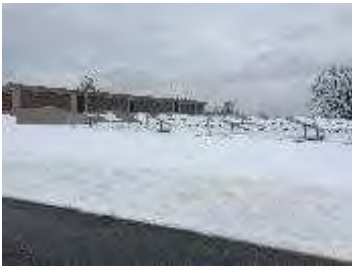
The roof mounted panels are self-ballasted. There are four inverters, selection Model PV175-208, 300 kw system total (Image 29, 30, & 31).

Image 30 – Grade Mounted System

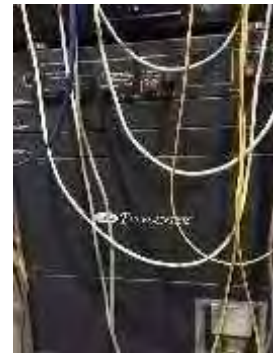
A Rauland tele-center paging system head-end is located in the MDF room. A Valcom paging interface is used to interface the hosted system to the paging system and has been problematic (Image 38).

Image 38 – Paging System

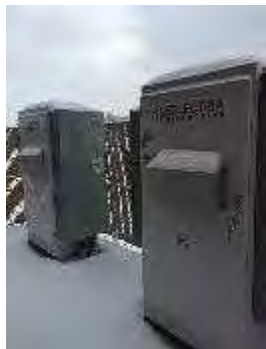
Image 31 – Inverters

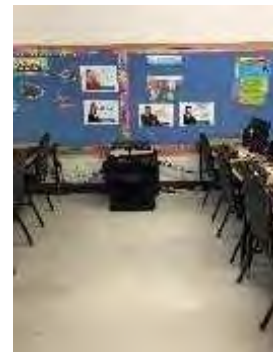
Most classrooms are equipped with A/U control systems for projector, document camera, and computer connections. Each also contains a sound reinforcement system. Projectors are ceiling mount type (Image 32, 39, 41, & 42).

Image 39 – Computer Lab Wiring

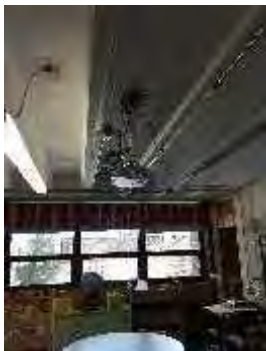
Image 32 – Typical Projector Set-up

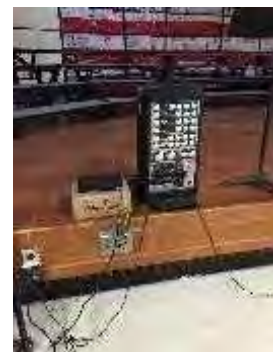
The cafeteria's existing Dukane local sound system is no longer in use. A portable system is used. The portable system is not tied into the fire alarm system which is a code requirement. (Image 40)

Image 40 – Portable Local Sound System

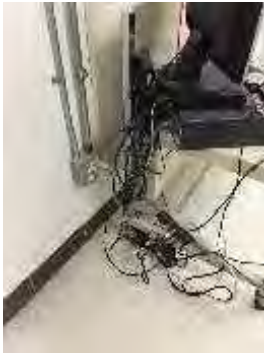
Image 41 – Classroom Data Wiring

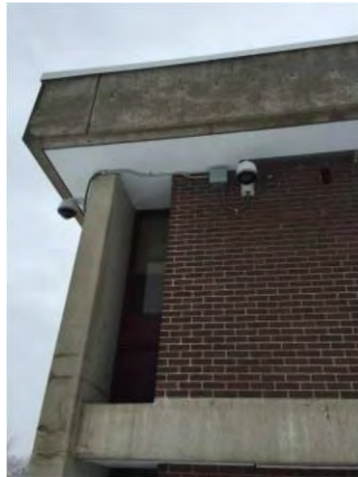
CCTV cameras are located on the exterior covering the building perimeter. They are connected to an S2 video management system; the head-end is located at the central administration office. (Image 45)

Image 45 – CCTV Cameras

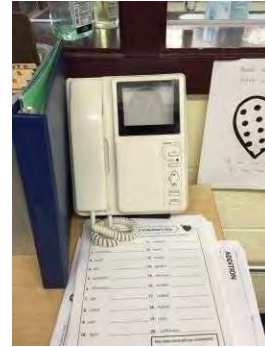
The building contains an Aiphone intercom door communication system at the main entry that is in fair condition. (Image 46, & 48)

Image 48 – Intercom Master Station

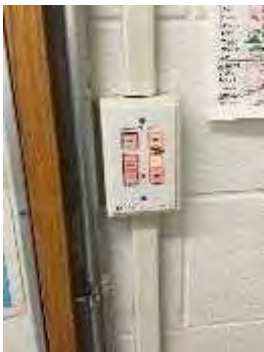
Image 42 – A/U Control System

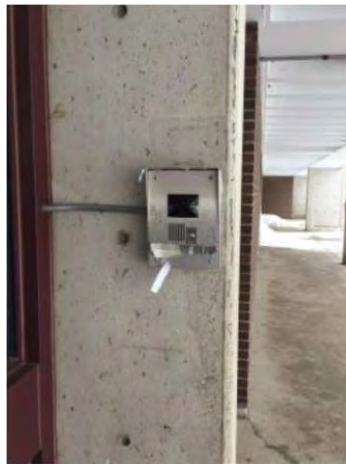
Image 46 – AI Phone Intercom  
at Main Entrance

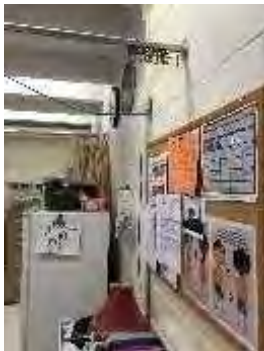
Image 49 – Intrusion System  
Panel

The intrusion system is a Honeywell system and is operational; however, appears to be in poor condition. (Image 47, & 49)

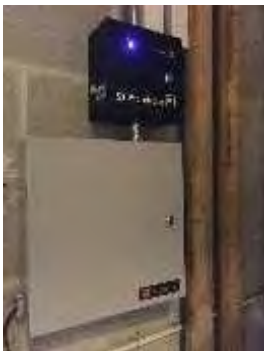
Image 43 – Exposed Data Wiring

A system of surface raceways has been installed to accommodate the various communications cables added over the years. There are numerous locations where communications cables are run exposed. (Image 43)

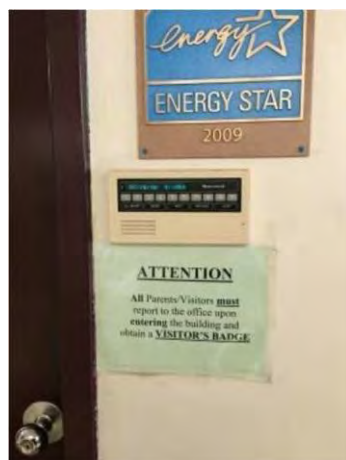
Image 44 – Access Controller

Access control is manufactured by S2 and there are micro-nodes located in the IDF closets to serve the access controlled doors. The system's head-end is located at the central administration office. (Image 44)

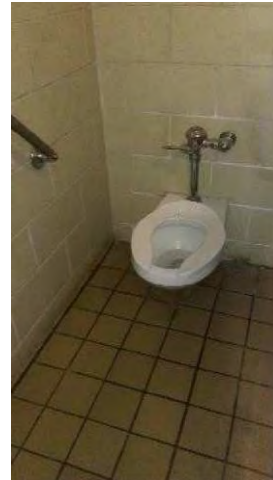
Image 1 — Wall Hung Water Closet

Water closets are wall hung vitreous china with manual flush valves. (Image 1)

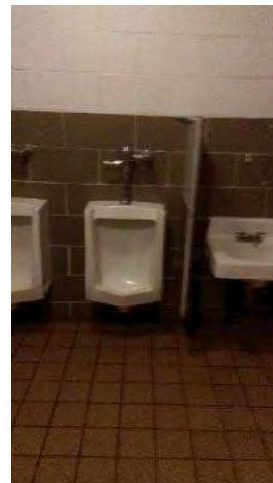
Image 2 — Urinals

Urinals are wall hung vitreous china with automatic sensor type flush valves. (Image 2)

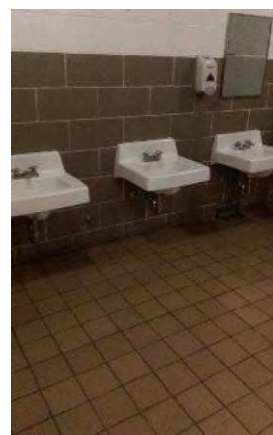
Image 3 — Lavatories

Lavatories are wall hung vitreous china. The lavatories are fitted with hot and cold water faucets (Image 3)

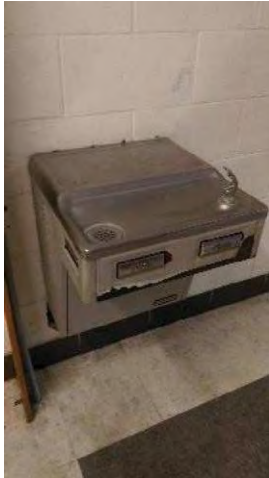
Image4 — Drinking fountain

Drinking fountains are stainless steel surface mounted with chiller. (Image 4)

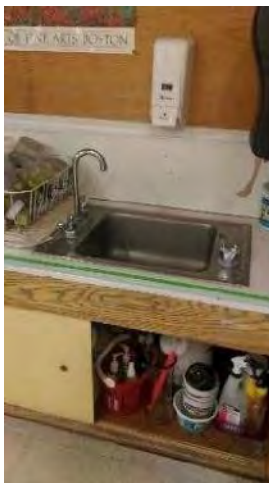
Image5 — College Sink

Classroom sinks are stainless steel drop-in type with hot and cold water faucet with gooseneck. Classroom sinks include a bubbler. (Image 5)

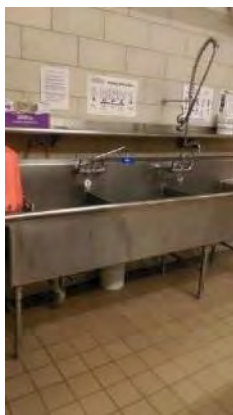
Image 6 — Pot Wash Sink

Kitchen area fixtures are in fair condition. The pot washing sink is not piped to a grease interceptor. (Image 6)

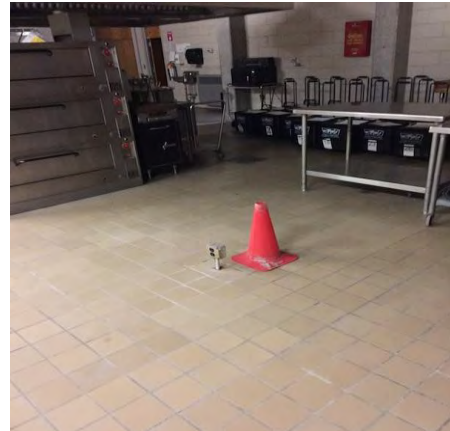
Image 1

Tripping Hazard (Image 1):

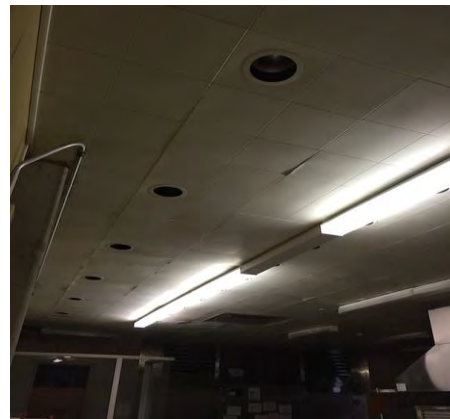
Image 2

The ceilings are not compliant with current health code (Image 2).

Non-compliant Ceilings (Image 2):

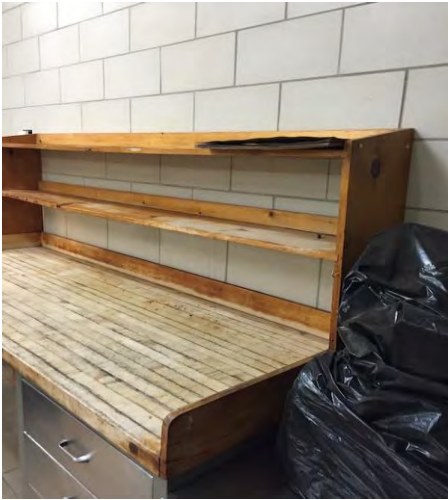
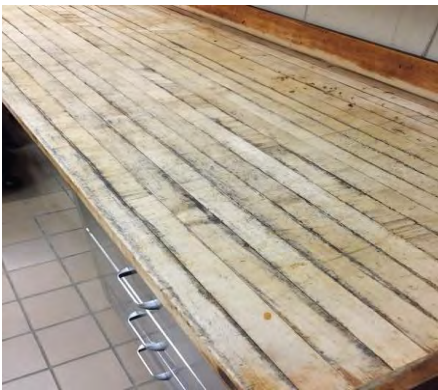
Wood tables (Image 4 & 5):

- Wood topped table can be seen in this image. Wood topped work surfaces are not allowed in a kitchen unless the wood surface is being used as part of a scratch baking program. There is no scratch baking taking place in this kitchen.
- Image 5 is a close up of the table shown in Image 4. Mold can be seen growing where the wood slats are glued together. This kitchen is mainly a warming kitchen so the risk is low, but all wood topped tables should be eliminated to prevent the possibility of contamination.
- The walk-in cooler panels and doors are outdated and inefficient. The condensing units for the walk-in coolers and freezer are located indoors, resulting in noise and heat being rejected into the indoor space. There is visible corrosion on the surface of the walk-in panels.

1. Eliminate all wood surfaces and replace with appropriate stainless steel tables and work surfaces.
2. Add appropriate mobile worktables to provide for additional flexible work surfaces.
3. Redeploy the dish room by eliminating the equipment from the dish room to provide for additional storage so this space can function as needed.
4. Replace the antiquated cooking equipment and exhaust hood to better prepare and cook food at this facility.

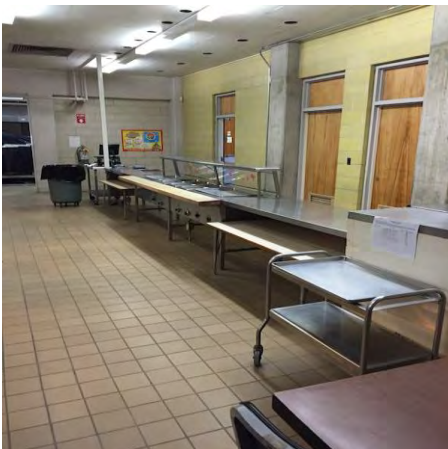
Image 6

Serving line (Image 6):

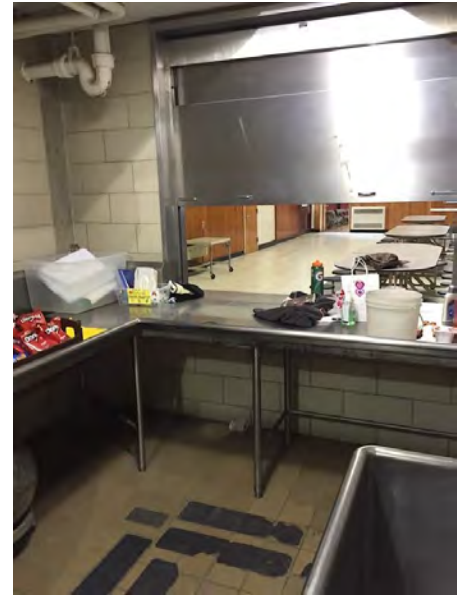
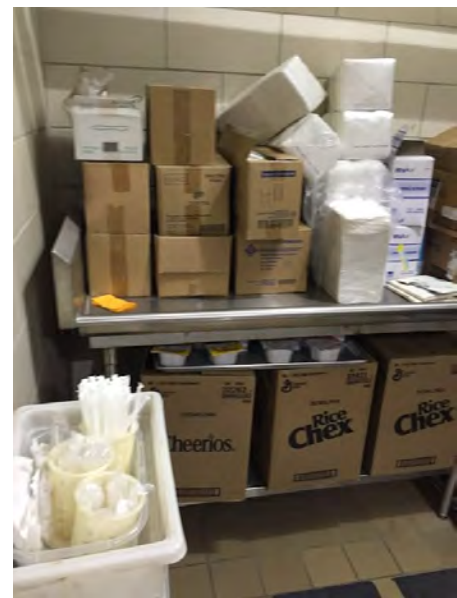
Dish washroom (Image 7 and 8):
