McCarthy Middle School

ARCHITECTURAL ASSESSMENT

The building survey for this report was conducted on February 16, 2016.

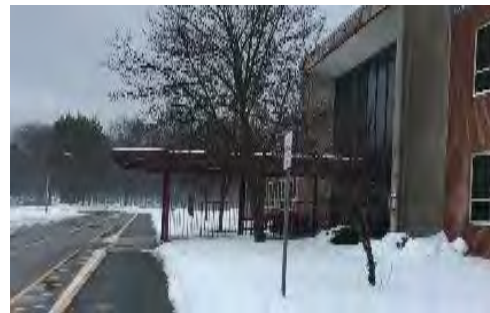
Image 2

The main entrance is handicap accessible (Image 2 and 3). However, due to the bus drop off area accessible parking is not located within the minimum distance of the front door. Accessible parking is provided along the side of the building in several locations with access to different points of the building such as near the cafeteria and gym (Image 4 & 5). Most exterior doors appear to be accessible for exiting. Ramps are located at doors where a transition to grade is required.

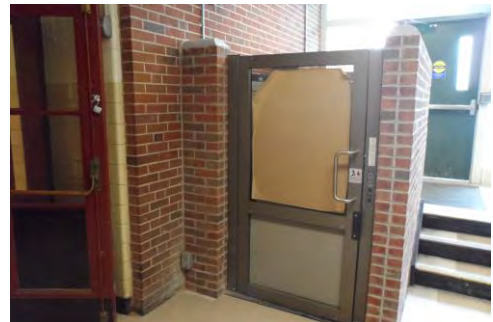
Image 8

The building includes barriers to accessibility, as it does not include an accessible route throughout the building. Several efforts have been made to improve access throughout the building, including a lift at the side entrance near the cafeteria/gym (image 8) and the installation of raised walkway in the hallway (Image 9). Access to other spaces remains non-conforming.

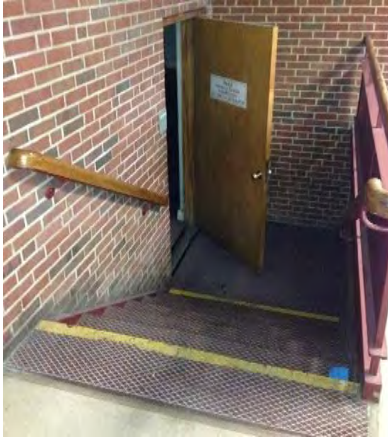
Image 11

The Performing Arts wing is accessible from the exterior however, from within the building a steep non-compliant ramp (Image 10) and stairway (Image 11) are the only means to access this area.

- At stairway to theater remove existing handrail and install new handrails that are compliant for diameter and extensions beyond the top and lowest risers (Image 11).

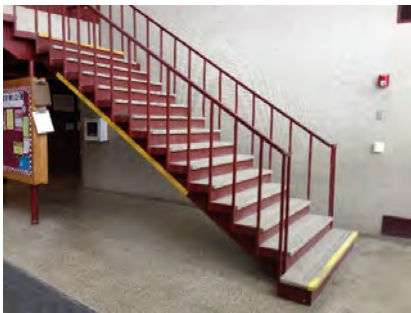
Image 12

- Stairways do not provide handrails and guard rails that meet code. Remove existing handrails and guard rails and install railings with extensions at both the top and bottom of the risers and guardrails that provide less than 4" opening (Image 12).

- Some areas do not provide cane protection. (Image 12) Install barriers to prevent someone from walking into or under the stairway.
- Several drinking fountains do not provide the required space clearance below and are not at the proper height. These fountains should be replaced with drinking fountains that meet accessibility requirements (Image 13).

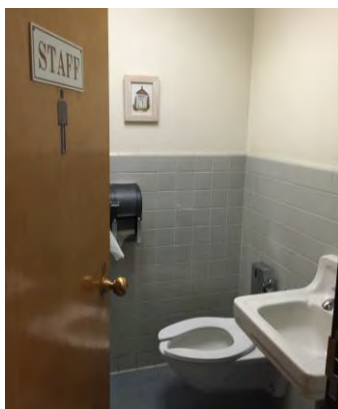
Image 14

- Many areas do not have push / pull clearances that meet accessibility requirements.
- Doors throughout the facility have knob hardware which should be replaced with lever hardware (Image 14)

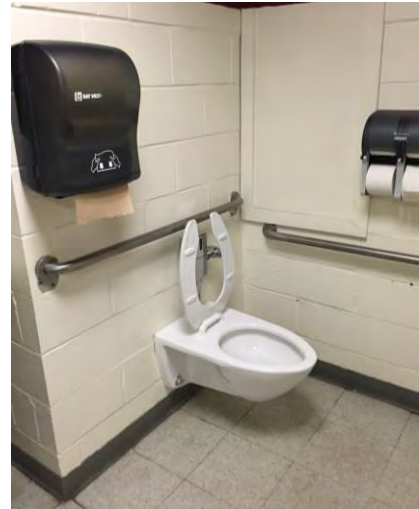
Image 15

- Several restrooms are not fully accessible or do not have accessories located properly (ie. Fixtures are located too high or not located correctly) (Image 15)

- Install new teacher wardrobes
- Install new casework and sinks to meet the current code requirements.
- Reinstall toilet fixtures and accessories to the correct height and install pipe guard under accessible sink.

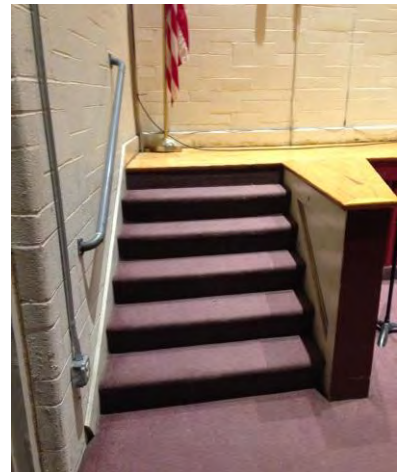
Image 16

- The auditorium stage is not accessible from the auditorium (Image 16). A lift should be installed from the main floor to the stage
- The auditorium control platform is non-accessible to someone in a wheelchair (Image 17).

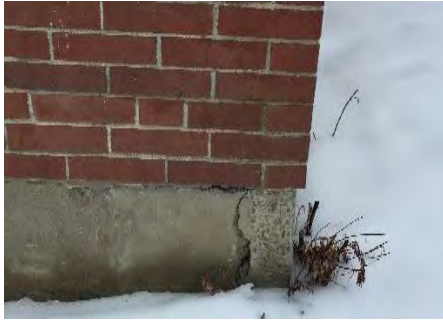
Image 18

- Foundation walls below grade are formed in place concrete that is in good to fair condition.
- Multiple top of foundation exposed corners are in fair to poor condition. One example seen at the Aux Gymnasium northwest corner foundation. (Image 18).
- Some areas around the foundation were parging

- Further investigation is warranted to determine the cause of cracking.
- Review areas of parging

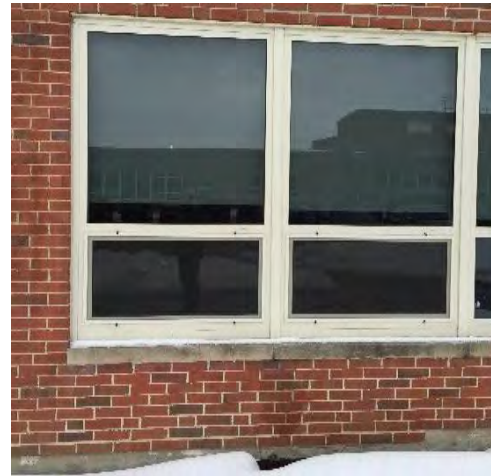
Image 22

- Aluminum-framed awning/fixed windows throughout the school and Library addition are in good condition.
- The sealing at the windows appears to be in fair condition.
- Multiple window precast sills have gaps or cracked mortar. Water runoff from the windows is stained below them (Image 22).
- The Gymnasium clerestory films are damaged or deteriorating (Image 23).

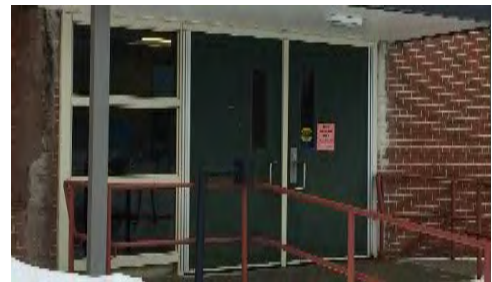
Image 24

- Hollow metal doors throughout the school and Library addition are in good condition (Image 24).

- Aluminum-framed louvers throughout the school are in fair condition. Areas with brick sill have gaps or cracked mortar. Water runoff from the louver is stained below them (Image 24).

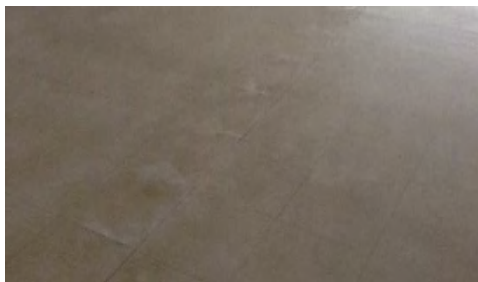
Image 28

- Corridor stairs have metal treads in fair condition. Corridor ramp slip resistant membrane is worn and only has plywood membrane surface (Image 27).
- Classrooms, offices, and cafeteria have VCT generally in fair condition. VCT in the Art/Band classrooms appear to be newer, however there are seams and tiles that are popping or separating (Image 28).

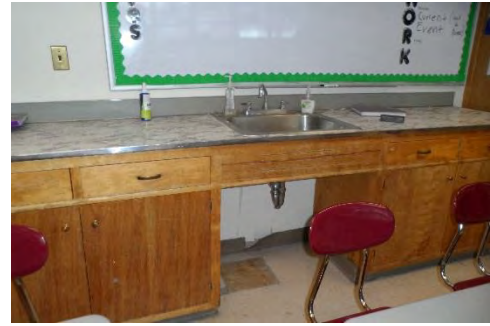
Image 35

- Teacher wardrobes are in fair condition (Image 34).
- Casework with counters and sinks in classrooms are in fair condition. Cabinets are delaminating and laminate countertops are lifting. These counter areas do not meet current accessibility code (Image 35).
- Toilet rooms in the locker room areas did not meet current code accessibility requirements for minimum heights. Accessories are mounted too high to meet current accessibility code requirements. Compliant under-sink protectors are not installed (Image 36).
- Locker room benches didn't allow proper width for accessibility requirements in current code. No accessible bench with fixed back was noted. Showers did not have accessible controls per current code requirements (Image 37).
- Designated accessible lockers are required in both locker rooms and in the general corridors.

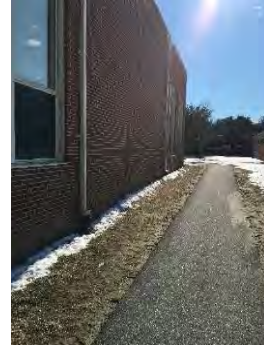
Image 1

Stormwater runoff from the roof of the building appears to be collected in downspouts on the building that discharge to a below grade closed drainage system (Image 1). Stormwater runoff from the paved parking lots to the north and south of the building is collected in catch basins (Image 2). The catch basin appear to discharge through a headwall into the stream adjacent to the site, however, it is also possible they drain to the drain main in North Road.

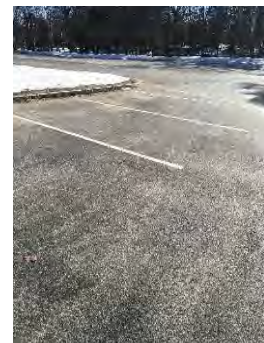
Image 3

Two fire hydrants were observed on site. One of the hydrants was in the parking lot to the south of the school and the other was to the east of the school along North Road. A water valve was observed next to the building along the south east face in the parking lot (Image3). Water may enter the building at this corner.

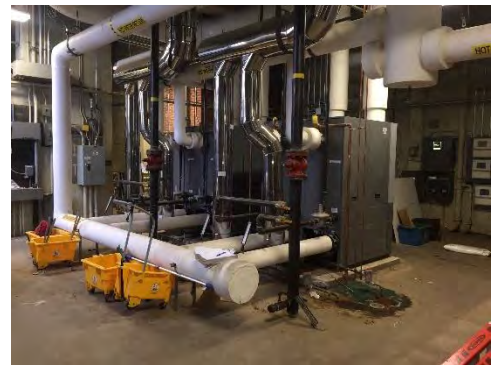
Image 2 - Condensing Boilers (Rear)

There are four (4) gas fired condensing boilers manufactured by Aerco, model Benchmark 2.0, each with an input capacity of 2,000 MBH and a gross output of 1760 MBH. (Image 1 & 2) These four boilers were installed in 2006 and are in excellent condition. Each boiler is provided with dual low water cut-offs and all operating and safety controls. The boilers are sequenced from an Aerco boiler management system controller. There are no motorized isolation valves at each boiler, which allows system return water to circulate through idle boilers and mix with the hot water coming out of the active boilers. This mixing reduces overall system water supply temperature, which makes the overall heating plant less efficient. Hot water expansion is handled through the use of two 600 gallon vertical style expansion tanks which are insulated. There is also a five gallon chemical shot feeder in the system for chemical treatment of the piping system. The heating system is designed to run on 30% propylene glycol for freeze protection. The heating hot water piping itself is schedule 40 black steel and is insulated with fiberglass insulation. One vent serves two boilers. These two stacks exit the building separately and are both constructed of double wall stainless steel. This breeching system penetrates the roof within the mechanical room. Combustion air is brought into the boiler room through two wall mounted louvers, with a high opening and a low opening that terminates 2 ft above the floor. The openings are dampened using electric actuators. In addition, combustion air is directly ducted to each boiler from a common roof mounted intake vent. The boiler room is ventilated by a roof mounted fan. The boiler room is heated via a vertical and a horizontal

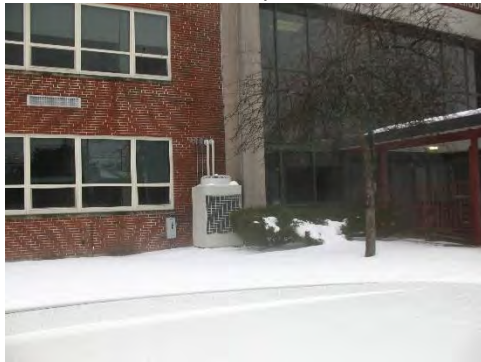
Image 8 – Library RTU

The library is served by a 17.5 ton constant volume roof top unit, which consists of a supply and exhaust fan, filter section, gas furnace and direct expansion cooling coil (Image 8). This roof top unit is associated with a galvanized sheet metal duct distribution system which delivers and returns the conditioned air to and from the spaces via ceiling diffusers and grilles. The unit delivers a mixture of outside air and return air, which is then conditioned through the unit's gas furnace or DX cooling coil. The library is broken into 3 temperature zones – north exposure, south exposure and center/clerestory. Duct mounted hot water coils further heat/reheat the tempered air being supplied by the rooftop unit. Hot water slopetop baseboard radiation is run along the perimeter of the library as supplemental heat. The fresh air damper at the rooftop unit is controlled by CO2 sensors in the space to match fresh air damper ventilation settings with actual room occupancy

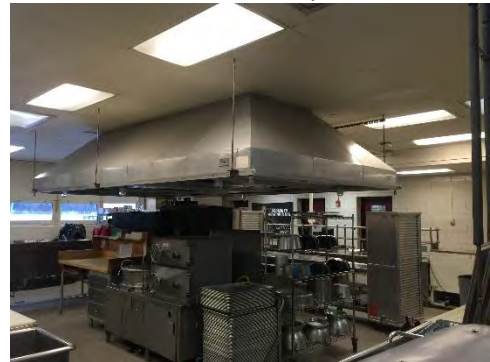
Image 12– Kitchen Unit Ventilator

The kitchen functions as a warming kitchen. The hood has no Ansul fire suppression system. The hood has an interior panel with adjustable slide gates to adjust airflow through the slide gate openings. (Image 10 & 11) Partial make-up air is supplied via a wall mounted vertical unit ventilator which draws in fresh air through a high louver. (Image 12) The remainder of the hood make-up air is transferred from the cafeteria via open doors/transfer grilles. The kitchen offices are heated by slopetop baseboard radiation. The offices are ventilated by a ceiling exhaust register.

- Install a variable speed demand control kitchen hood control system. This system monitors the heat and smoke given off by cooking processes and adjusts hood airflow to compensate. When little cooking is taking place, the hood runs at reduced airflow, saving energy.

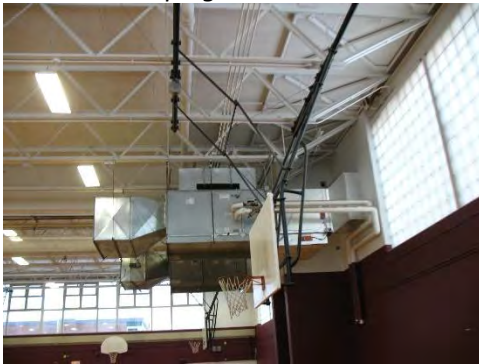
Image 15– Slopetop Radiation at Gym Clerestory

The main gym is served by two 6800 CFM Trane indoor air handlers, hung exposed from the gym ceiling, free blowing supply air into the gym (Image 14). These air handlers consists of a supply fan, filter section, hot water coil, and face and bypass dampers with external bypass. Each air handler draws in ventilation air through a wall louver located at the rear of the unit while return air is drawn in from the bottom of the unit. The unit delivers a mixture of outside air and return air, which is then heated through the hot water coil. The gym is provided with economizer cooling, which uses cool outdoor air to provide cooling during moderate weather. A roof mounted exhaust fan, tied into low wall mounted grilles, provides exhaust and economizer relief. The fresh air damper at the air handler is controlled by CO2 sensors in the space to match fresh air damper ventilation settings with actual room occupancy.

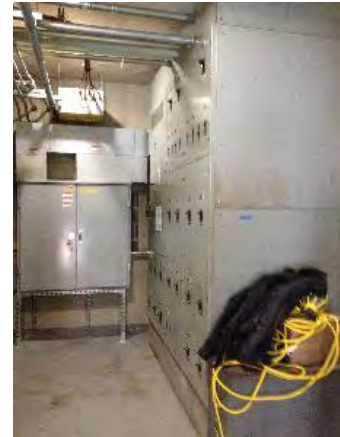
Image 1 – Main Switchboard

The primary service runs underground into a vault mounted transformer behind Receiving. Secondary service consists of a bus duct between the transformer vault and a 2,000 ampere, 120/208 volt, 3 phase, 4 wire switchboard. The switchboard has a pringle fused main disconnect switch. The two distribution sections consist of breakers.

1. Provide new pad mounted transformer to replace existing vault transformer.
2. The original FPE switchgear is in poor condition, generally full and should be replaced. The existing feeders and branch circuits would be refed from the new switchgear.

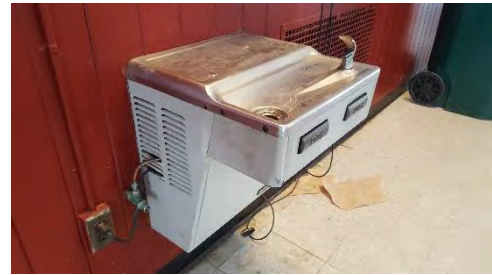
Image 5 – Drinking Fountain

Drinking fountains are a mix of stainless steel wall mounted push bar type and recessed vitreous china push button type (Image 5 and 6).

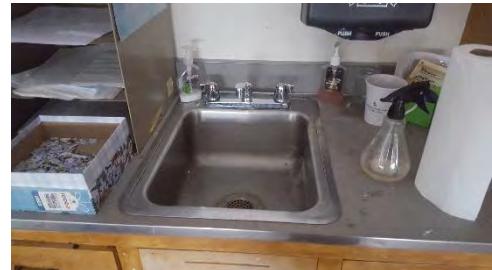
Image 7 – Classroom Sink

Classroom sinks are counter mounted stainless steel with hot & cold water handle faucets (Image 7).

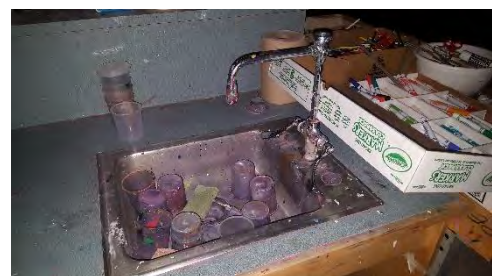
Image 8 – Art Sink

Art sinks are counter mounted stainless steel with hot & cold handle faucets equipped with a vacuum breaker and thermoplastic trough style sink with (2) wall mounted faucets. Art sinks are equipped with sediment traps. (Image 8, 9, & 10).

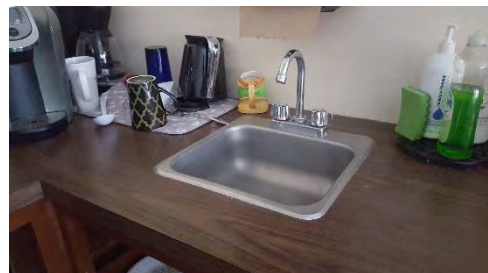
Image 11 – Teacher's Lounge Sink

Teachers' Lounge sink is a counter mounted stainless steel sink with hot & cold water handle faucet (Image 11).

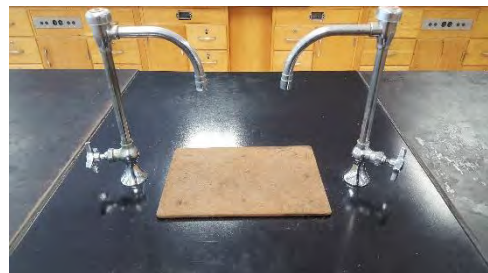
Image 12 – Science Sink

Science sinks are epoxy resin type with gooseneck faucet equipped with vacuum breakers. Sinks are not equipped with acid neutralization tanks or collection system (Image 12).

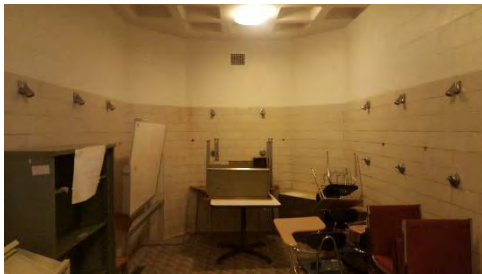
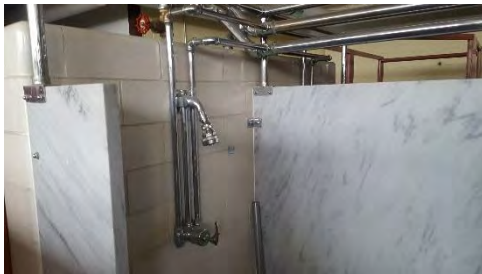
Locker room showers are surface mounted with metering shower valves. Water supply temperature to showers is controlled by master mixing valve located in recessed cabinet in locker area. Shower is no longer in use and is now utilized for storage (Image 14 & 15).

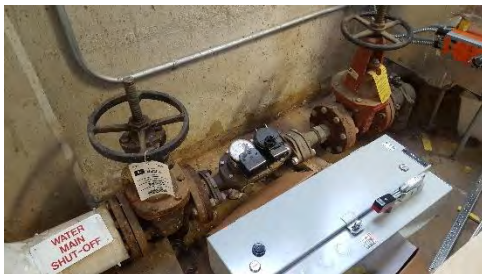
Image 17 – Domestic Water Service & Meter

The domestic water service is located in the Mechanical Room. The service appears to be 4" in size and includes a meter (Image 16).

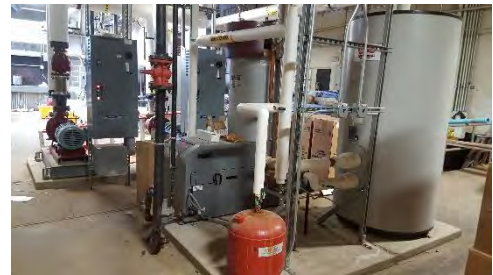
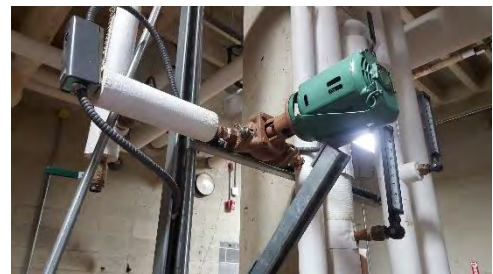
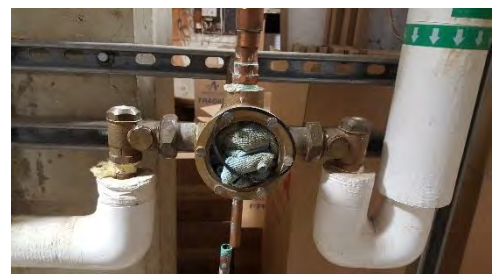
The building domestic hot water is generated through a gas-fired water heater. The water heater has a gas input of 1,000,000 BTUH. Hot water is stored in a 320 gallon tank. The hot water system is recirculated but the master mixing valve is not working (Image 17, 18, 19).

1. We recommend video inspection of existing drains to confirm integrity and correct pipe invert.
2. Provide new high-efficiency gas-fired domestic water heater once the existing water heater has expired.
3. Install new mixing valve.
4. Inspect hot water expansion tank for corroded fitting and leaks.
5. Provide reduced pressure backflow preventers at Janitor's closet soap dispenser.
6. Paint gas piping exposed to exterior.

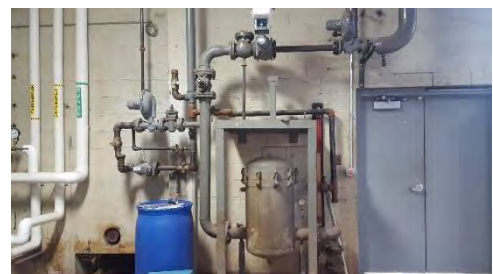
Image 20 – Gas Service & Meters

Building is serviced by natural gas. The gas meter is located along exterior of building. Gas service is 4" in size (Image 20).

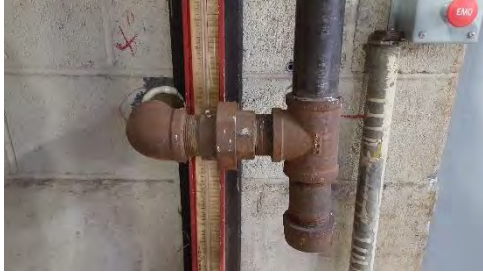
Image 18 – Gas Piping

Gas piping is black steel with either welded or threaded joints depending on pipe size (Image 21).

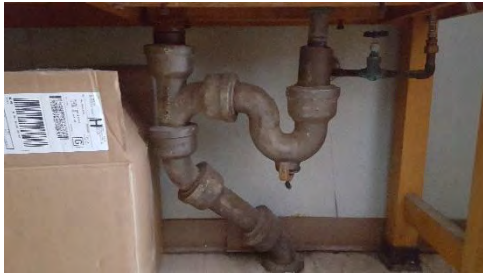
Image 19 – Cast Iron Sanitary Piping

In general, existing cast iron drainage piping can be re-used if sized appropriately. We recommend video inspection of existing drains to confirm integrity.

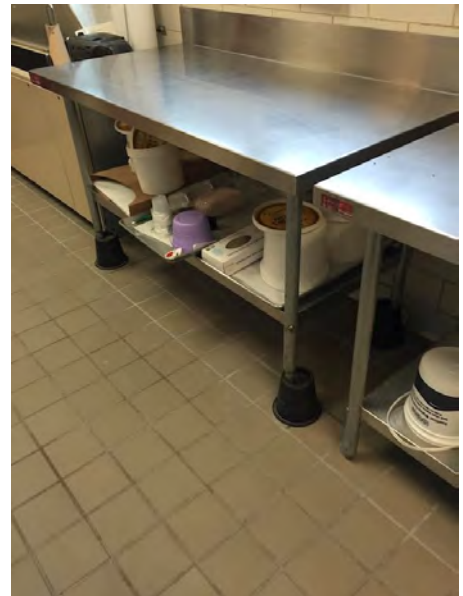
Image 4

- Wood topped table can be seen in this image. Wood topped work surfaces are not allowed in a kitchen unless it is being used for scratch baking purposes. There is no scratch baking taking place in this kitchen.
- Image 5 is a close up of the table shown in Image 4. Mold can be seen growing between where the wood slats are glued together. This kitchen seems to mainly be a warming kitchen so the risk is low but all wood topped tables should be eliminated.

1. Eliminate all wood surfaces and replace with appropriate stainless steel tables.
2. Add appropriate mobile worktables to provide for additional flexible work surfaces.
3. Add hand sink to provide for hand washing stations.
4. Replace the antiquated cooking equipment and exhaust hood to better prepare and allow more cooking at this facility.
5. Supply a new hood and fire suppression system for code compliance and for tie in to the building fire alarm system.
6. A targeted refit of foodservice equipment for this kitchen is estimated to cost approximately \$210,000.
