Parker Middle School

ARCHITECTURAL ASSESSMENT

The building survey for this report was conducted on February 17, 2016.

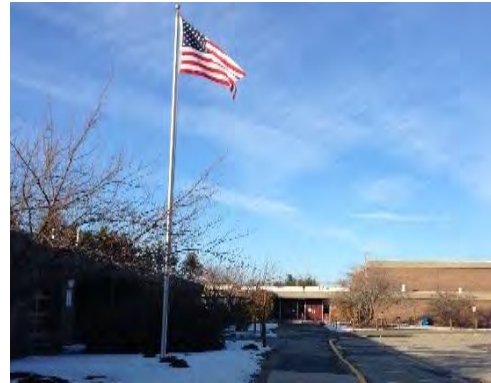
Image 1

There is a large parking area with designated accessible parking spaces located near a rear entrance, and two accessible parking spaces are located and on an accessible path to the front door (Image 1). The front entrance provides a ramp with handrails for accessibility (Image 4).

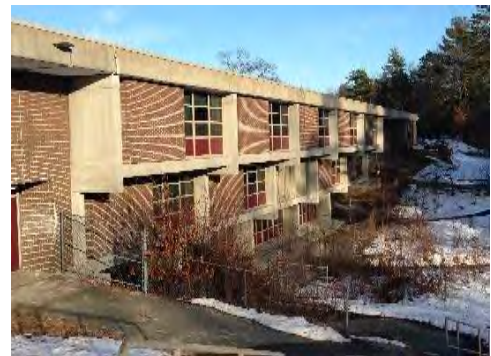
Image 2

Due to the steeply sloped landscape there are many areas and pathways around the building that are not accessible (Image 2 - 3). An enclosed lift provides access from the main level into the inner courtyard space and paved pathways provide access to areas within the courtyard (Image 5).

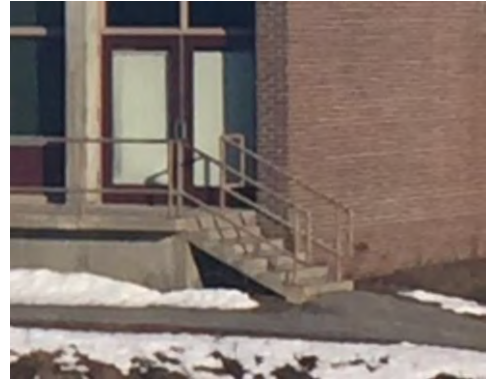
Image 6

Many stairway handrails around the exterior of the building do not provide the proper handrail extensions (Image 6 & 7).

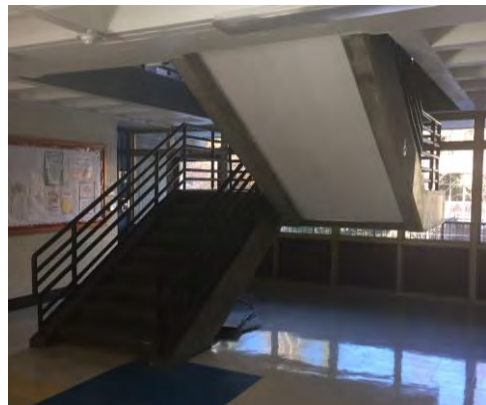
Image 8

The building includes barriers to accessibility, as it does not include an accessible route throughout the building. The ground level north and south classroom wings at the main building are only reachable by stairs or by exiting and reentering the building through the courtyard. The installation of elevators is required to connect these lower level floors to the main level (Image 8).

The stair way connecting the main level and the lower levels do not provide the correct handrail extensions or the required “cane detection” to prevent a visually impaired person from hitting their head on the stair riser or landing (Image 8).

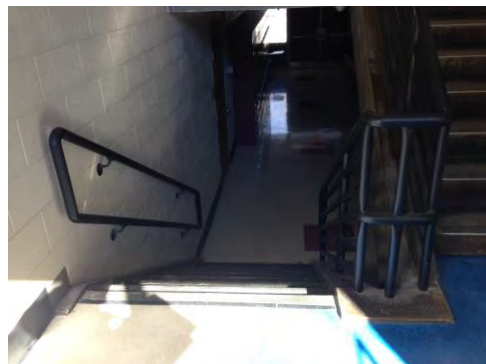
Image 9

In general, the handrails at each of the interior stairways do not meet the ADA / MAAB requirements (Image 9).

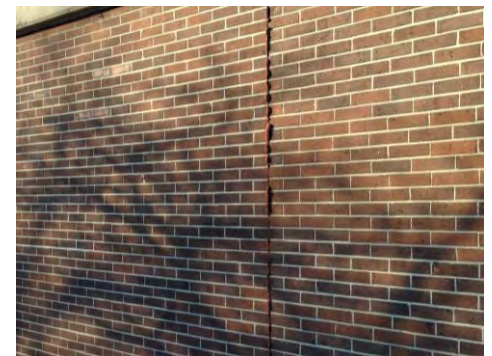
Image 16

- Exterior walls are mostly brick veneer w/CMU backup in fair condition. Some brick are showing moisture and sever cracking in contained areas (Image 14 & 15).
- Control joints are in fair condition throughout the school. Boy's Locker Room uneven brick settle with ruptured joint (Image 16).
- Some precast concrete cantilevers are spalling and exposing rebar (Image 17).
- Pod classrooms are wood/vinyl cladding and are in fair condition. Some cladding is falling off the structure (Image 18).

- Remove debris from weeps to allow proper ventilation and drainage from wall cavity.
- Further investigation is warranted to determine the cause of brick cracking.
- Repair/install a new control joint.
- Where precast cantilevers are spalling remove all the loose concrete and then patch to match profile of the cantilever.
- Re-install cladding at pod classrooms.

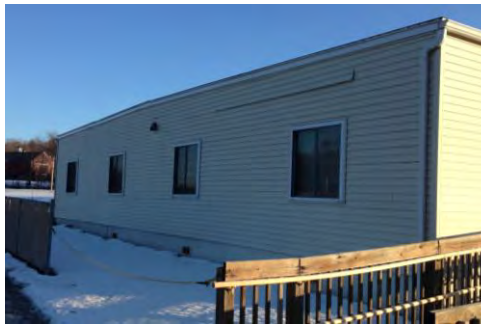
Image 18

The louvers are a combination of aluminum fin construction and simple steel mesh construction. There are vents and openings around the building that are in fair to poor condition and some have become nesting areas (Image 18).

- Clean and repair vents and louvers.

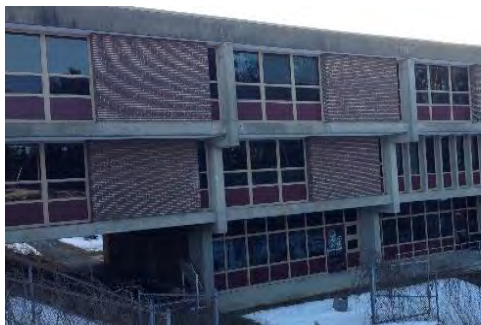
Image 19

- Aluminum-framed hopper/fixed windows throughout the school and Library addition are in good condition. The sealing at the windows appear to be in good condition (Image 19).

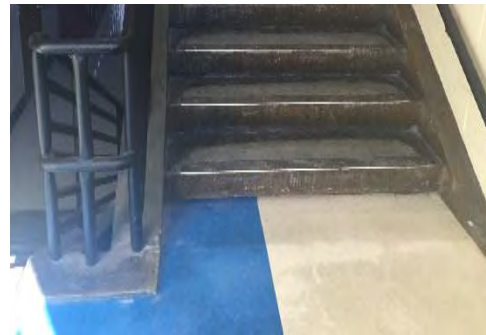
Image 22

- Sports resilient flooring system in gymnasium is in good condition.
- Corridors in original building have VCT floors in fair condition.
- Corridor stairs have metal treads in fair condition. Stairs do not have slip resistant membrane (Image 22).
- Classrooms, offices, and cafeteria have VCT generally in fair condition. Some classrooms VCT seams and tiles are popping or separating (Image 23).
- Toilet rooms have porcelain tile in fair condition.

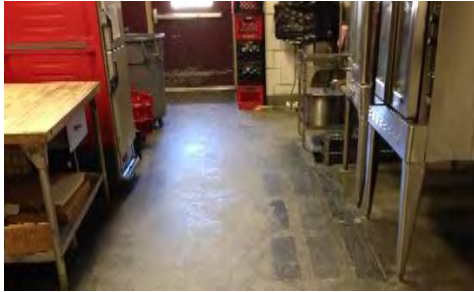
Image 24

- Locker rooms and athletic offices have sealed/painted concrete in fair condition.
- Library carpet is generally in fair condition.
- Custodial closets and storage rooms have sealed/painted concrete in fair condition.
- The kitchen and serving area are exposed concrete with no slip-resistant flooring (Image 24).

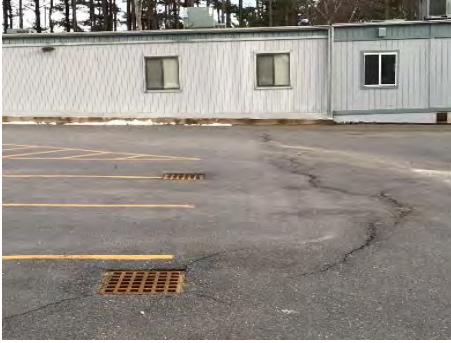
Image 5

The modular buildings are drained by downspouts that discharge at grade (Image 4). There was an addition constructed at the school in 2005. Stormwater runoff from the roof of the addition is collected in downspouts and piped underground to two drywells (Image 5). Stormwater runoff from the rest of the roof is likely collected and discharged into the stream.

The two drywells on site are located in a parking lot on the west side of the building (Image 5). Stormwater runoff from the parking lot and driveway entrance are collected in catch basins and piped to the drywells for recharge.

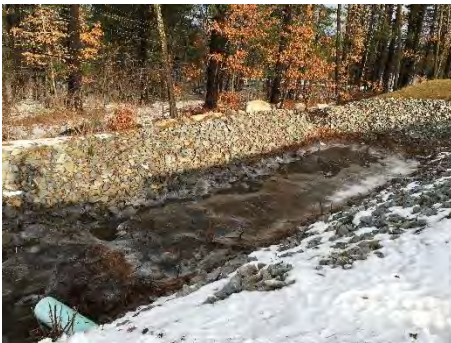
Image 6

Stormwater runoff from the parking lot along Crooked Spring Road is collected in catch basins and directed to a bioretention basin located between the parking lot and the wooded area (Image 6). The bioretention basin appears to overflow to the wooded area.

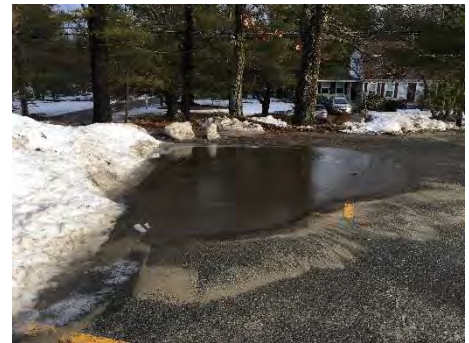
Image 10

The asphalt pavement within the site is in generally fair condition with some areas of cracking and degradation (Image 9). There is some accumulation of sediment in paved areas onsite and some areas of ponding/icing (Image 10 & 11).

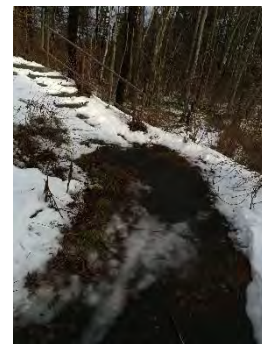
Image 12

Walkways onsite are asphalt and are generally in fair condition. The walkways around the modular building were iced over and difficult to walk on. The walkways along the northeast face of the building were snowy and icy and difficult to walk on (Image 12).

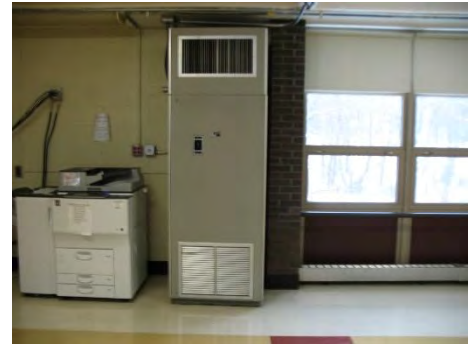
The building is not provided with a central cooling plant. The Administration area is served by dedicated through the wall air conditioners at some perimeter offices and by ductless wall mounted air conditioners in the main office and in the offices at the front of the building as part of a VRF heat pump system. The library is cooled by a 17.5 ton Trane rooftop unit with DX cooling. The two computer labs are cooled by 5 ton ducted horizontal unit ventilators with an add-on DX coils. The teacher's lounge has the main distribution frame server racks, so is cooled by an oversized 7-1/2 ton Liebert DX computer room style air conditioner (Image 1). The portable classrooms are cooled by rooftop units with DX cooling. The

Image 1 – Teacher's Lounge Oversized Air Conditioner

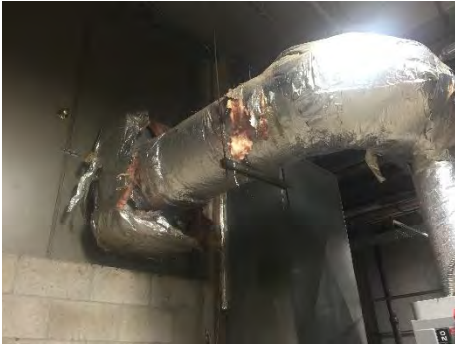
Image 5 – Boiler Combustion Air Ducting

In addition, combustion air is directly ducted to each boiler from a louver installed in the inactive leaf of a door (Figure 5). Heating hot water is circulated throughout the building in a variable primary pumping scheme using two (2) Bell and Gossett 15 HP base mounted end suction pumps. These pumps are variable speed pumps, controlled by Yaskawa variable speed drives. Each pump is served by its own tangential air separator which is uninsulated (Figure 7). There is no ventilation in the boiler room. There is still some abandoned equipment, pumps and valves in the boiler room from the old steam system. Some of the steam piping has been abandoned in place at the ceiling.

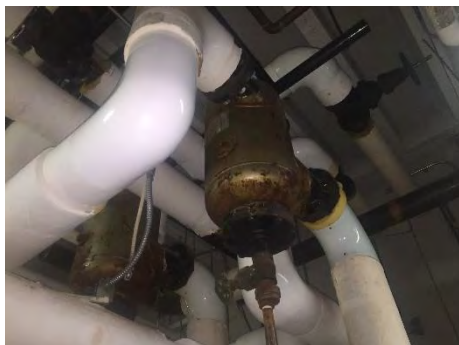
Image 7 – Uninsulated Air Separators

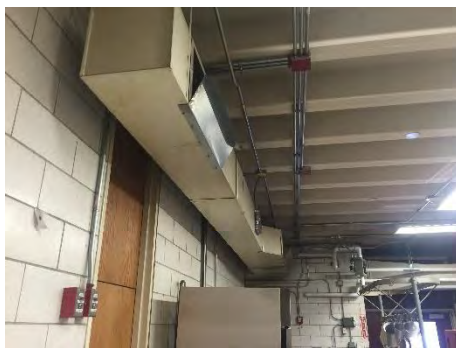
Image 12 – Kitchen Make-up Air Ductwork

The kitchen functions as a warming kitchen. The canopy hood does not have an Ansul fire suppression system (Figure 11). The hood is ducted to two roof fans with motorized dampers in each dedicated duct. Partial make-up air is supplied by both a ducted make-up air unit and a ducted unit ventilator (Figure 12). Within these units is a supply fan, hot water coil, face and bypass dampers, a filter rack and outside air/return air dampers. The remainder of the hood make-up air is transferred from the cafeteria via open doors to the cafeteria. The kitchen is heated by a small horizontal unit heater when the air units are not running. The kitchen office is heated and ventilated by a wall mounted unit ventilator and ventilated by a wall exhaust register.

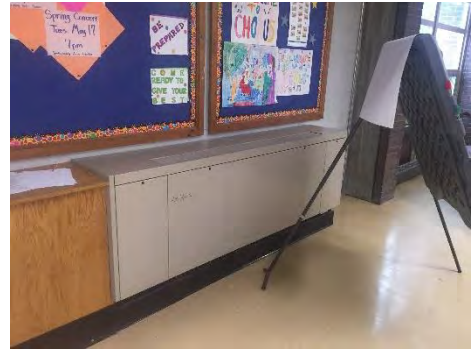
Image 13 – Classroom Unit Ventilator

Single wall mounted vertical unit ventilators (Image 13) and pedestal type baseboard heat under the windows (Image 14) are provided in each classroom.

The unit ventilators provide outside air through the use of a through wall louver system which is ducted to the back of the unit ventilator.

Within the unit is a supply fan, hot water coil, face and bypass dampers, a filter rack and outside/return air dampers. The unit ventilators are provided with electric actuators. Each unit ventilator is controlled via the standalone wall mounted sensor tied into the Trend DDC control system. This combination temperature/CO2 sensor provides demand control ventilation to more closely match fresh air damper

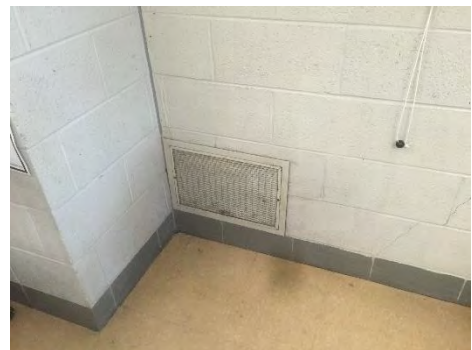
Image 16 – Typical Classroom Low Exhaust Grille

Each classroom is provided with a low wall mounted exhaust grille which communicates to a central roof mounted exhaust fan through a galvanized sheet metal duct collection system. (Image 16).

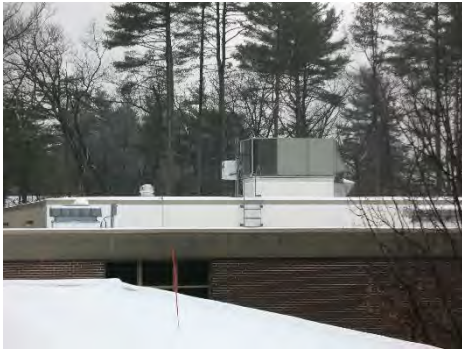
Image 17 – Library rooftop unit

The library is served by a 17.5 ton constant volume roof top unit which consists of a supply and exhaust fan, filter section, gas furnace and direct expansion cooling coil (Image 17) This roof top unit is associated with a galvanized sheet metal duct distribution system which delivers and returns conditioned air to and from the spaces via ceiling diffusers and grilles. The unit delivers a mixture of outside air and return air, which is then conditioned through the unit's gas furnace or DX cooling coil. The library is broken into 6 temperature zones. Duct mounted electric heating coils further heat/reheat the tempered air being supplied by the rooftop unit to their respective zones. Electric baseboard heat is run along the perimeter of the library as supplemental heat. The fresh air damper at the rooftop unit is controlled by CO2 sensors in the space to match fresh air damper ventilation settings with actual room occupancy.

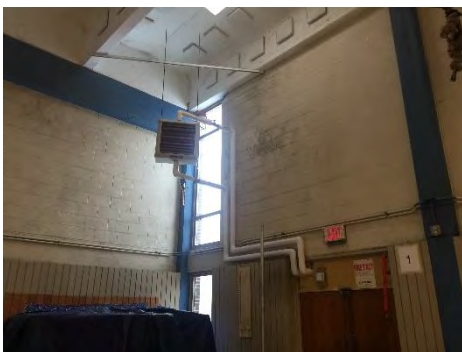
Image 18 – Gym Unit Heater

The main gym is now heated by two horizontal unit heaters (Figure 18). The gym was originally heated and ventilated by concealed Nesbitt vertical heating and ventilating units located in each corner of the gym (Figure 19). These H&V units are ducted to wall grilles (Figure 20). These units still have pneumatic damper operators. It appears as if these units are no longer operating.

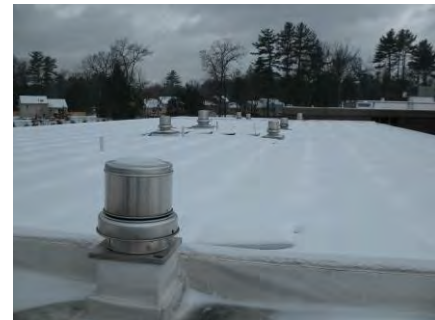
Image 21 – Typical Roof Fans

Throughout the building, general exhaust is provided through the use of roof mounted exhaust fans (Image 21). These fans serve areas such as toilet rooms, storage rooms, custodial closets, mechanical spaces and electric rooms. All the fans are associated with their own independent galvanized sheet metal duct collection systems and all terminate within the spaces with ceiling or wall mounted grilles. Overall the fans appear to be functioning. The fans appear to have been replaced in the early 2000's and are in good condition.

1. Provide routine maintenance on all exhaust fans such as replacing belts and lubricating their motors and shafts. Replace fans as necessary.

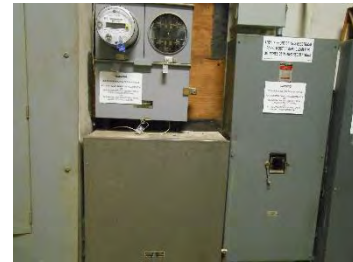
Image 1 — Main Disconnect

An 800 ampere, 277/480 volt, 3 phase, 4 wire service serves the building. The main service equipment is located within the building's boiler room. The service consists of an enclosed main breaker and main distribution panels. The equipment is of original vintage and manufactured by Westinghouse. New energy efficiency Powersmiths transformers have been provided throughout the building (Image 1 & 29)

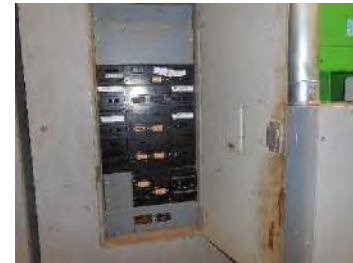
Image 2 — Original Panels

Branch circuit panelboards vary from original Westinghouse panelboards that are in poor condition to recently installed Cutler Hammer panelboards that are in good condition. There has been some additional branch circuitry added throughout the school (Image 2 & 3).

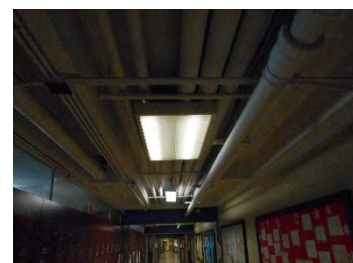
Image 4 — Corridor Lighting

Corridor lighting consists of surface mounted fluorescent fixtures with acrylic lenses. Corridor lighting is controlled via line voltage switches at the ends of the corridor (Image 4).

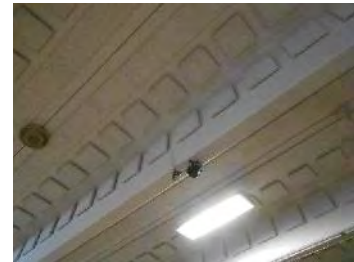
Image 6— Cafetorium Lighting

Gym lighting and cafeteria lighting consists of high output, 2x4 fluorescent high bays. Light levels seem adequate. It was noted that one fixture in the gym was not working (Image 6 & 8).

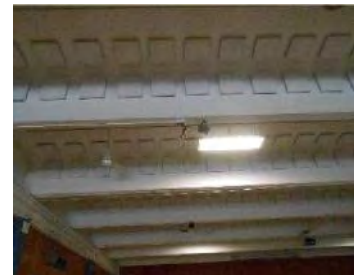
Image 7 – Track Lights

Incandescent track heads are used to light the area in the cafetorium for performances (Image 7).

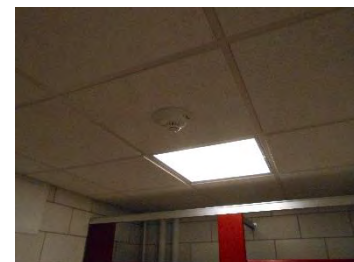
Image 9— Toilet Rooms

Toilet rooms contain ceiling mounted wraparound fixtures and 2'x2' recessed fluorescent fixtures. (Image 9).

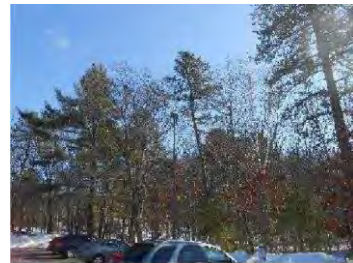
Image 12— Pole Mounted LED Flood

The site is lit with a combination of recently installed pole and building mounted LED flood lighting. Under the main canopy, existing lighting has been upgraded to LED lighting (Image 12, 13, & 14).

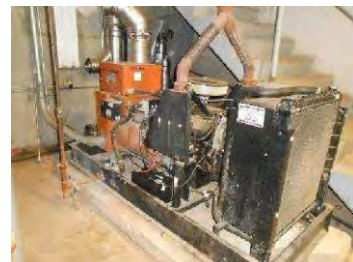
Image 15 — Generator

An interior natural gas Generac 97A02142 generator, 65 kW, 120/208 volt, is installed in the boiler room. The generator feeds an ASCO transfer switch and serves emergency lighting, as well as other loads. The emergency system does not comply with current electrical code as the emergency equipment is not separated from normal equipment. Exit signs are provided throughout the building (Image 15 & 16).

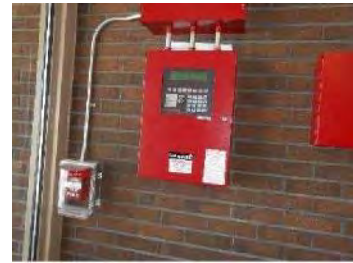
Image 17 — Fire Alarm Control Panel

The fire alarm system consists of an addressable Gamewell control panel. The control panel is located in the lobby. Horn/strobes are ADA compliant and located throughout the school. Manual pull stations also seem to be compliant (Image 17, 18, & 19).

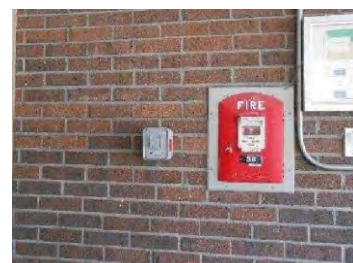
Image 20 — Master Box & Knox Box

An exterior master box and knock box are located at the main entrance (Image 20).

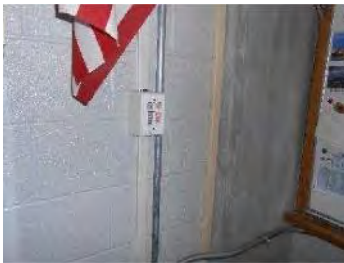
Image 23 — A/U Control System

Most classrooms are equipped with A/U control systems for projector, document camera, and computer connections. Each also contains a sound reinforcement system. Projectors are ceiling mount type (Image 23).

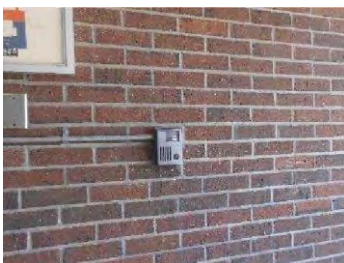
Image 25 — Aiphone Intercom

The building contains an Aiphone intercom door communication system at the main entry that is in fair condition (Image 25 & 27).

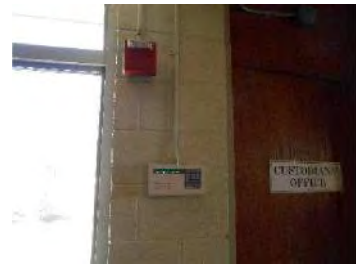
*Image 26 — Intrusion
Keypad at Main
Entrance*

The intrusion system is a Honeywell system and is operational; however, appears to be in poor condition (Image 26 & 28).

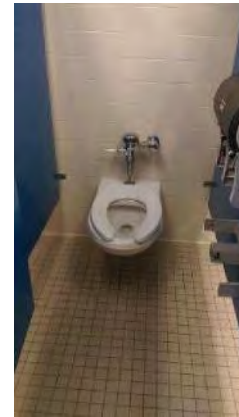
Image 1 — Wall Hung Water Closet

Water closets are a mix of wall hung and floor mounted vitreous china with manual or automatic sensor type flush valves (Image 1).

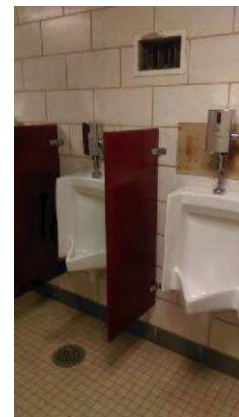
Image 2 — Urinals

Urinals are wall hung vitreous china with automatic sensor type flush valves (Image 2).

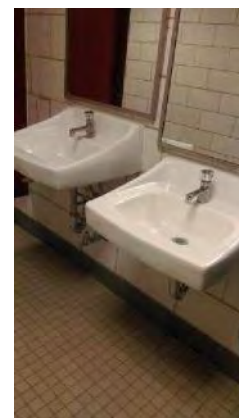
Image 3 — Wall Hung Lavatories

Lavatories are wall hung vitreous china. The lavatories are fitted with metering faucets (Image 3).

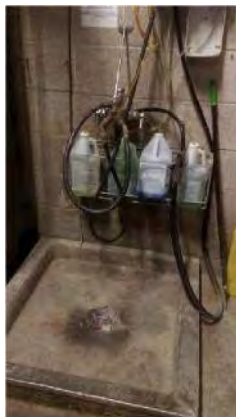
Image 4 — Janitor's Sink

Janitors sinks are floor mounted mop receptors. Faucets are equipped with vacuum breakers. (Image 4).

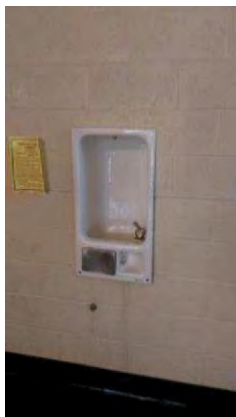
Image 6 — Drinking fountain

Drinking fountains are vitreous china recessed type (Image 6).

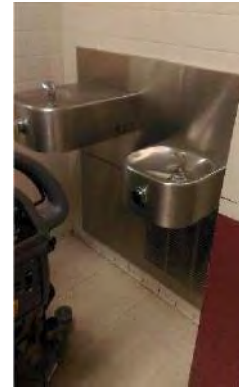
Image 7 — Electric Water Cooler

Electric water coolers are stainless steel surface mounted or stainless steel hi low fixtures with recessed chiller (Image 7 & 8).

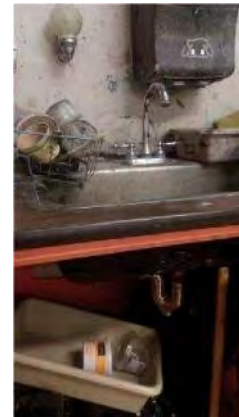
Art sinks are counter mounted stainless steel with dual lever faucets and are not equipped with sediment traps (Image 8).

- Provide reduced pressure backflow preventers at Janitor's closet soap dispenser.
- Provide plaster traps at Art classroom sinks.

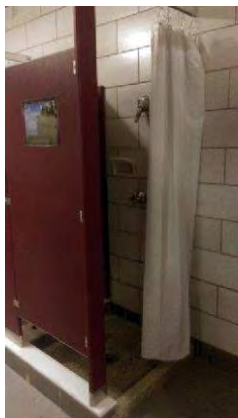
Image 10 — Shower

Showers include terrazzo bases with floor drains. Individual hot and cold water supplies feed each institutional shower head. Gang showers include single tempered water supplies and institutional shower heads. The tempered water is delivered from a master mixing valve (Image 10).

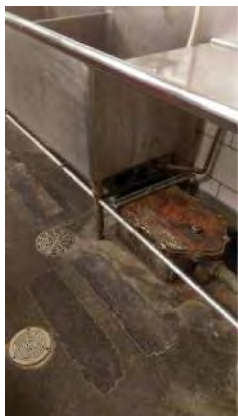
Image 11 —
Kitchen Pot Sink

Kitchen area fixtures are in fair condition. The pot washing sink is piped to a floor mounted grease interceptor (Image 11).

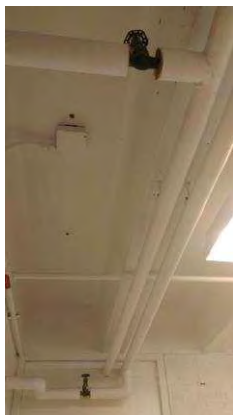
Image 13 – Water
Piping

Piping is copper tubing with sweat joints. The majority of piping is insulated. In general, the original gate valves are in fair condition. In portions of the building that have been recently renovated the piping is insulated, labeled and the ball valves are in good condition (Image 13).

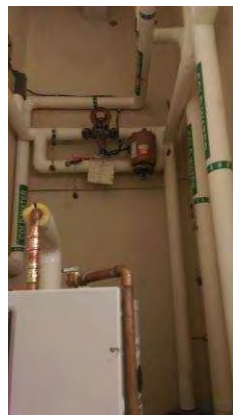
Image 15– Electric
Water Heater

In a recently renovated area of toilet rooms, hot water is generated through a 9 kW electric water heater with a storage capacity of 20 gallons (Image 15).

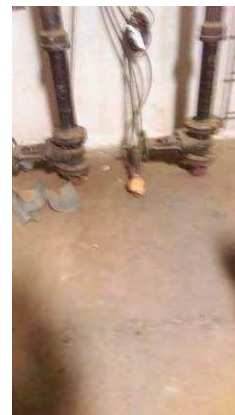
Image 17– Sewage
Ejector

In the boiler room the floor drains are directed to a duplex sewage ejector installed in floor. The basin appears to be vented. Two (2) 4" pump discharge lines are valve at floor then combine and the line is directed to a gravity drain (Image 17).

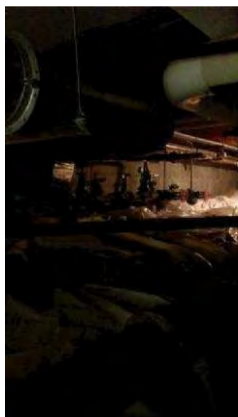
Image 12 — Water
Service

The domestic water service is located in the Mechanical Room. The service appears to be 4" in size and includes a meter (Image 12).

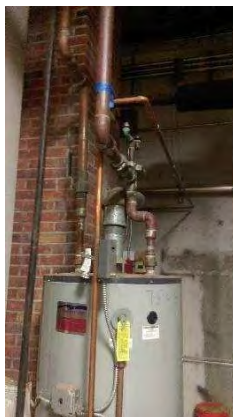
Image 14- Gas Water
Heater

The main Building domestic hot water is generated through a gas-fired standard efficiency non-condensing storage tank type water heaters. The water heater has a natural gas input of 77,000 BTUH and a water storage capacity of 100 gallons (Image 14).

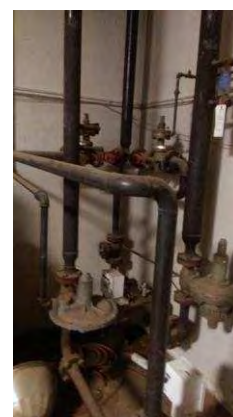
Image 16 - Gas Meter

Building is serviced by an elevated pressure natural gas service. The gas service, regulator and meter is located inside the Boiler Room. Gas service is 3" in size (Image 16).

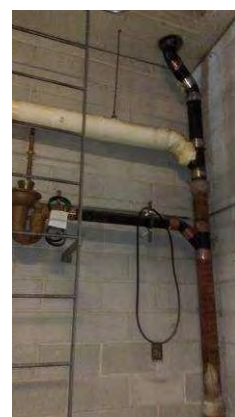
Image 18 - Repaired
Rainleader

The flat roofs are collected by roof drains and interior cast iron rain leaders. The roof and drains are in fair condition. Portions of the horizontal rain leader piping is insulated. There is evidence of sections of the original cast iron rain leader piping which has been replaced (Image 18).

In general, existing cast iron drainage piping can be re-used if sized appropriately. We recommend video inspection of existing drains to confirm integrity.

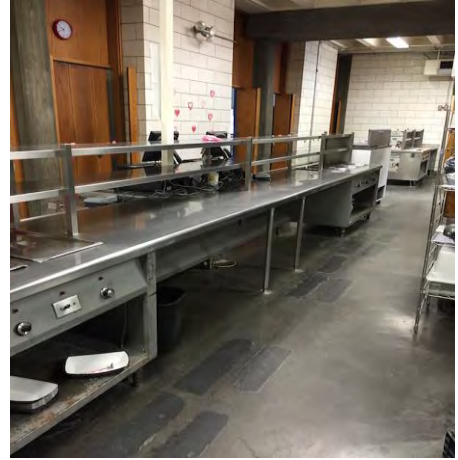
Image 1

The kitchen serves the typical school lunch program in two serving lines with two cashier terminals exiting at the center of the serving lines. The serving line is rather simple and equipped with hot wells but no cold wells. The serving lines' base cabinets (Image 1) are painted galvanized steel as was common at the time of the original installation but in modern installation the bases would be stainless steel. The concern with painted galvanized steel is that the paint becomes damaged and rust and corrosion set in.

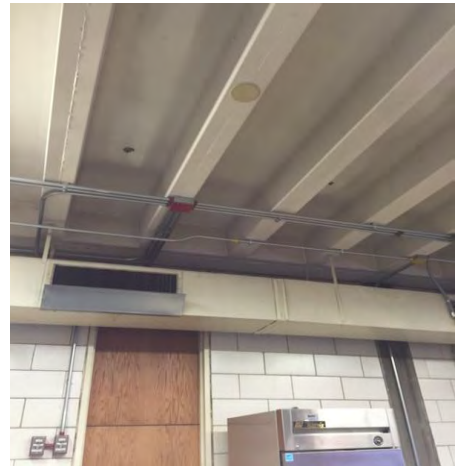
Image 2

The walls are constructed of the appropriate materials and have held up well. The floor is a sealed concrete, which must be very slippery. In fact anti skid strips have been glued onto the floor. The anti-skid strips are unsanitary but a necessity. The ceilings (Image 2) are open to the structure above. Conduits and other utility runs are exposed to the kitchen below. If built today, the current food code requires that the kitchen ceiling be of a smooth, non-absorbent, easily cleanable surface.

Other issues with open ceilings are that the hood and the walk-in refrigerated rooms are open to above. Again, the current standard requires that those items be sealed to the surfaces above and around them.
