Dore & Whittier Architects Inc.

South Row Elementary School

SOUTH ROW ELEMENTARY SCHOOL ARCHITECTURAL ASSESSMENT

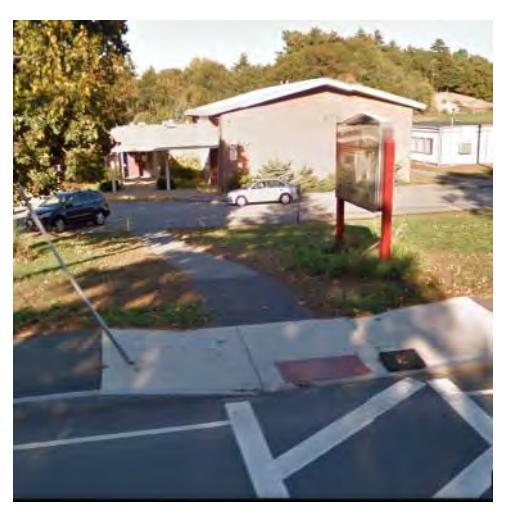
Image 7

A cross walk with accessible curb cuts is provided for students crossing Boston Road (Image 7) however, once on

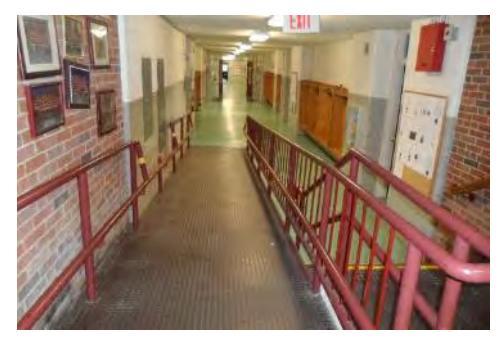
Where ramps and stairs are provided throughout the building efforts have been made to meet the requirements for accessibility. However, these efforts fall short in some cases. Image 11 indicates a ramp where the upper handrail was dropped to accommodate the location of the existing electrical panels. This condition should be revised to provide a continuous handrail on both sides of the ramp. In other locations the handrails at the stairway do not

- Renovate main office counter to meet accessibility requirements
- Replace existing handrails at the stage to meet ADA / MAAB
- Install a lift or ramp to access stage
- Install segment of upper handrail on ramp in corridor
- Install new handrails at stair locations to meet ADA
 / MAAB requirements for dimension of handrail and extension beyond the top and bottom riser.
- Provide clear access to the accessible restroom
- Renovate restrooms, offices and classrooms to provide push / pull clearances at doorway
- Install protection around sink pipes

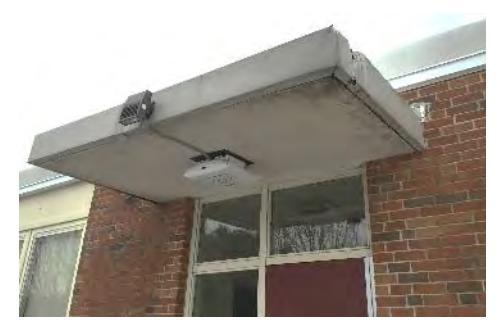
Image 24

- The side entrance canopy has metal fascia damage causing water runoff on walkway and appears to be leaking into the canopy causing damage to the soffit. (Image 24)
- Investigate the source of ceiling tile stains inside the school.

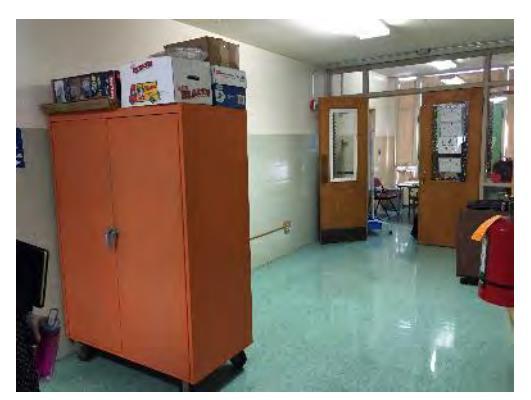
Image 48

At the South Row School many areas are inappropriate for the function they are serving. This is evident with vestibules acting as teaching spaces and small group learning (image 48). Corridors are used for storage, and storage closets are used as office space.

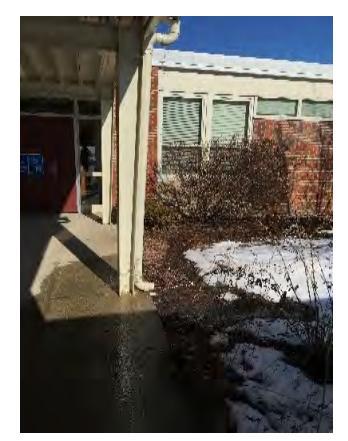
Image 1

Stormwater runoff from the roof appears to be collected through the building or through downspouts that discharge to a below grade closed drainage system. There are a few downspouts that drain at grade from the overhang to the main entrance of the building (Image 1).

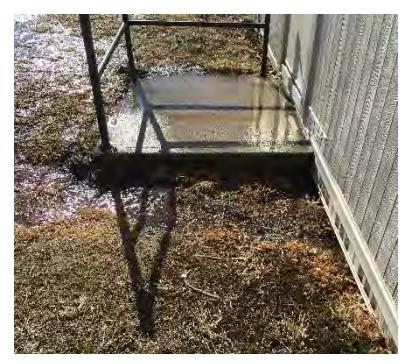
Image 2

There is a modular building to the east of the permanent building. Stormwater runoff drains towards the building and some of the ground surface beneath the modular building has started to erode away (Image 2).

- Mill and overlay sections of pavement where cracking/degradation has occurred.
- Regrade paved areas to prevent ponding which can lead to ice patches in the cold weather.
- Install drains or curbing to prevent erosion along edge of pavement.
- Install drains or regrade to avoid erosion underneath the modular building.

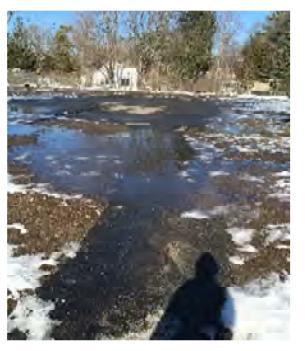
Image 3

There is some ponding on site in the paved areas to the north and east of the permanent building (Image 3 and 4). Ponding and runoff has caused some erosion along the pavement edge along the east side of the building (Image 4 and 5).

The asphalt pavement within the site is in generally fair condition with some areas of cracking and degradation. There is some accumulation of sediment in paved areas onsite and some areas of ponding/icing (Image 3, 4, and 11). Pavement edges are degraded in areas of the site with no curbing (Image 12)

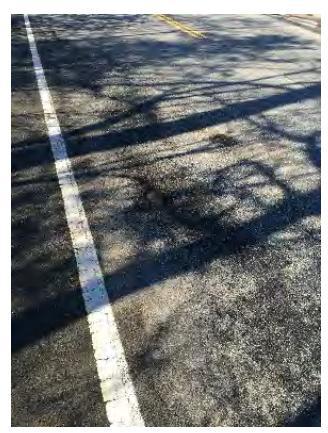
Image 7

There is a water main in Boston Road that the site water services likely connect to. Water valves were observed in front of the South Row School Building in Boston Road (Image 7).

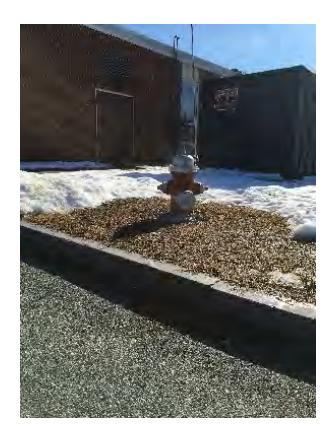
Image 8

One fire hydrant was observed on site and one fire hydrant was observed along Boston Road directly adjacent to the site. The hydrant on site is located along the south end of the western face of the building (Image 8).

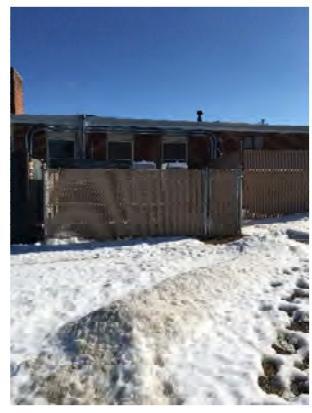
Image 9

There is electrical equipment located along the southern end of the west face of the building. Electrical services enter the building along the west face of the building (Image 9).

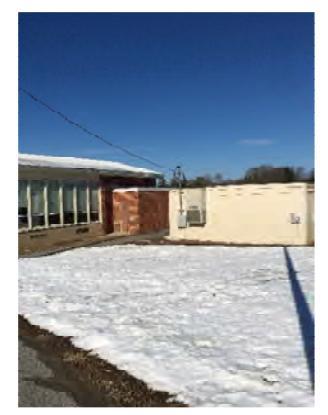
Image 10

The modular building appears to have its own electrical services. Overhead wires go from a utility pole on Boston Road to a utility pole on site to the south of the modular building. The wires then connect to the modular building (Image 10).

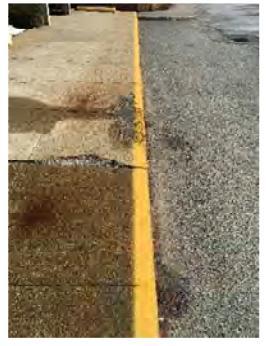
Image 13

Walkways onsite are asphalt or concrete and are generally in fair condition with some areas of cracking/degradation. There are some areas of ponding. Walkway edges are degraded in areas of the site with no curbing. (Image 13).

Curb onsite is generally vertical granite curb although there is some concrete curb along the walkways to the south of the building. The vertical granite curb is generally in good condition (Image 13).

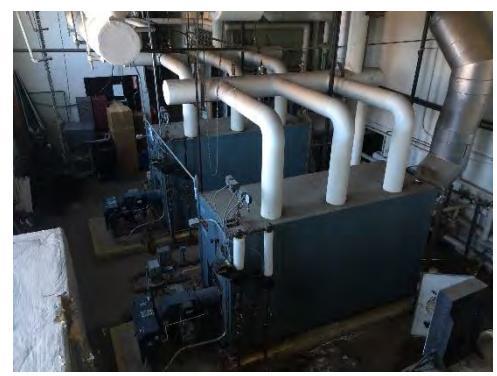
Image 1: Steam Boilers

There are two (2) gas fired cast iron steam boilers, manufactured by HB Smith, model 28A, 13 section each with an input capacity of 4180 MBH and a gross output capacity of 3297 MBH producing 5 psi low pressure steam. (Image 1) Each boiler is fired by a Powerflame model C3-G-25 power burner firing natural gas. These two boilers were installed in 2003 and are in fair condition. Boiler B may have a slight leak, as it is wet under the boiler. Each boiler is provided with dual low water cut-offs and all operating and safety controls. Each boiler operates using its own controls. The steam distribution piping is schedule 40 black steel and is insulated with what appears to be fiberglass insulation.

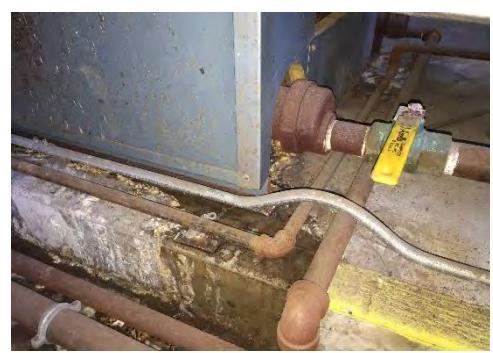
Image 3 : Water Seeping Out of Boiler B

- 1. Replace condensate pump with cracked casing
- 2. Investigate source of water emanating from under Boiler B (Image 5).
- Extend condensate receiver vent piping to exterior of building. (Possibly use abandoned generator stack).
- 4. Add ventilation to electric room.
- 5. Restore piping to blowdown cooler or replace

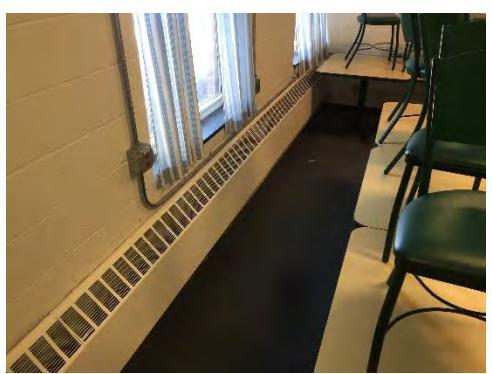
Image 10: Typical Slopetop Finned Radiation

The Administration Area is heated by perimeter slopetop finned radiation and generally controlled by wall mounted pneumatic thermostats. (Image 10) The Main Office and Principal's Office are controlled by DDC wall sensors. Each room is ventilated by operable windows and a ceiling exhaust register tied into a central rooftop exhaust fan. The Main Office, Principal's Office and Nurse's Office are cooled by Daikin wall mounted ductless heat pumps tied into a 2 ton condensing unit mounted at grade. (Image 11 & 12) The Coach's Office is ventilated by a ceiling exhaust register. The network server equipment is located in the Coach's Office, which, with no cooling, overheats the office at times.

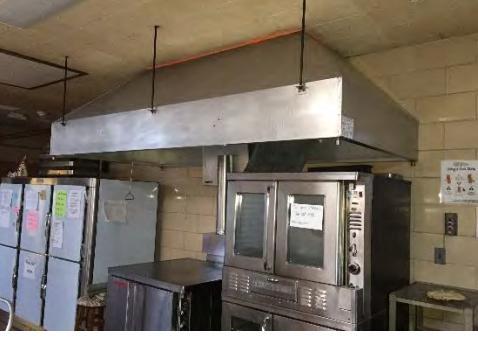
The kitchen functions as a warming kitchen. The hood has no Ansul fire suppression system. (Image 13). The hood has an interior panel with adjustable slide gates to adjust airflow through three slide gate openings. (Image 14) The open ended stack for the gas-fired ovens terminates under one of these openings. Partial make-up air is supplied via a horizontal ceiling mounted unit ventilator which draws in fresh air through a roof vent. The remainder of the hood make-up air is transferred from the cafeteria via open doors. The kitchen office is heated by inverted slopetop finned radiation mounted high on the wall, controlled by a pneumatic thermostat. The office is exhausted by a ceiling register.

1. The kitchen hood is starved for make-up air when all the kitchen doors are closed.

Image 13: Kitchen Hood

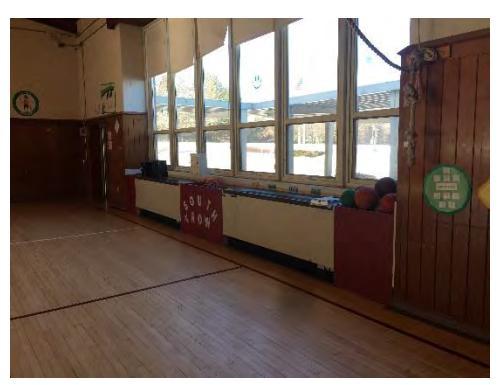
Image 16: Gymnasium Unit Ventilator

Single wall mounted vertical unit ventilators are provided in each classroom, in the library and in the gymnasium. (Image 15) Four wall mounted unit ventilators are provided in the Gym. (Image 16) These units provide fresh air through the use of a through wall louver system which is ducted to the back of the unit ventilator. Within the unit is a supply fan, steam coil, face and bypass damper filter rack and outside/return air dampers. Each unit ventilator is controlled via a DDC wall mounted sensor. The unit ventilators are functioning and are in good condition. Maintenance staff report that there is excessive air infiltration around the louvers on the unit ventilators.

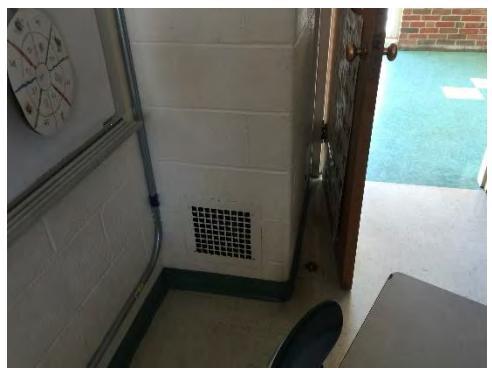
Image 17:Typical Low Classroom Exhaust Register

Each classroom and the library are provided with a low wall mounted exhaust register which communicates to a roof mounted exhaust fan through a galvanized sheet metal duct collection system. (Image 17) The gym is provided with two low wall mounted exhaust registers tied into a roof mounted exhaust fan.

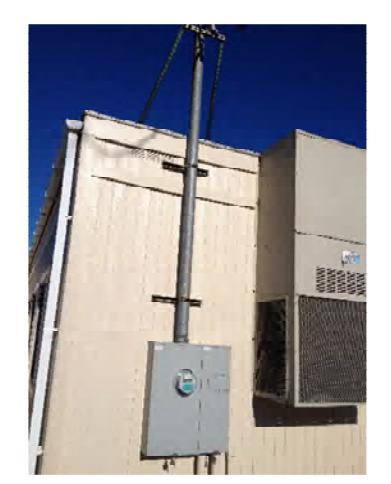
Figure 5- Portable Meter/Breakers

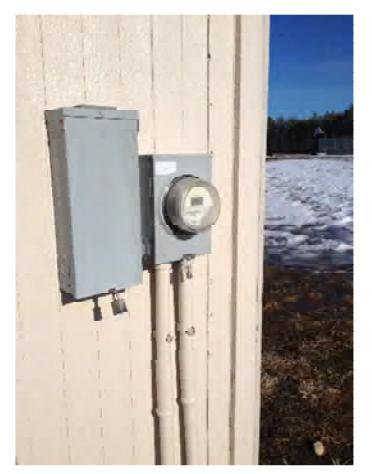
Figure 6 – Electric Meter #3 on Portables

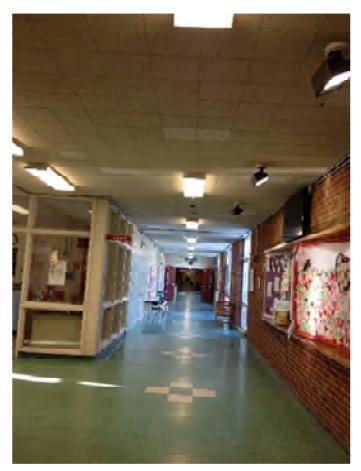
The lighting in general is in fair to good condition. Fixtures have been replaced with wraps with T8 lamps and electronic ballasts. The existing wiring and switches were reused however. The ceilings consist of concealed spline and are not easily accessible.

Figure 7 – Corridor Lights

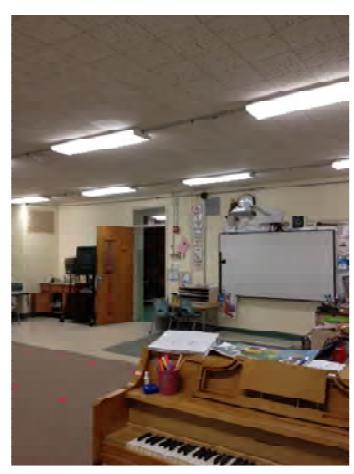
Figure 8 – Classroom Lights

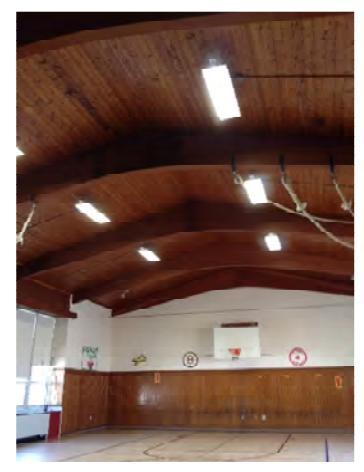
Figure 9 – Gym Lights

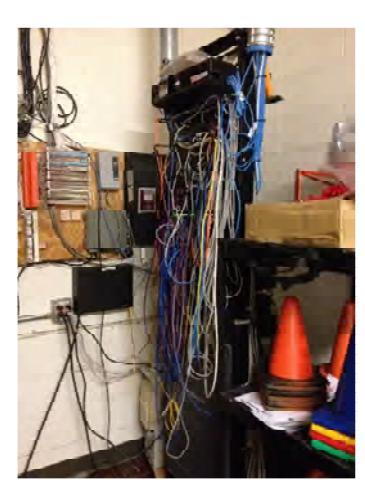
The data cabling infrastructure is generally CAT5. The MDF rack is located in the Gym Office. The rack is not located within a conditioned dedicated room. Wireless access nodes exist throughout school. Typical classroom does not have data outlets except at teacher's station.

Figure 26 - MDF Rack in Gym Office

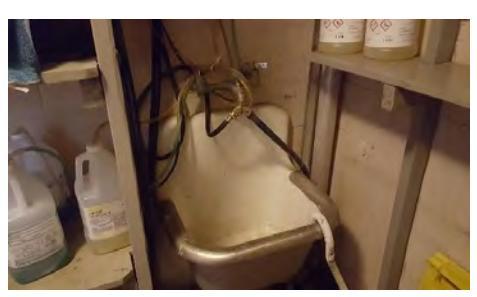
Utility sinks are wall hung enameled steel sink with wall mounted faucet. Faucets are not equipped with vacuum breakers. (Figure 4)

Figure 4 – Utility Sink

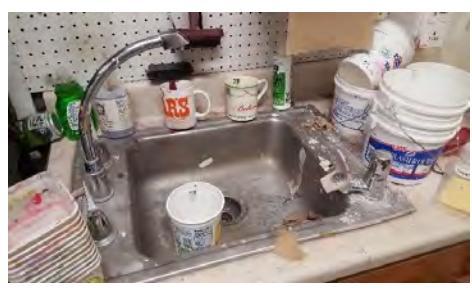
Art sinks are counter mounted stainless steel with hot & cold handle faucets and are not equipped with sediment traps. (Figure 9)

Figure 9 – Art Sink

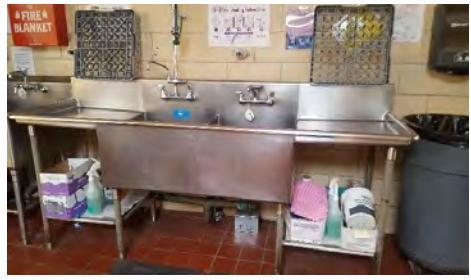
Kitchen area fixtures are in fair/good condition. The 2 compartment pot washing sink is not piped to a grease interceptor. (Figure 12, Figure 13)

Figure 12 – 2-Compartment Sink

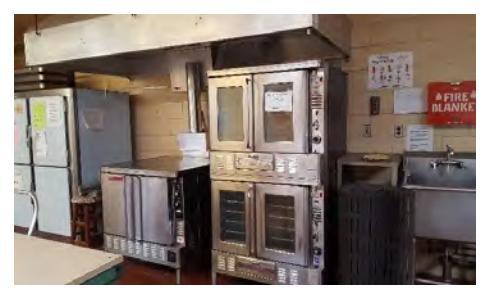
Figure 13 – Kitchen Equipment

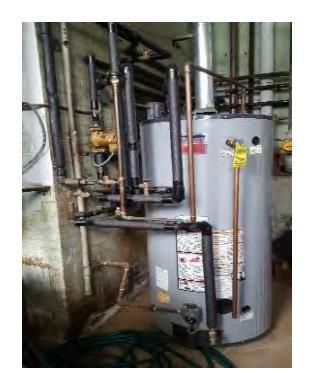
The building domestic hot water is generated through a gasfired storage type water heater. The water heater has a gas input of 77,000 BTUH and a storage capacity of 100 gallons. The hot water system is recirculated but no master mixing valve. (Figure 15, Figure 16)

Figure 15– Gas Fired Water

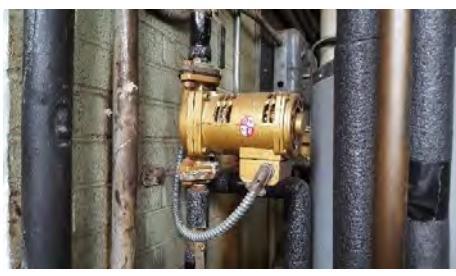
Figure 16 – Hot Water Recirculating Pump

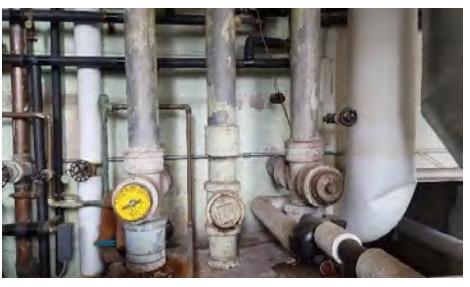
In general, cast iron is used for sanitary drainage. Piping and fittings above slab are no-hub with coupling joints and bell & spigot. Where visible, the cast iron pipe appears to be in good condition. (Figure 19, Figure 20) Smaller pipe sizes appear to be copper for waste.

Figure 19 – Cast Iron Drainage Piping

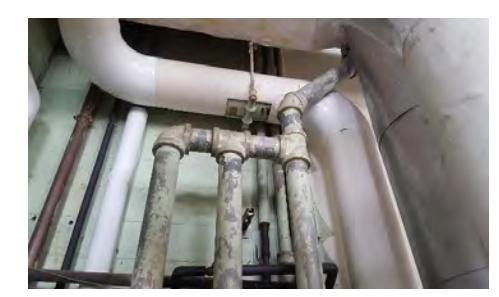
Figure 20 – Cast Iron Vent Piping

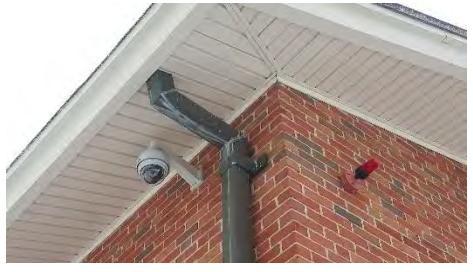
Figure 21 – Pitched Roof & Downspout

The flat roofs are collected by roof drains and interior cast iron rain leaders. Pitched roofs are collected with gutters and downspouts either spill onto a flat roof or discharges to a below grade collection system. Canopy is collected with scupper drains and downspouts and discharges to a below grade collection system. (Figure 21, Figure 22, Figure 23)

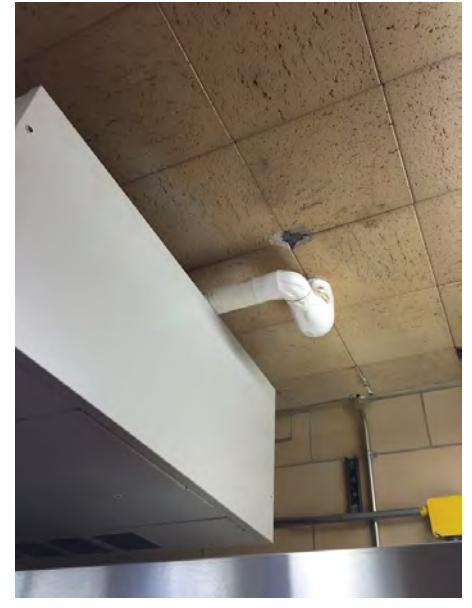
Figure 2

The school's cafeteria kitchen serves the school lunch in two serving lines with a cash out station exiting at the center where the two lines meet. The serving and support equipment is mostly outdated. Some equipment has been covered with plastic and designated as broken. Floors and walls are constructed of the apprpriate materials but the ceilings are not complaint with current health code (Figure 2).
