# Westlands School

## ARCHITECTURAL ASSESSMENT

### GENERAL DESCRIPTION

The building survey for this report was conducted on February 16, 2016.

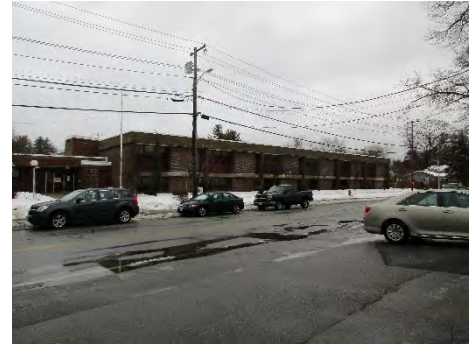
Image 1

The school was designed by The Architects Collaborative in 1967 and constructed in 1968 (Image 1). The school underwent a window replacement project in 2004 and a complete roof replacement in 2011.

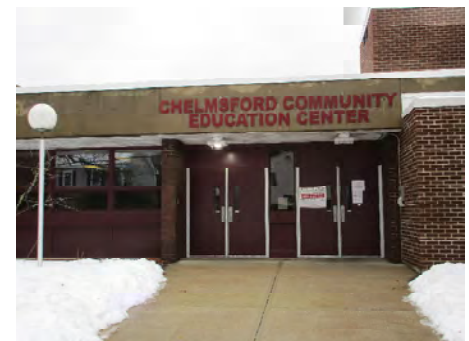
Image 3

Due to the relationship of the front door to the main street it is difficult for accessible parking to be located near the main entrance. However, the entrance doors are accessible and the front lobby is located near the entrance (Image 3). Accessible parking is located at the rear of the building adjacent to an entrance located near the recreation room and accessible to the cafetorium and main office space (image 4).

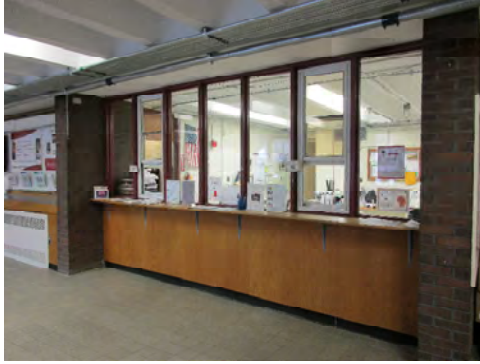
Image 5

portion of the desk for “roll-up service” (Image 5). The main classroom wing is located on different levels than the lobby and require the use of the stair or elevator located adjacent to the main lobby. The elevator does not appear to have all of the proper controls to meet the current accessibility requirements (Image 6). The stair handrail does not extend beyond the lower tread as required (Image 7).

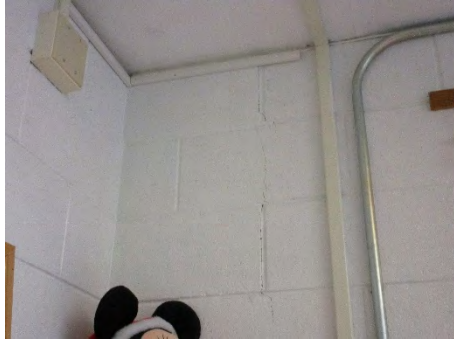
Image 35

- In some of the rooms the CMU walls have severe cracking in the corners of the room (Image 34).
- In some of the rooms throughout the school there are cracks in the face of the CMU walls (Image 35, Image 36).
- The building expansion joint is drying out and shrinking (Image 37, Image 39).
- There are several areas in the building that have old plastic wall anchor sleeves that have never been removed (Image 39).
- There are several areas in the building where the wall paint is scuffed.

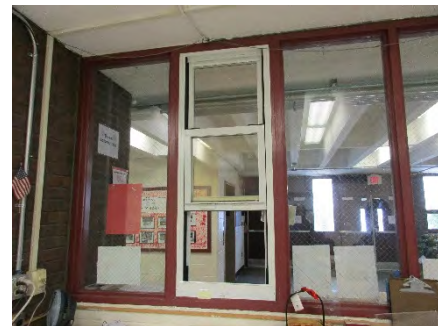
Image 42

- Some of the wood doors and hollow metal doors, as well as the hollow metal frames, have some scuff marks and fading.
- Some of the door vision panels and transoms have wired glass.
- The Admin. Department's storefront / borrowed lite system has wired glass (Image 42).

- Where the wood door finish is fading, strip down door to raw wood and refinish to match rest of wood doors. At the hollow metal doors that are scuffed or the paint is fading, scrape doors to remove any loose paint and repaint to match color of other hollow metal doors; the same to be done to the door frames, as needed.
- Remove all wired glass panels from the interior doors and replace with tempered glass during a larger renovation or if the door is otherwise in need of replacement.
- Remove all wired glass panels from the interior Admin. storefront / borrowed lite system and replace with tempered glass during a larger renovation or if the storefront / borrowed lite system is otherwise in need of replacement.

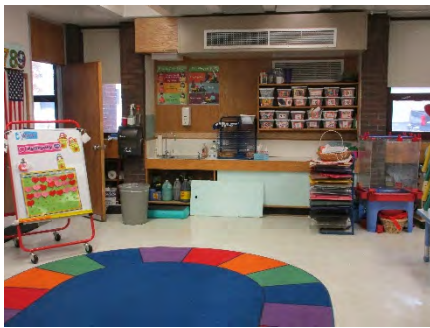
Image 44

- Much of the fixed furniture appears to be in fair condition but appears tired and dated. This was specifically noted with the classroom casework and the teacher's work room casework (Image 43-46).
- The toilet room fixtures and toilet partition walls are in very poor condition. Most of the fixtures are not accessible and the partitions are rusted, dented and / or broken (Image 47, Image 48).

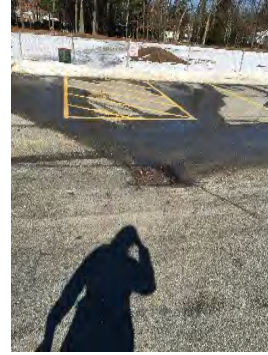
Image 1

Catch basins were observed in the parking and driveway areas of the site (Image 1). Catch basins were also observed in the asphalt play area to the north of the school (Image 3).

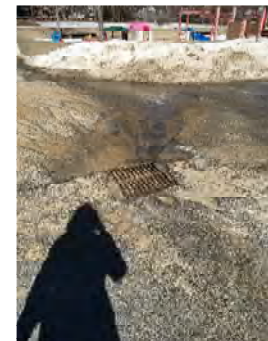
Image 2

Drain manholes were observed in Dalton Road directly to the south of the existing building (Image 2). Stormwater runoff from the site likely discharges to the town system in Dalton Road.

Curbing onsite is vertical granite curb. The curb is in generally good condition with some areas that need to be reset (Image 2, 6, and 12).

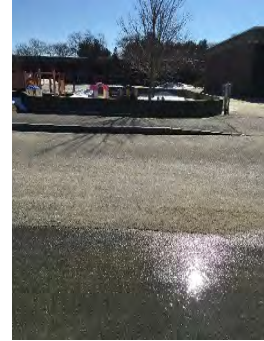
Image 9

There is a transformer located at the northwest corner of the building (Image 9). Record plans show an underground power source running from Dalton Road to the transformer at the northwest corner of the building.

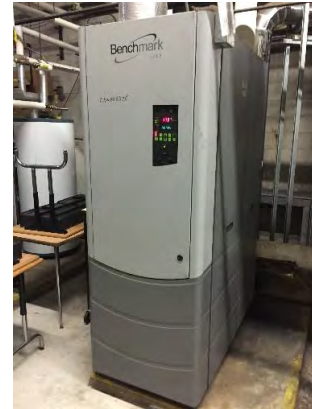
Image 1 – Hot Water Boilers

Boiler flue gases are vented through the use of individual double wall breeching tying into existing Van Packer breeching systems that exit through the roof. The existing stack is still in place but not used due to asbestos. Combustion air for the boilers is provided through the use of existing insulated sheet metal vent ducts which connect to a wall louver. One duct, which the boiler ducts connect to, drops low where another duct runs higher in the space for the two (2) domestic water heaters. Both ducts are provided with pneumatic dampers (Image 1, & 2).

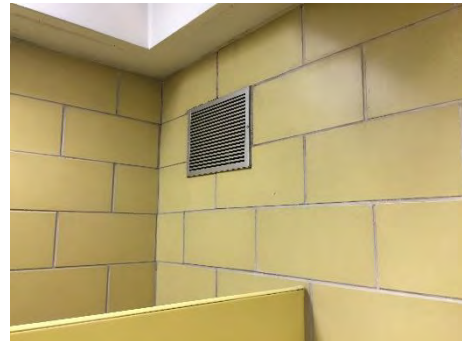
Image 16 – Restroom Convactor

The restrooms are heated by hot water convector units that appear to be in fair to poor condition. The restrooms are typically exhausted by ceiling or sidewall exhaust air grilles that are connected to exhaust air fans are located on the roof. Some of the exhaust air grilles were soiled (Image 16, and 17).

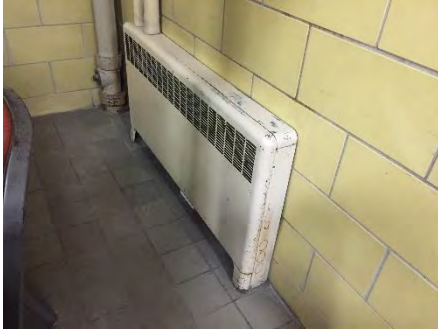
Image 18 – Corridor Unit Heater

The main entryways are heated by hot water convector units that appear to be originally installed equipment; some of the unit heaters show signs of corrosion on the cabinets. The majority of corridors are not provided with code required fresh air ventilation. The corridors are heated by a combination of hot water convectors and fin tube radiation that appear to be in poor to fair condition (Image 18)

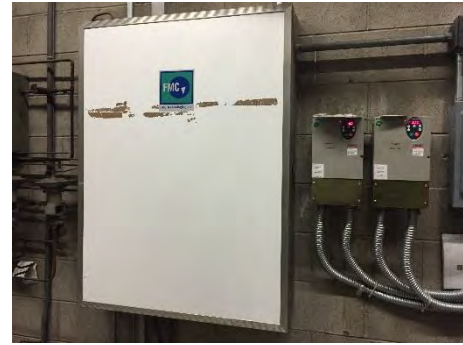
Image 19 – DDC Controller

The majority of the building HVAC systems and the heating plant are controlled by a combination DDC (direct digital control) and pneumatic control system. The ATC control system was upgraded during the 2014 HVAC system renovation project. The DDC/ATC system utilizes Trend controllers manufactured by Niagara and transducers by Mamac Systems that have been installed by FMC Control Technologies. The Control system has a DDC (direct digital control) front-end controller, DDC equipment controllers, and network type thermostats and is tied into a townwide Energy Management System controlled by DPW. The majority of the renovated heating and ventilation system have DDC controls controlling basic equipment functions (ON/OFF, Temperature setpoints, and thermostats of the unit ventilators, air handling units, and baseboard). The pneumatic compressors have been replaced with dual compressors with 1 HP motors manufactured by Jenny and the original refrigerant air dryer is in place (Image 19 and 20).

- Provide a complete DDC control system for optimal control and comfort and tie it into the townwide building management system.

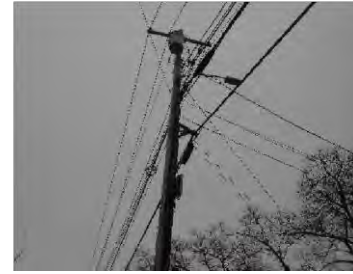
Image 1 – Utility Pole Riser

The service is fed from a utility pole riser to a utility company owned pad mounted transformer adjacent to the building (Image 1, & 2).

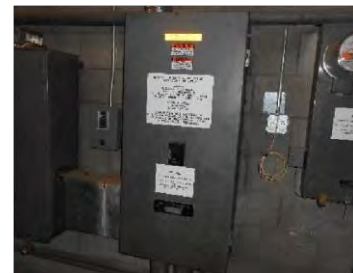
Image 3 – Main Disconnect

A 1,200 ampere, 120/280 volt, 3 phase, 4 wire service serves the building. The main service equipment is located within the boiler room. The service consists of an enclosed main/breaker and a main distribution panel. The equipment is original and manufactured by GE. (Image 3)

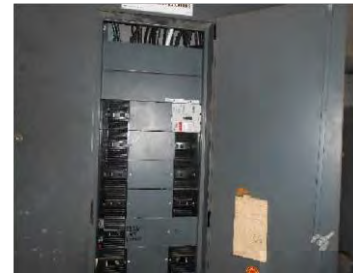
Image 4 - Panels

Branch circuit panelboards are original and in poor condition (Image 4).

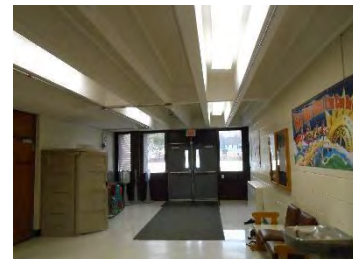
Image 5 Corridor Lighting

Corridor lighting consists of surface mounted wraparound fluorescent fixtures with acrylic lenses and surface cylinders. Corridor lighting is controlled via line voltage switches at the ends of the corridor (Image 5).

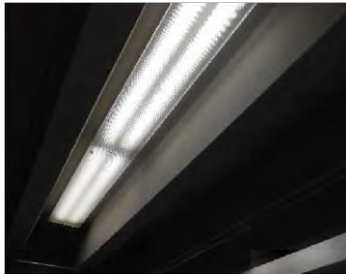
Image 6– Classroom Lighting

Classroom lighting consists of surface mounted wraparound fluorescent fixtures. Light levels appear adequate in the classrooms. Each classroom has been equipped with an occupancy sensor and two switches that control the lights. Wall mounted direct/indirect is also provided at the teacher wall (Image 6).

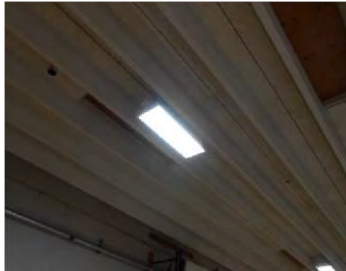
Image 7 – Gym Lighting

Gym and Cafetorium lighting consists of high output, 2x4 fluorescent high bays. Light levels seem adequate (Image 7 & 9).

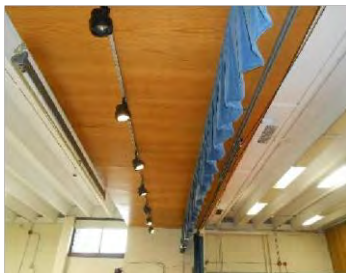
Image 8 – Platform Track Lights

Incandescent track heads are used to light the platform on the stage for performances (Image 8).

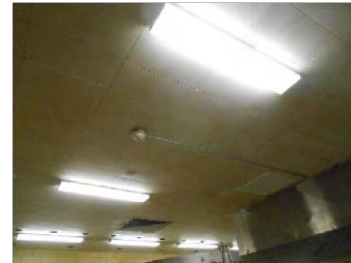
Image 10 – Kitchen

Kitchen has surface wraparound fluorescent fixtures (Image 10).

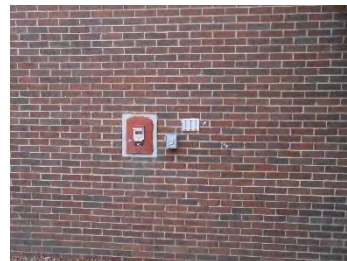
Image 23 – Master Box & Knox

An exterior master box and knox box are located at the main entrance (Image 23).

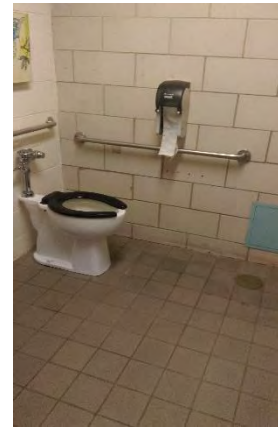
Image 1 – Water Closet

Water closets are floor mounted vitreous china with manual flush valves (Image 1).

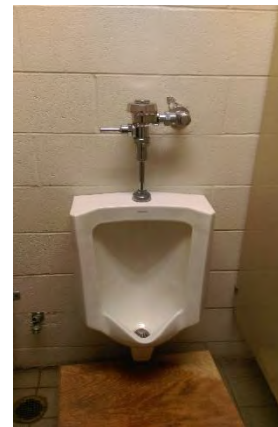
Image 2 – Urinal

Urinals are wall hung vitreous china with automatic sensor type flush valves (Image 2).

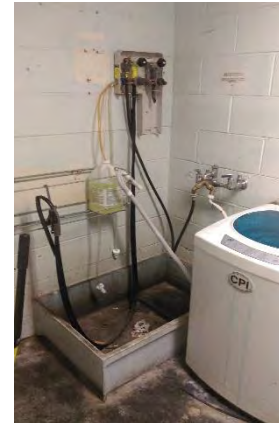
Image 4 – Janitor's Sink

Janitors sinks are floor mounted mop receptors. Faucets are equipped with vacuum breakers (Image 4).

1. Provide reduced pressure backflow preventers at Janitor's closet soap dispenser.
2. Local sewer may require Kitchen waste be directed to exterior grease trap.
3. Install a high efficiency water heater including master mixing valve, recirculated hot water and expansion tank on cold water make-up line.
4. Sanitary waste, vent and storm drainage piping should be video-taped to determine condition.
5. Original domestic water piping should be replaced. Domestic water piping shall be insulated, labeled and isolated with tagged brass ball valves. The valve tags should be charted for ease of maintenance.

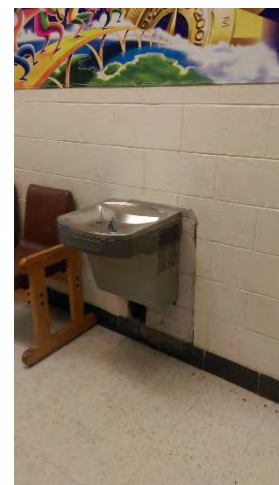
Image 5 – Drinking Fountain

Drinking fountains are stainless steel floor mounted or wall mounted with chiller (Image 5).

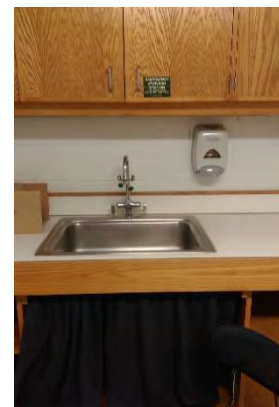
Image 6 – Staff Sink

Staff sinks are stainless steel drop-in type with hot and cold water faucet with gooseneck (Image 6).

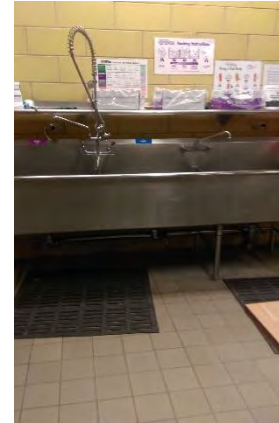
Image 7 – Pot Wash Sink

Kitchen area fixtures are in fair condition. The pot washing sink is not piped to a grease interceptor (Image 7).

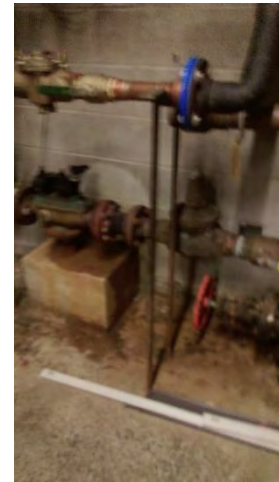
Image 8 – Water Meter

The domestic water service is located in the Mechanical Room. The service appears to be 3/4" in size and includes a meter, pressure reducing valve and a reduced pressure backflow preventer (Image 8).

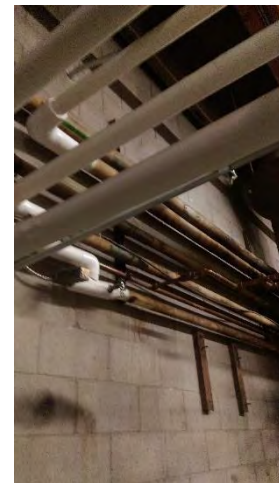
Image 9 – Water Piping

Piping is copper tubing with sweat joints. The majority of piping is insulated but not labeled. In general, the original gate valves are in poor condition (Image 9).

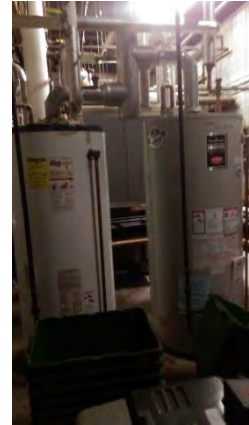
The main building domestic hot water is generated through a pair of gas-fired standard efficiency non-condensing water heaters. The water heaters have a natural gas input of 77,000 BTUH each and a water storage capacity of 100 gallons (Image 10).

*Image 10 – Water Heaters*

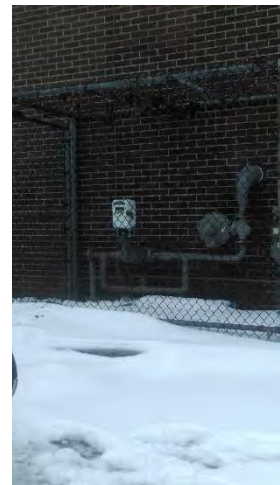
*Image 11 – Gas Meter*

Building is serviced by an elevated pressure natural gas service. The gas service, regulator and meter are located on the exterior in a caged area. Gas main distribution is 4" in size. A sub-meter is installed is dedicated to an emergency generator (Image 11).

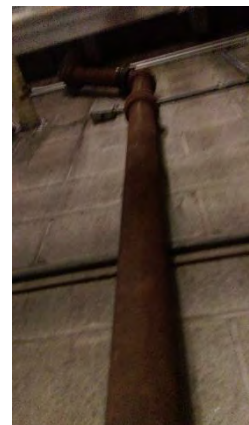
In general, cast iron is used for sanitary drainage. Piping and fittings above slab are no-hub with coupling joints and bell and spigot. Where visible, the cast iron pipe appears to be in poor condition. Smaller pipe sizes appear to be copper for waste (Image 12).

*Image 12 – Cast Iron Piping*

In general, existing cast iron drainage piping can be re-used, if sized appropriately. We recommend video inspection of existing drains to confirm integrity.

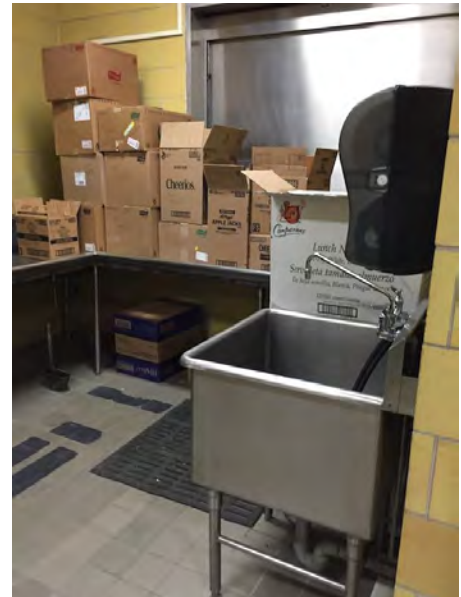
Image 1

The kitchen is spacious but the equipment is antiquated. Some has failed and is no longer used. For example, what was the dish room sits idle and is being used as storage of not only dry goods but for placement of equipment that is broken down and no longer used (image 1).

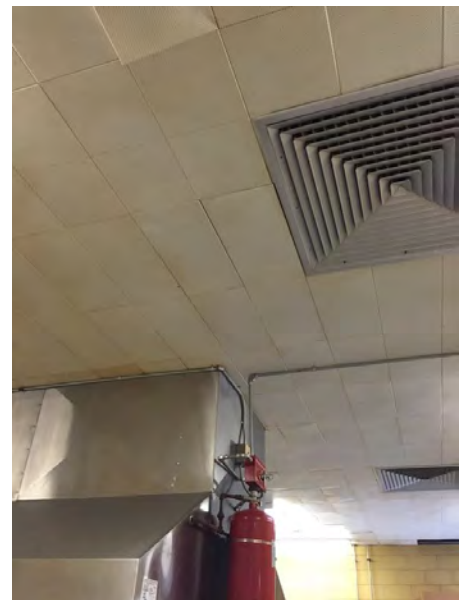
Image 2

The kitchen is equipped to serve the typical school lunch program in a single serving line configuration. Floors and walls are constructed of the appropriate materials and have held up well. The ceiling is not of an appropriate material and in some locations is deteriorating (Image 2).
